SWEDE JOHNSON CREEK FISH AND FISH HABITAT INVESTIGATION

EDI PROJECT NO.: 08-YC-0027

JANUARY 2009

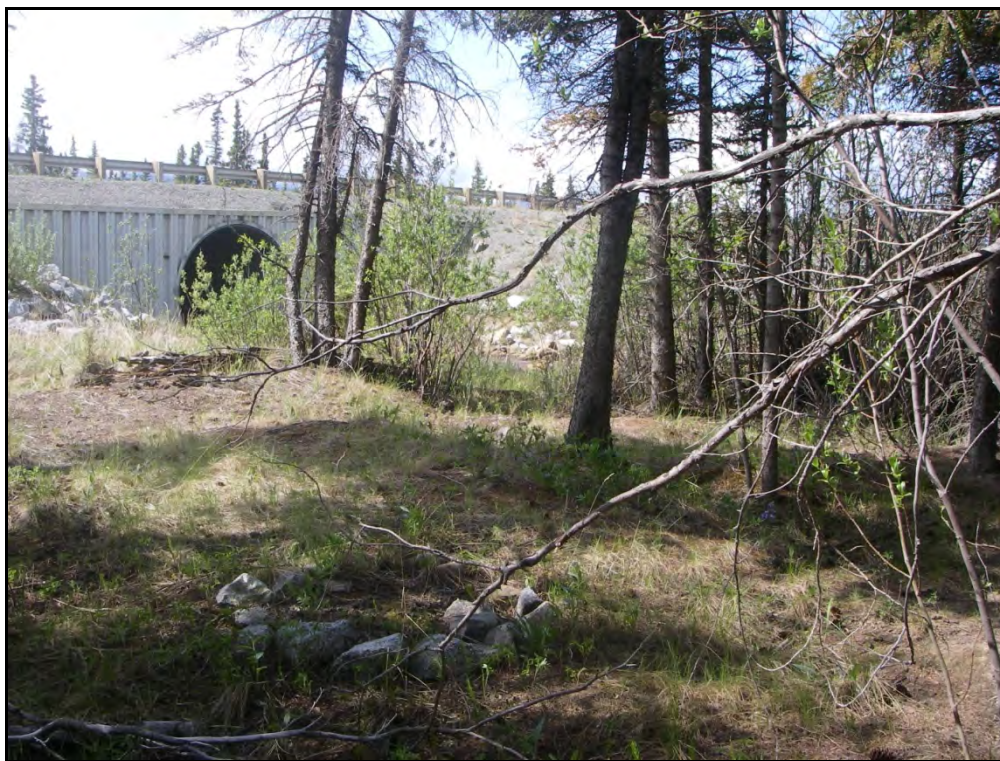
The main fishing location historically visited by the KFN for Arctic grayling fishing was at the downstream outlet of the highway crossing at Tributary 1. There remains at this site traces of a past ‘fish camp’, with a fire ring, and bars set up for hanging fish (Photo 1). It should be noted that the original culvert at this crossing was perched by 0.20 m, potentially creating a barrier to fish passage and allowing for increased harvesting at the culvert outlet; however, adult grayling should be capable of overcoming a 20 cm obstruction. Parker (2000) lists the jumping ability of adult Arctic grayling to be 1.0 m provided there is a pool of 1.25 m. Another complicating factor, however is that the culvert was determined to be undersized; there may have been a velocity barrier associated with high flows moving through a small diameter culvert. If this culvert did present a barrier to fish passage, it potentially explains the high fisheries value of this location, and why that fishery was hurt with the replacement of the old culvert with a newer, larger model that presented no barriers to fish passage.

Photo 1. Remains of small ‘fish camp’ at Tributary 1 (Highway crossing km 1799.2)

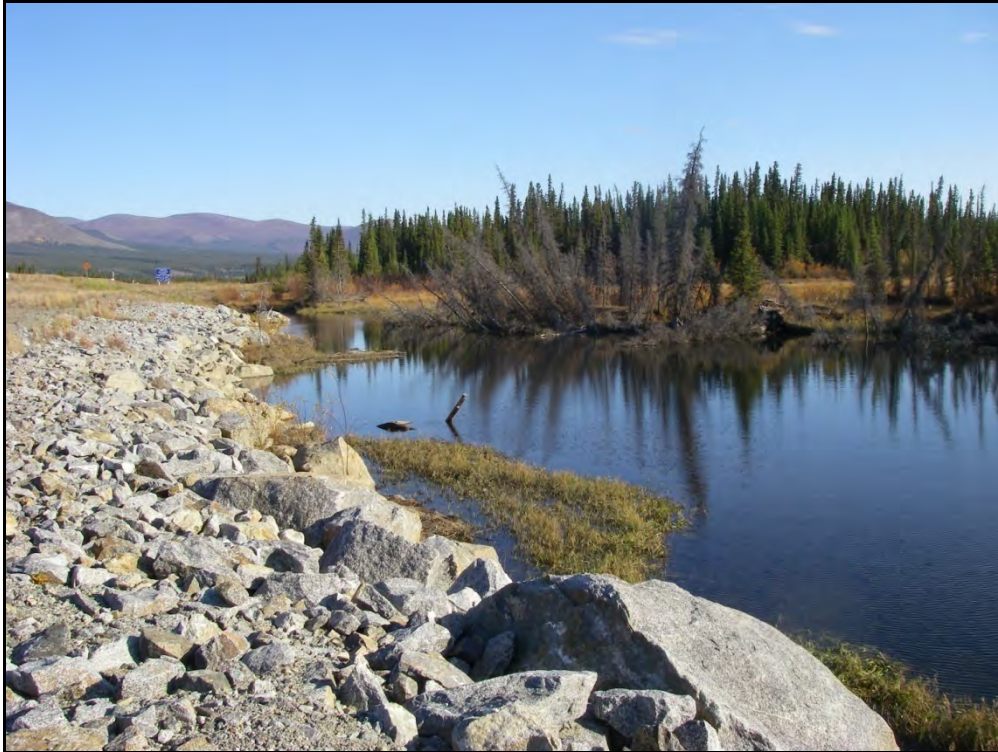
In addition to the replacement of the three culverts, improvements to the highway required infilling of 750 m² surface area of the wetland (average depth approximately 1 m) along the west side of the highway (Photo 2). Because this infilling led to a loss in fish habitat, it was determined that this habitat must be

Photo 2. Infill area along west side of highway north of the Swede Johnson crossing.

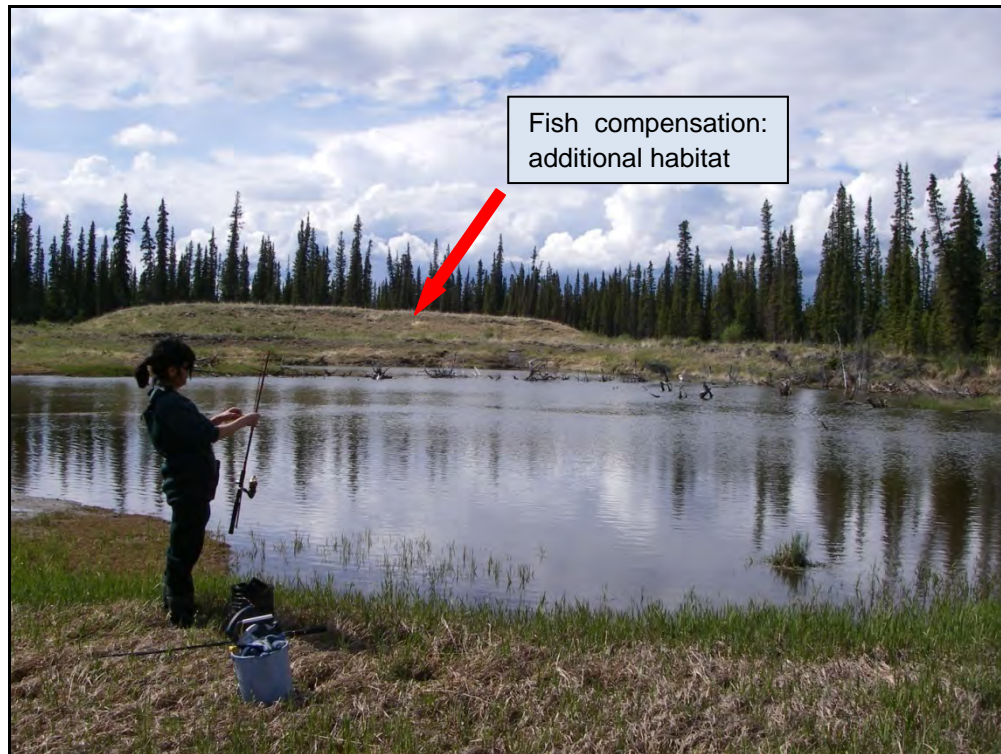
compensated for through creation of new habitat elsewhere. The loss of this habitat was compensated for through the creation of 1,200 m² of additional habitat within the wetland complex (average depth to be approximately 1 m), located on the northeast edge of the pond (Photo 3). This habitat compensation led to the net increase of 450 m² (1,200 m² - 750 m²) of new fish habitat. It was anticipated that with existing groundwater levels and surface flow into the wetland there would not be any significant impact to overall water levels within the wetland complex associated with the creation of new habitat (Water License MS-99-141, Amendment).

Photo 3. Wetland complex showing additional habitat dug out as compensation for infill area.

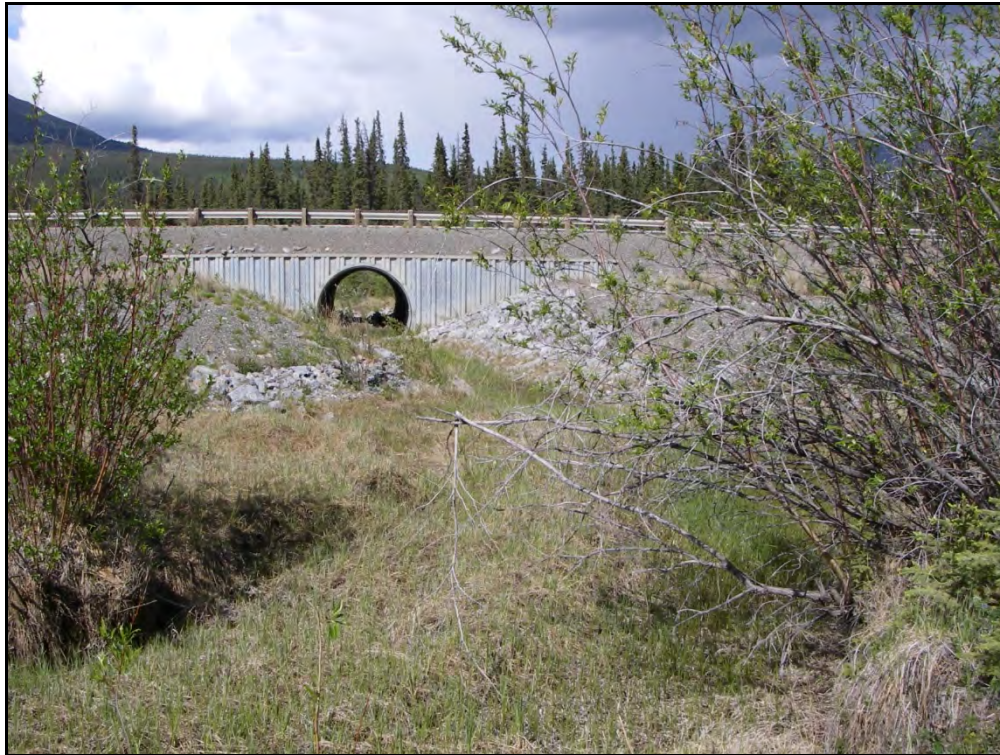
At the Swede Johnson Creek crossing no water was flowing through the culvert during either the spring or late summer investigation. The large amount of terrestrial vegetation including grasses and shrubs immediately upstream of the culvert provides evidence that water has not flowed through this channel in quite some time (Photo 6).

Photo 6. Dry channel bed in Swede Johnson Creek just upstream of culvert, looking downstream.

A possible explanation for the cessation of water flow in the Swede Johnson culvert is that the inlet channel for the crossing was not dug deep enough to allow water passage from upstream Swede Johnson Creek to be, in part, diverted into the culvert channel, causing the entire flow to move into the wetland complex. Local topography provides evidence of recent increased water levels in the wetland complex. There are a number of large coniferous trees in the centre of the wetland. Water levels in the wetland complex remained steady enough for these trees to grow to maturity, however, in recent years, water levels have increased slightly and these trees drowned and are now standing dead. Unfortunately these increased water levels are not sufficient to reintroduce flow through the Swede Johnson culvert.

Alterations to Swede Johnson Creek, immediately upstream of the culvert at km 1798.9, to lower the bottom culvert inlet creek would re-introduce water flow through the culvert, and the section of the creek immediately downstream of the highway. This alteration would increase Arctic grayling habitat for migration, rearing and nursery uses in the watershed, and re-open access to the upstream wetland area. Beaver or beaver dam management may also be necessary to maintain a migration route through Tributary 1 and/or Swede Johnson Creek. Alterations to improve and increase fish habitat within the Swede Johnson watershed cannot guarantee an increase in the value of the Arctic grayling fishery in this area to the Kluane First Nation. However, there exists the possibility that this area could again be used by high numbers of Arctic grayling.

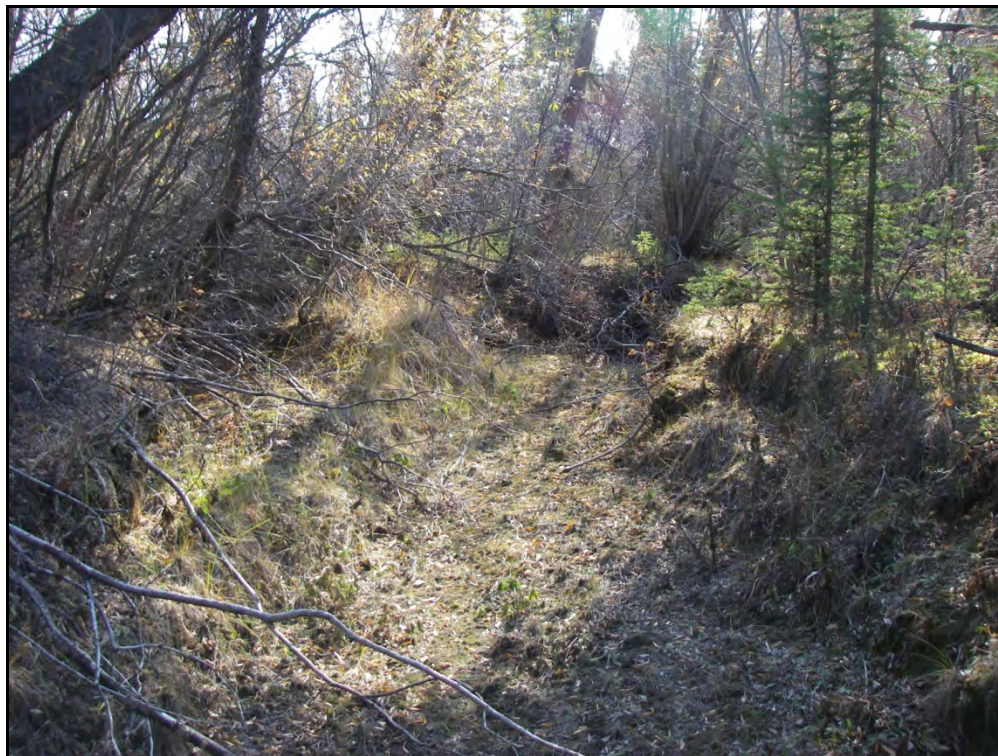
Photo 7. Swede Johnson Creek dry channel bed approximately 400 m downstream of highway crossing.

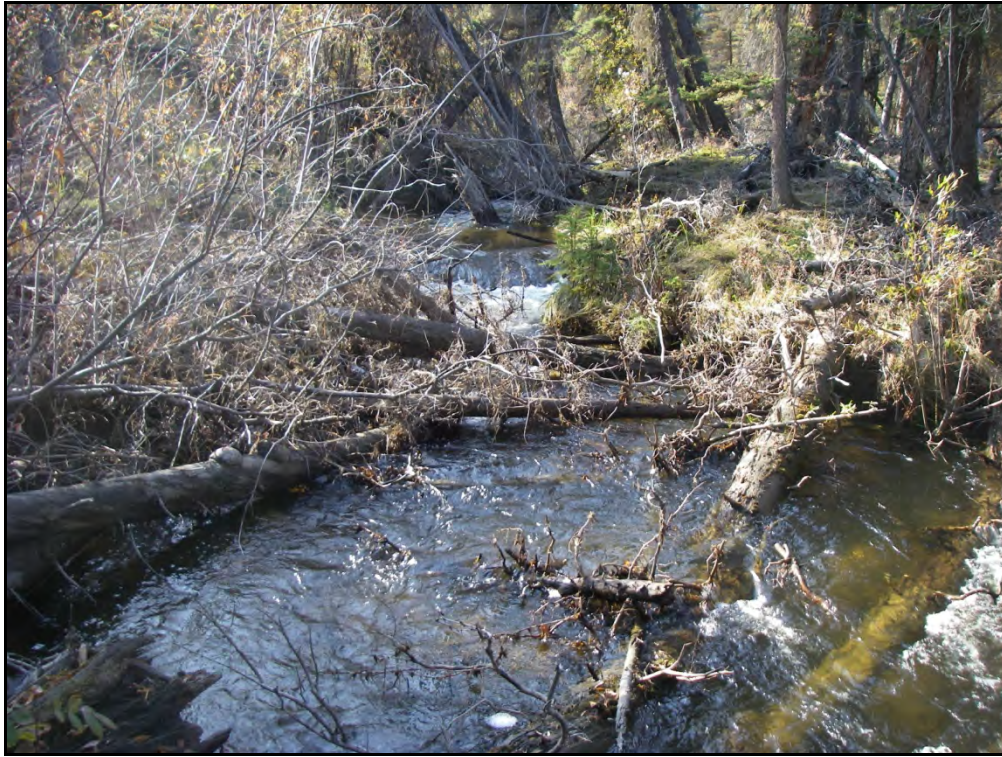
Photo 9. Log jam present on Swede Johnson Creek, just downstream of confluence with Tributary 1.

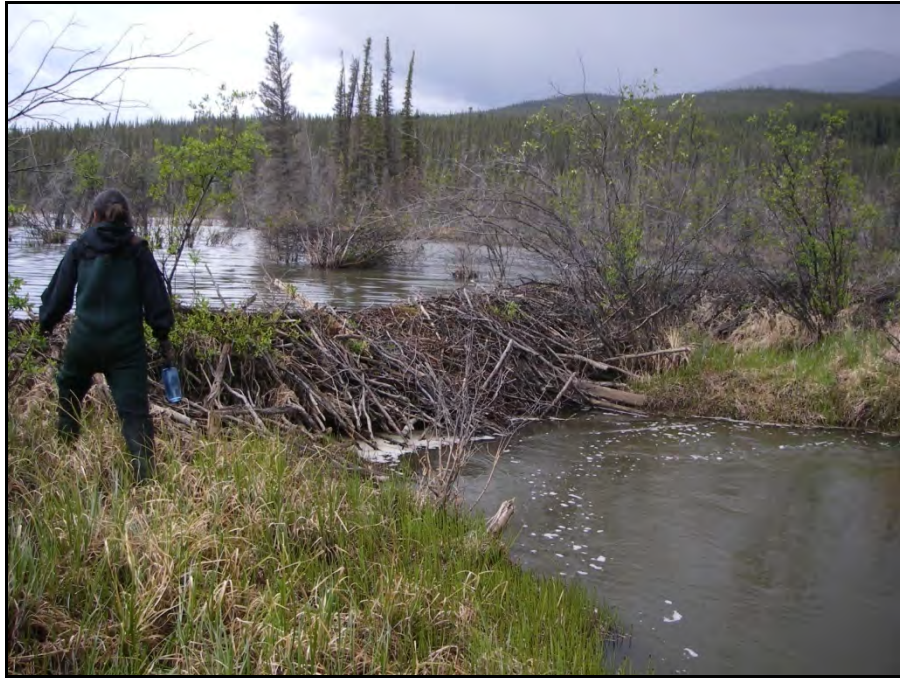
Approximately 500 m downstream from the Tributary 1 highway crossing (km 1799.2), a number of beaver dams have enlarged a pre-existing pond (Photo 15). This pond has beaver dams at both the inlet and outlet. While the upstream dam is not a complete barrier to fish passage (Photo 16), the downstream network of dams is very extensive, and can be considered an obstruction to fish passage (Photo 17).

Photo 17. One of the beaver dams which together creates an obstruction to fish passage at pond outlet.

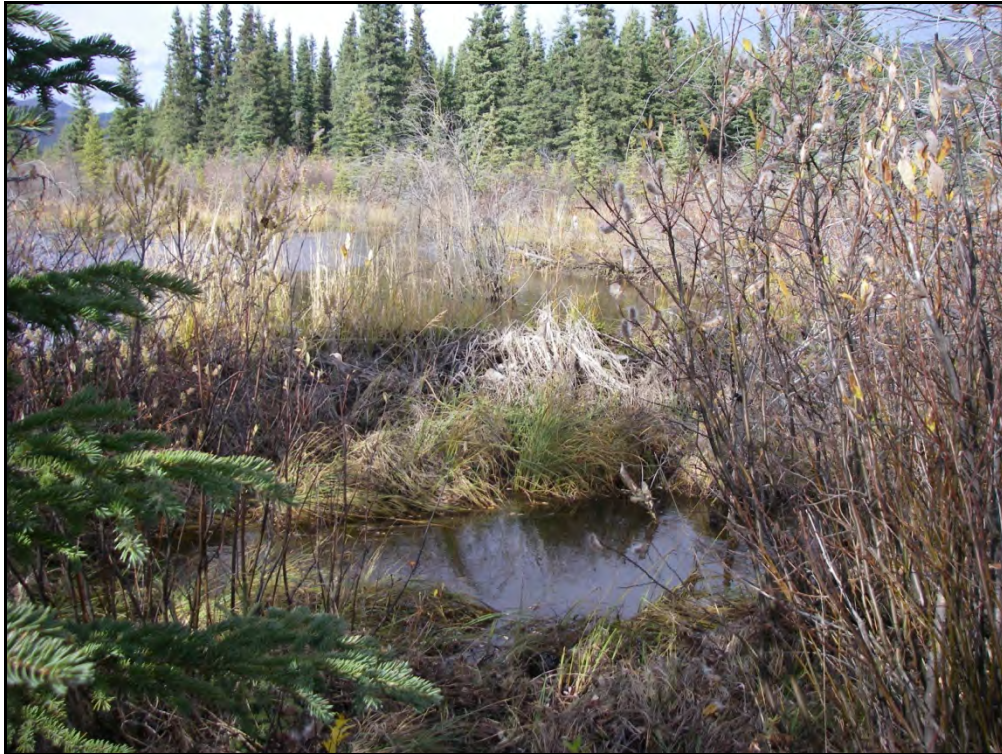
Cover was abundant, largely composed of small woody debris, with lesser amounts of undercut banks and overhanging vegetation. Riparian vegetation was composed largely of shrubs/willow and coniferous forest. Crown closure in some areas was quite high, largely due to the narrow channel width and abundance of willows in the riparian areas. Approximately 750 m upstream from the highway crossing the first in a series of beaver dams is present. These dams were thought to pose a significant barrier to all fish passage (Photo 18 and Photo 19).

The presence of these beaver dams prevents this stream from providing any valuable fish habitat upstream of the highway crossing. Downstream of the crossing, spawning habitat is poor due to a lack of suitable substrate; rearing habitat is very good due to an abundance of cover, with many small pools and moderate flow velocities; overwintering potential is poor due to general shallow depth of the watercourse.

Photo 18. Beaver dam on Tributary 2 which both slows water flow and acts as a barrier to fish passage.

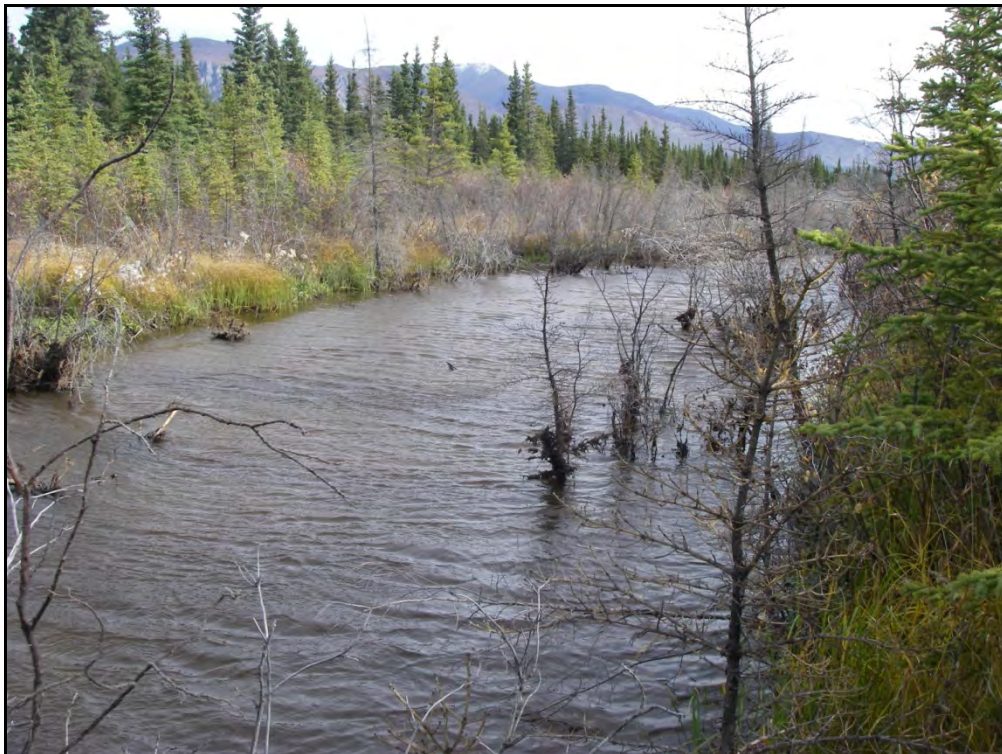
Photo 19. Backwater area on Tributary 2, upstream of largest of the beaver dams.

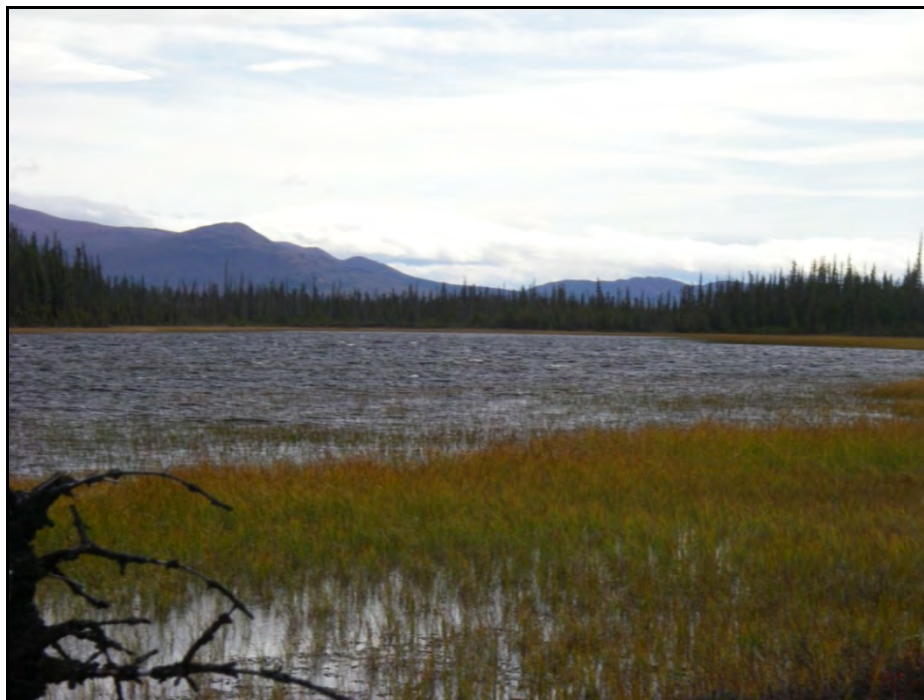
Waterbody 1 is small and narrow, and heavily vegetated (Photo 20). Though it appears from current mapping information that it is linked with Tributary 2 through an outlet approximately 1 km in length, this outlet is now entirely vegetated, and no open water channel is present (Photo 21). The historical channel can be seen as a break in the mature coniferous forest; however, the presence of small conifers in addition to grasses and shrubs throughout the area previously occupied by the water channel provides evidence that no water has been present for some time (Photo 22). This waterbody provides no fish habitat as there is no access, and the water depth is too shallow to permit overwintering.

Photo 20. View of Waterbody 1 from southeast point, looking northwest. Note heavily vegetated shorelines.

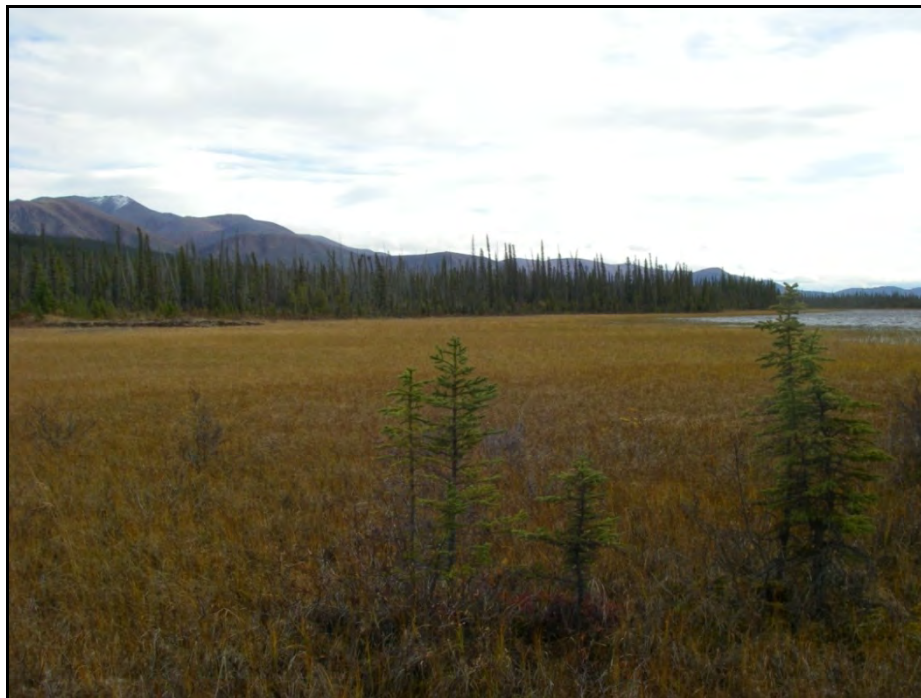
Photo 21. Location of mapped water body outlet, any watercourse previously present is now completely vegetated.
