# Hermit Lake Arctic Grayling Investigation and Restoration Planning

## **EDI Project**

20Y0105

April 2021

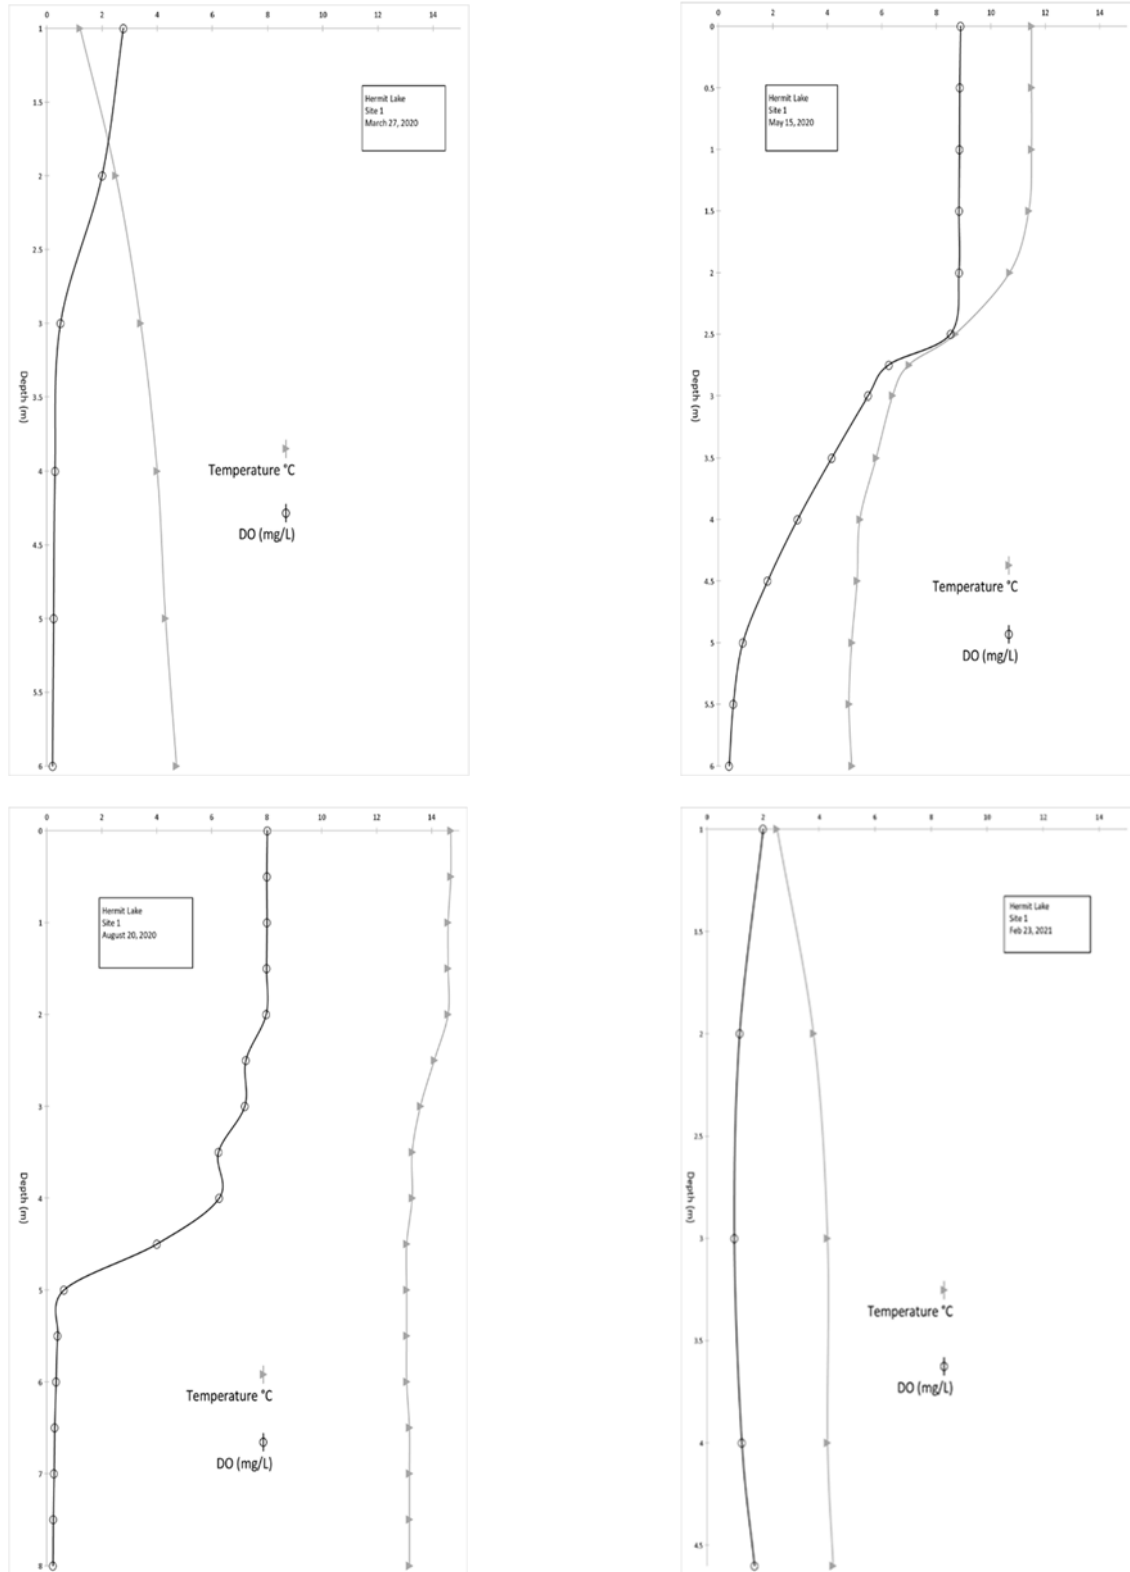
Figure 1. Dissolved oxygen profiles in Hermit Lake between March 27, 2020 and February 23, 2021.

Dissolved oxygen profiles collected at Hermit Lake on March 27, 2020 and February 23, 2021 showed similar results with overall low dissolved oxygen (below 3.0 mg/L) throughout the water column and water temperatures between 2 and 4 °C (Figure 1, top left and bottom right). These profiles were collected at the deepest spot in Hermit Lake and field crews did not observe any areas signs of inflow or different ice conditions that may indicate different conditions in different parts of the lake.

Dissolved oxygen can be a limiting factor and can determine fish presence or absence in small lakes like Hermit Lake. Low oxygen levels over a period of time have been shown to cause lethal and/or physiological and behavioural effects, especially in young fish (CCME 1999). Late winter dissolved oxygen levels in the lake were quite low (maximum of 2.78 mg/L in 2020 and 2.71 mg/L in 2021). These levels are below the Canadian Water Quality Guideline for the Protection of Aquatic life of 6.5 mg/L in cold water (CCME Canadian Council of Ministers of the Environment 1999). While these guidelines are known to be conservative, the levels found in the late winter are well below this guideline. Interestingly, a recent study found that adult and juvenile Arctic grayling exhibited both increased ventilation rate and increased incidence of surface movement as dissolved oxygen concentrations dropped to 4 mg/L and speculated that 4.0 mg/L was a critical threshold for winter survival (Davis et al. 2019). Using this threshold, grayling overwintering would not be possible in Hermit Lake during the late winter of 2020 and 2021.

Dissolved oxygen profiles collected at Hermit Lake during the spring (May 15) and summer (August 20) 2020 found considerable different conditions compared to the winter months (Figure 1) with much higher dissolved oxygen levels. During the spring sampling event, dissolved oxygen levels were relatively high within the upper 2.5 m of the water column and decreased to low levels—similar to the winter—within the lower 2 m of the water column. The water temperature profile also showed evidence of stratification during this sampling event with temperatures over 11 °C at the surface, a rapid change within the thermocline at a depth of 2.0 to 2.5 m and a gradual decline to just above 3 °C near the bottom. The summer sampling event was completed at a slightly deeper location within the lake and showed high levels of dissolved oxygen within the upper 4.0 m, followed by a rapid reduction down towards 5.0 m, followed by very low dissolved oxygen within the lower 3 m of the water column. The water temperature profile during the late summer did not show stratification and temperatures decreased only slightly below the surface temperature of just over 14 °C.

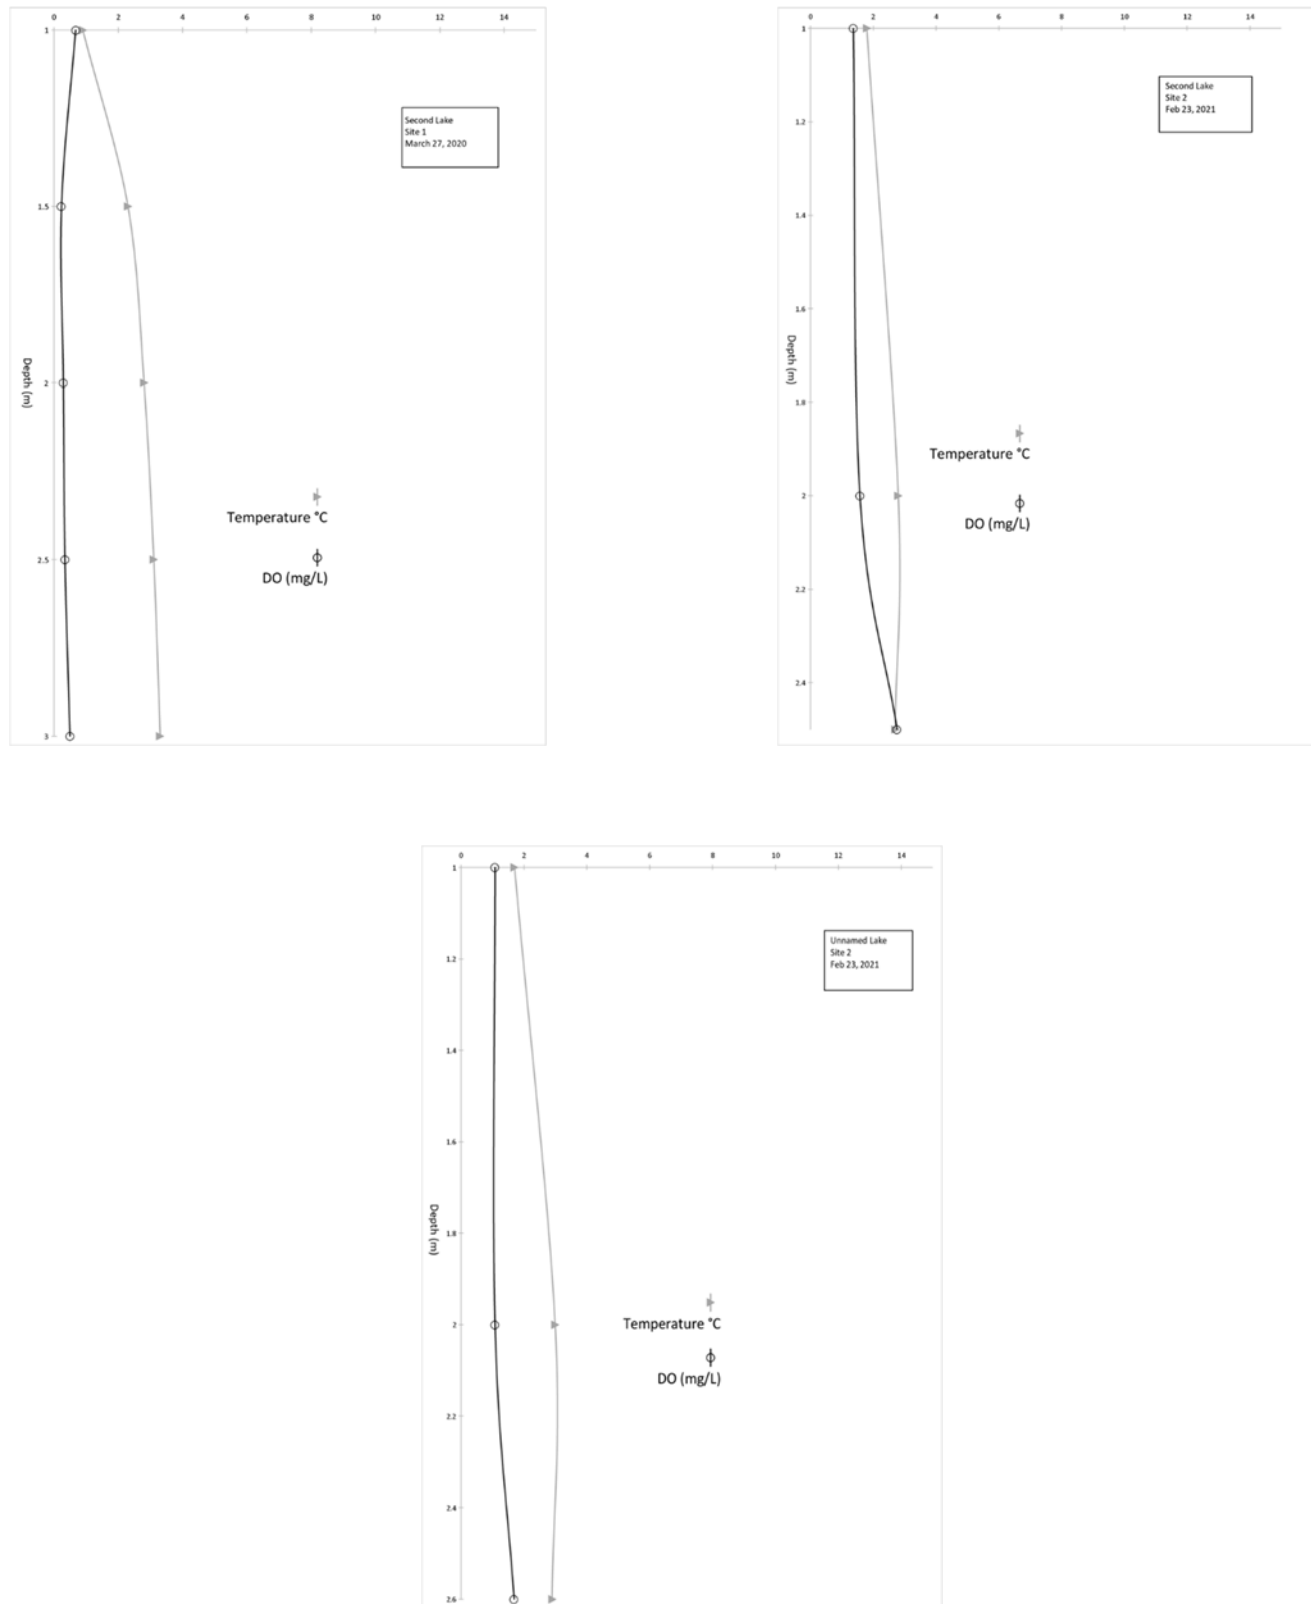
Figure 2. Dissolved oxygen profiles recorded between March 27, 2020 and February 23, 2021 in Second Lake (top) and Unnamed Lake (bottom).

Dissolved oxygen and temperatures were collected at Second Lake and an unnamed lake to provide perspective on the Hermit Lake data. Both of these lakes were also known to have Arctic grayling present as recently as 1999. However, the winter profiles collected at both lakes during the winter of 2020 and 2021 (Figure 2) recorded very low dissolved oxygen levels (below 3 mg/L) similar to that of Hermit Lake. Based upon these observations, the status of Arctic grayling within both of these lakes is also questionable. Due to summer access constraints, neither of these lakes were investigated during the summer months during the current assessment and it is therefore not possible to theorize what may have changed in these lakes over time.

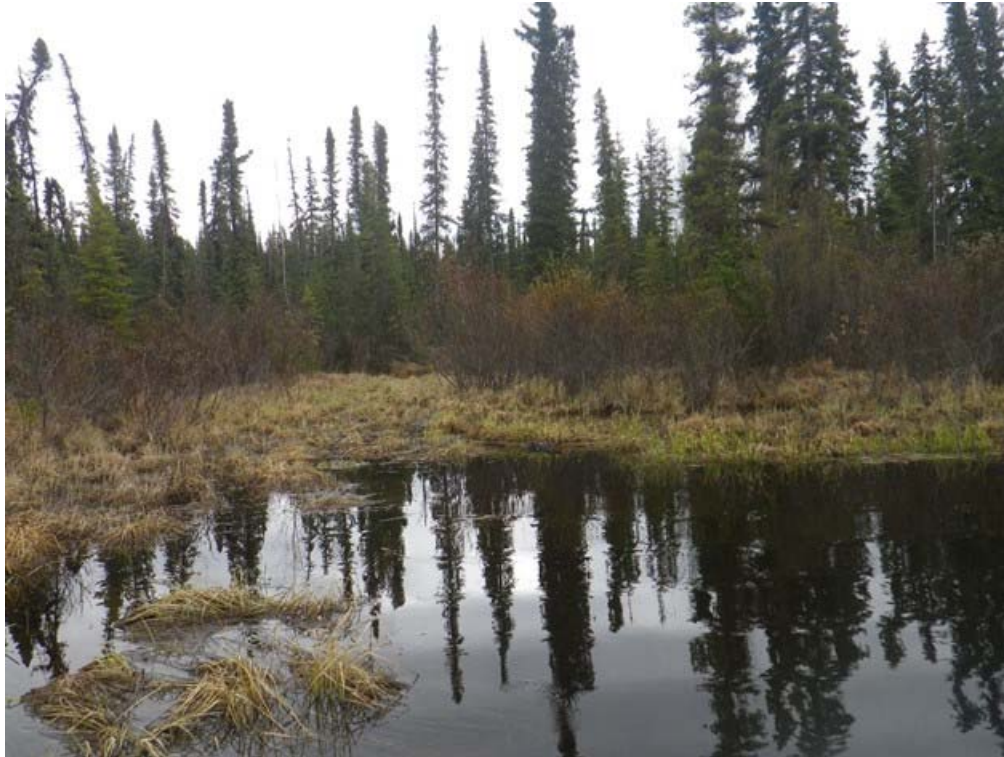
The first of two planned field investigations of the Hermit Creek area was conducted on May 15, 2020. The field crew started the investigation by walking downstream from the outlet of Hermit Lake. At the time of the investigation, the crew noted that there was no defined outlet at the south end of the lake and that flow was minimal (Photo 1 in Appendix A). The crew continued to walk downstream for 500 meters before ending the first portion of the investigation. They noted that there was a large amount of instream woody debris and that substrate was many composed of fines and organics. Flows were limited during this time (Photo 2 in Appendix A) suspected to be between 1 – 10 L/sec. As the crew moved further downstream, the stream was found to frequently go subsurface. No fish were observed in the creek or lake.

Photo 1. Downstream view of the outlet of Hermit Lake on May 15, 2020.

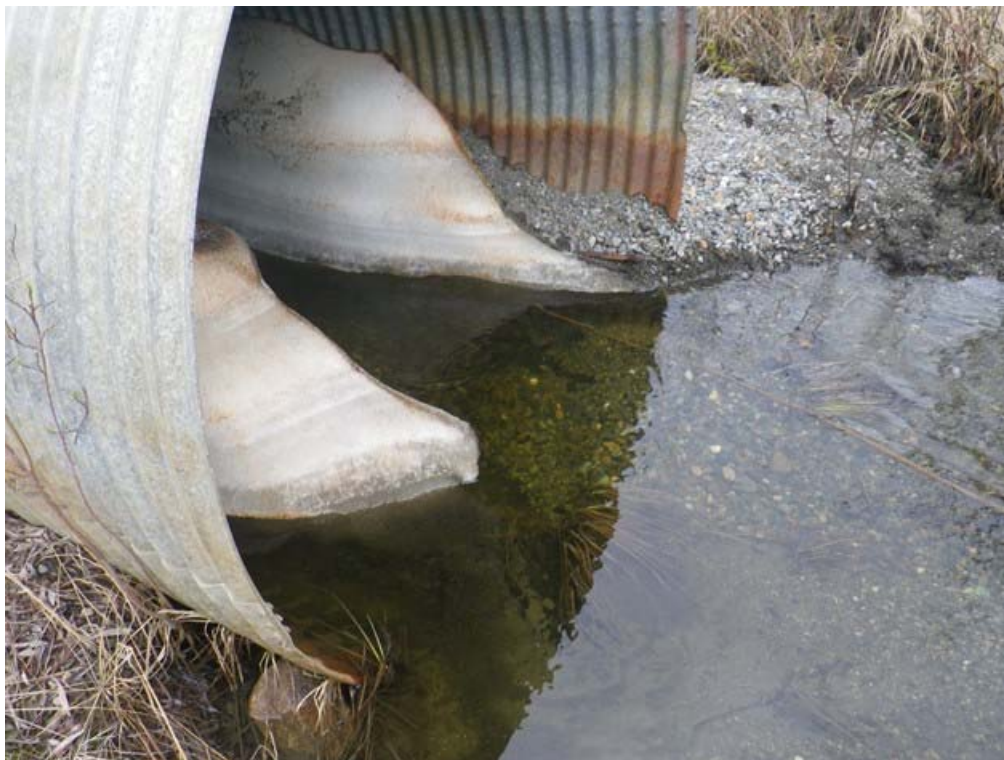
The second portion of the May 15 investigation included the portion of the stream between the Sawmill Road culvert and the outlet of Hermit Creek into Teslin Lake. At the time of the investigation, the Sawmill Road culvert appeared to be plugged with ice, but flow was observed at the downstream end (Photo 2 in Appendix A). The field crew continued to walk downstream of the culvert to an old bridge, observing natural woody debris throughout the creek channel and substrate consisting of fines and cobble. No fish were observed during the creek walk and the crew noted that the old bridge could be a potential impediment to upstream fish passage.

Photo 2. Downstream end of the Sawmill road culvert on May 15, 2020.

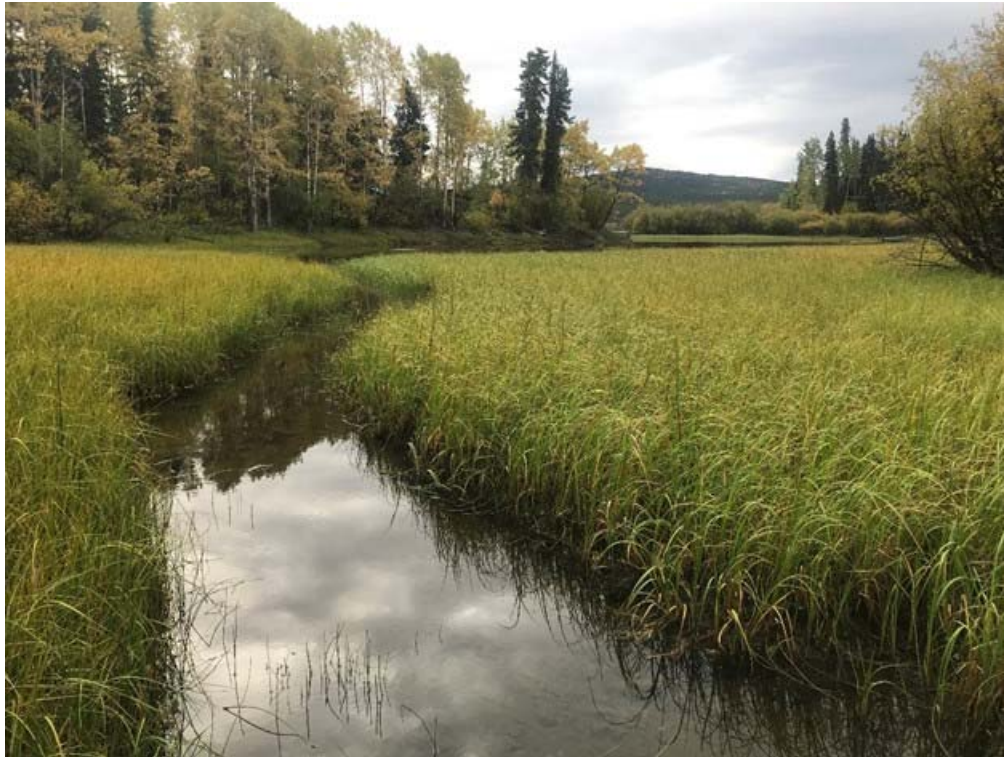
Photo 3. Downstream view of Hermit Creek outlet into Teslin Lake on September 9, 2020.

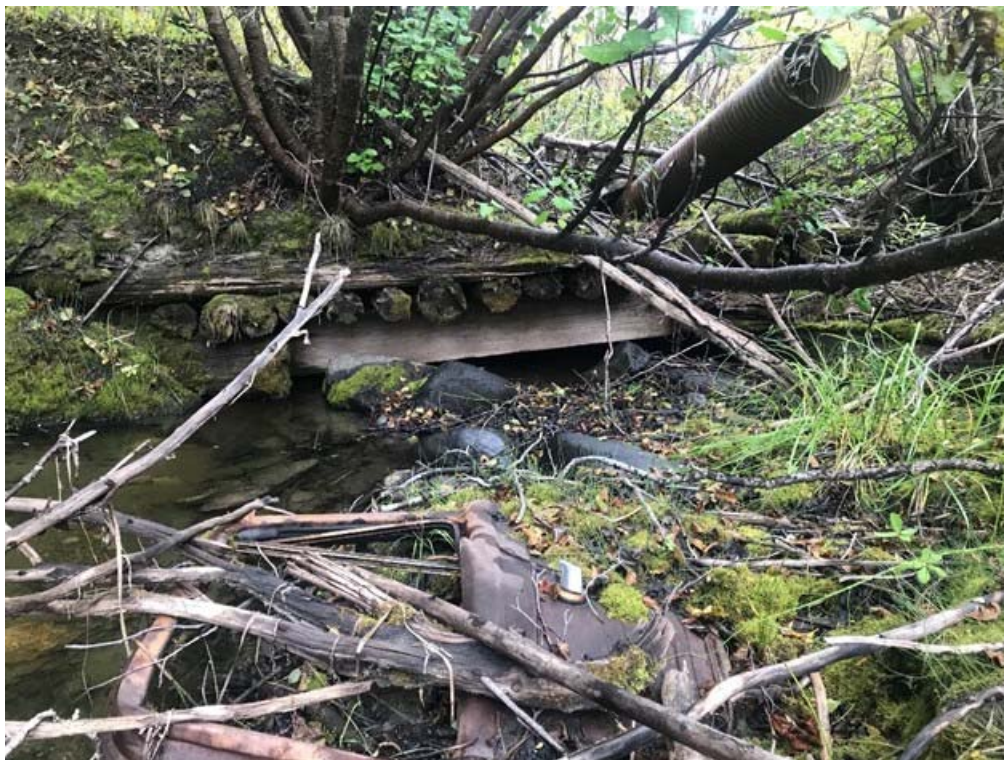
Photo 4. Upstream view of old bridge near the outlet of Hermit Creek on September 9, 2020.

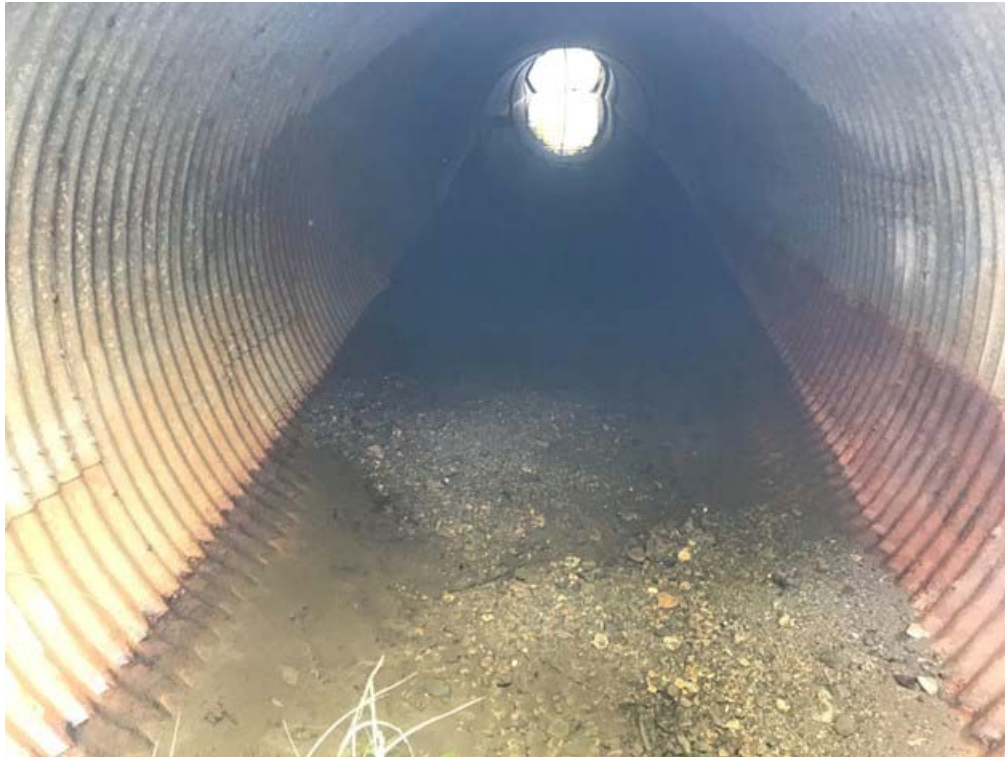
On September 9, 2020, a field crew walked the majority of Hermit Creek downstream of Hermit Lake in an upstream direction. Between the Sawmill Road culvert and Teslin Lake, it was noted that water flow was higher than previously observed during the 2018 investigation at the time of year. Habitat downstream of the old bridge was deemed to be good with some cover and instream vegetation for juvenile fish (Photo 3 in Appendix A); one juvenile pike was observed in the channel. Flow proceeded to be subsurface under the old bridge although fish passage was observed to be possible in high water conditions (Photo 4 in Appendix A). The crew noted that removal of the old bridge would help to improve habitat and upstream fish passage potential across a broader range of flow levels. Habitat upstream of the bridge included a poorly defined channel that extended to the Sawmill road culvert, with fish passage still a possibility although habitat quality was deemed to be poor. At the time of the investigation, the Sawmill Road culvert was back watered allowing for fish to pass through to the upstream end (Photo 5 in Appendix A).

Photo 5. View of Sawmill road culvert from the upstream end looking downstream on September 9, 2020.

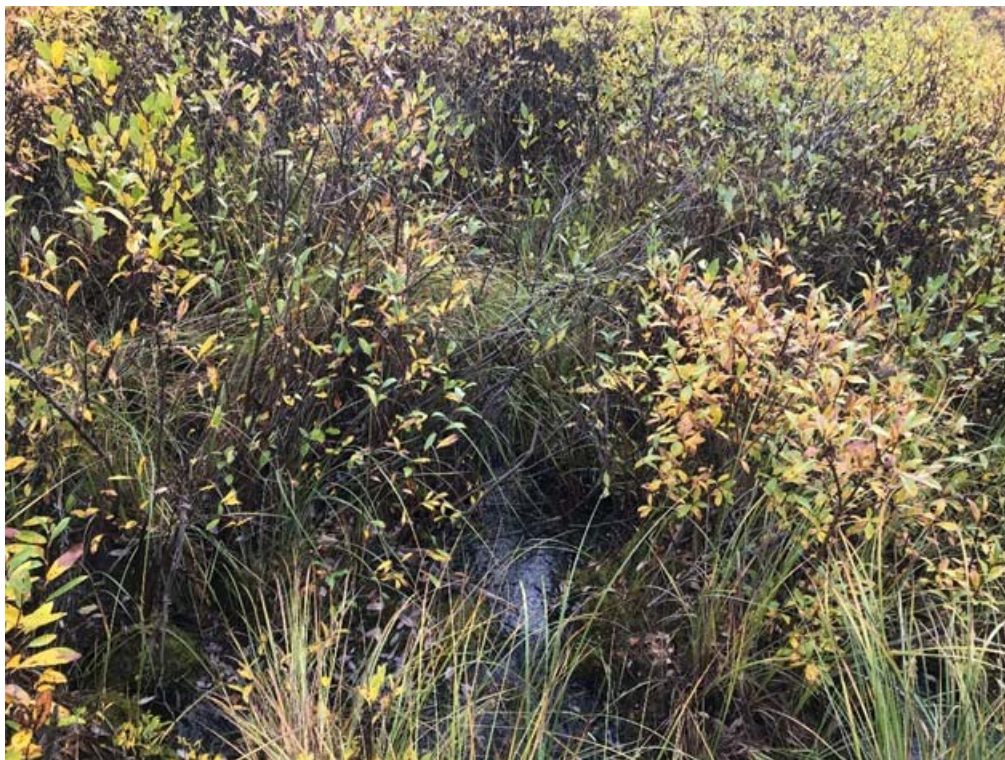
Surface flow remained consistent for the first 100 meters above the Sawmill Road culvert until the creek passed under powerlines where it branched off into shallow braids, taking on the characteristics of a wetland area (Photo 6 in Appendix A). Between 230 and 360 meters upstream from the culvert, the creek had inconsistent concentrated flow, often going subsurface and was likely unpassable by fish. At 390 meters upstream the creek reverted to a more defined channel with concentrated flow until approximately 480 meters. At this point the creek was shallow and flow was spread out (Photo 7 in Appendix A) with no presence of

Photo 6. Hermit Creek approximately 200 meters upstream of the Sawmill culvert on September 9, 2020.

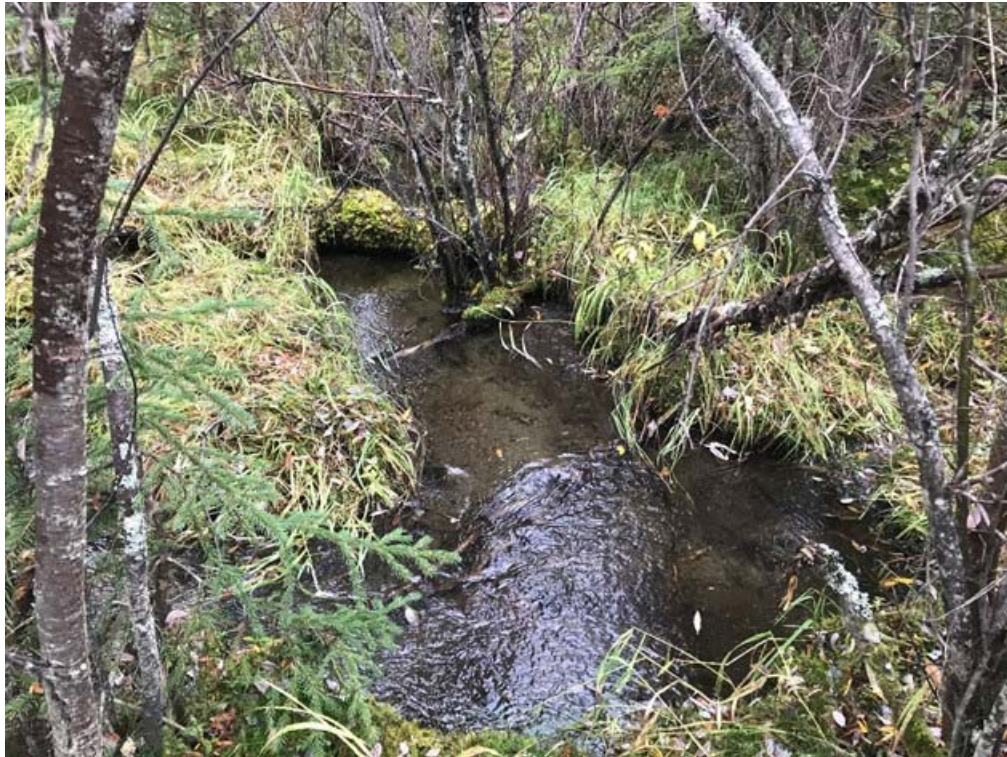
pools, posing a challenge for fish passage. The field crew continued to walk until 570 meters upstream of the Sawmill Road culvert where the creek continued to have concentrated flow. The substrate of the creek was composed of fines and sands throughout. No fish were observed between the Sawmill Road culvert and the end of the survey at 570 m upstream.

Photo 7. Hermit Creek 480 meters upstream of the Sawmill road culvert on September 9, 2020.

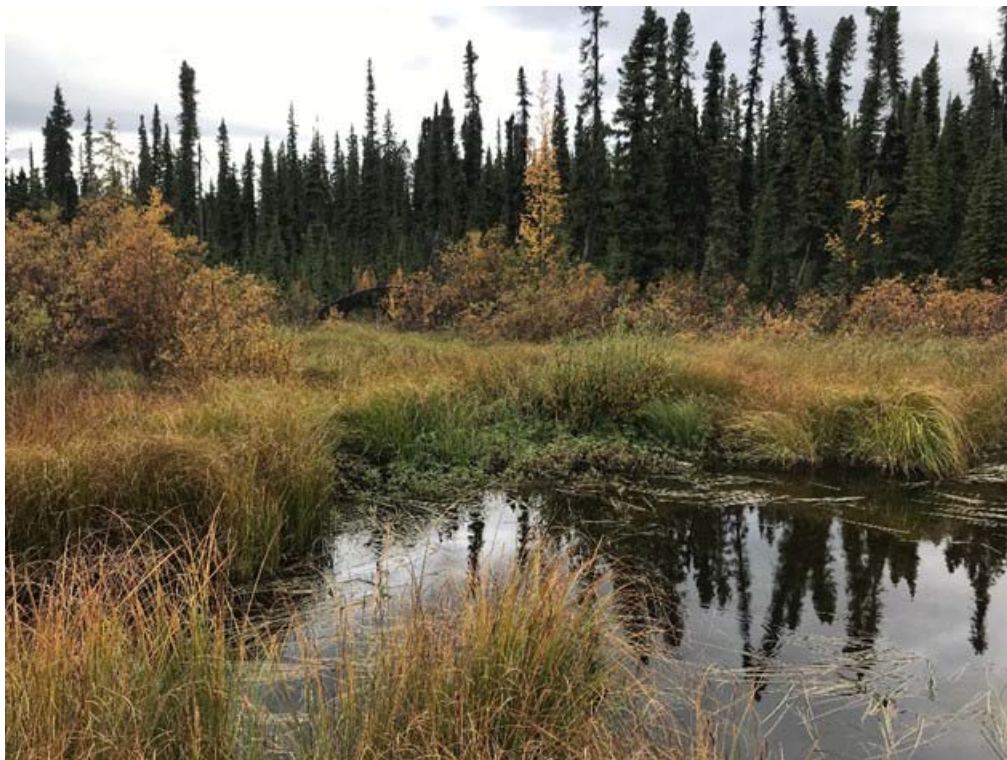
The outlet of the Hermit Lake was found to be poorly defined at the time of the field assessment (Photo 8 in Appendix A) and there was no noticeable flow until after an ATV bridge approximately 30 meters downstream of the lake (Photo 9 in Appendix A). Habitat quality increased below the ATV bridge to about 200 meters downstream, where there were pockets of substrate including fines and some rocks (Photo 10 in Appendix A).

Photo 8. Outlet of Hermit Lake on September 9, 2020.

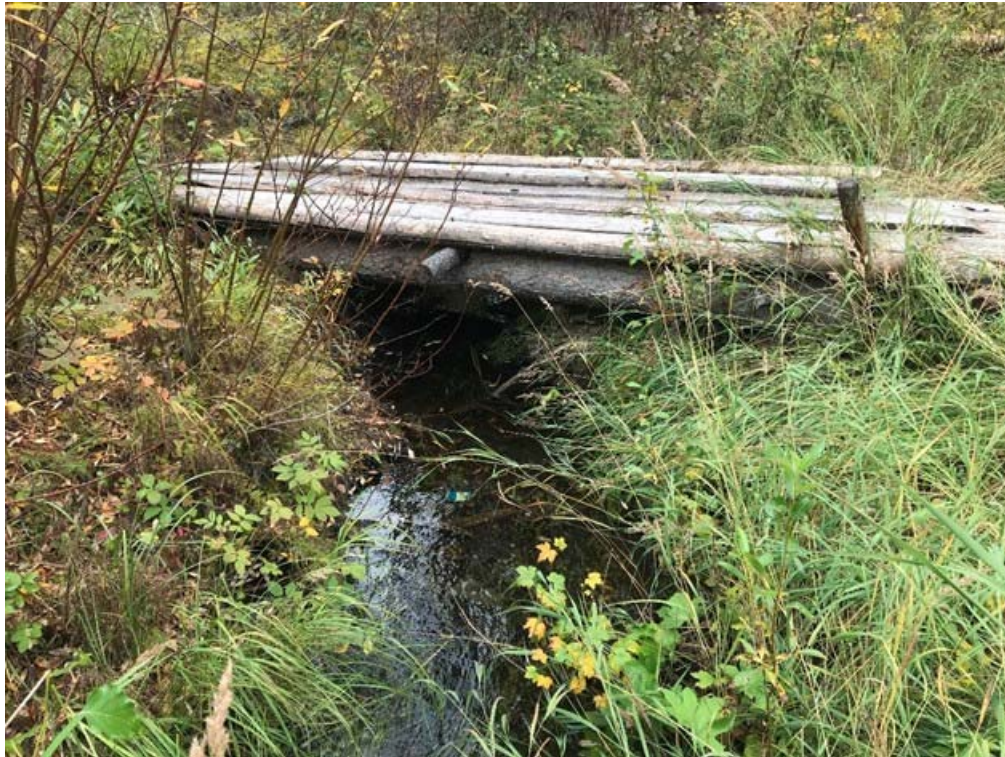
Photo 9. Upstream view of flow under the ATV bridge downstream of Hermit Lake on September 9, 2020.

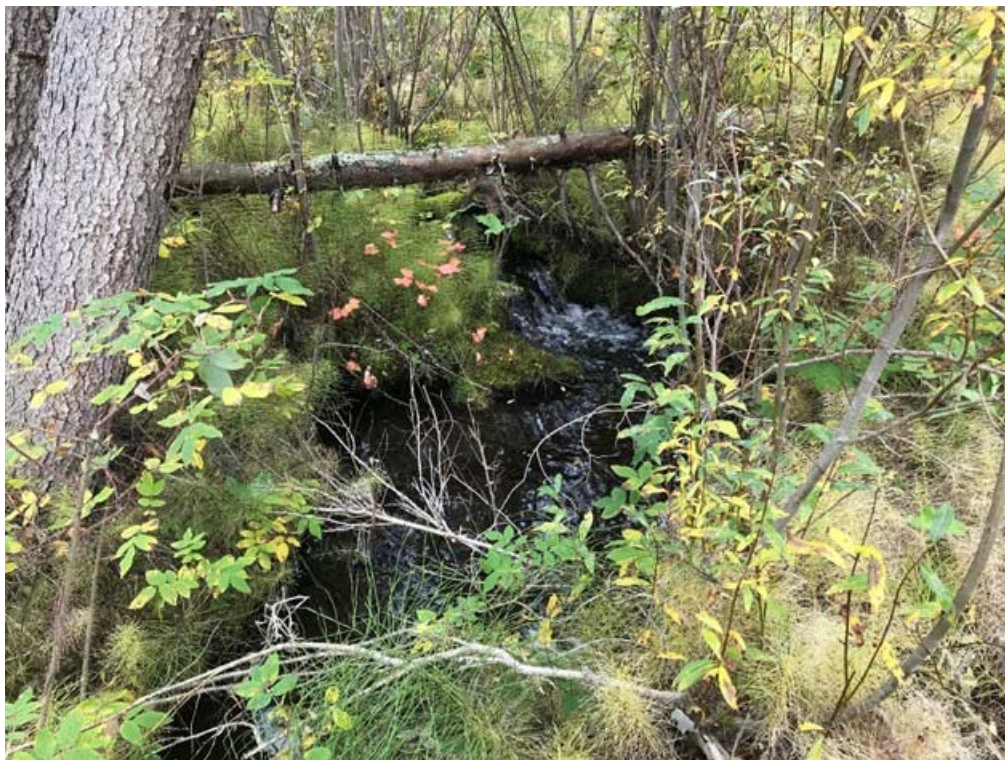
Photo 10. Upstream view of Hermit Creek approximately 200 meters downstream of Hermit Lake on September 9, 2020.
