Haines Junction Candidate Stocked Lake Investigations

Alsek Renewable Resource Council
180 Alaska Highway
Haines Junction, YT Y0B 1L0

EDI Environmental Dynamics Inc.
2195 2nd Ave
Whitehorse YT Y1A 3T8

22Y0129
Version: 1
April 2023

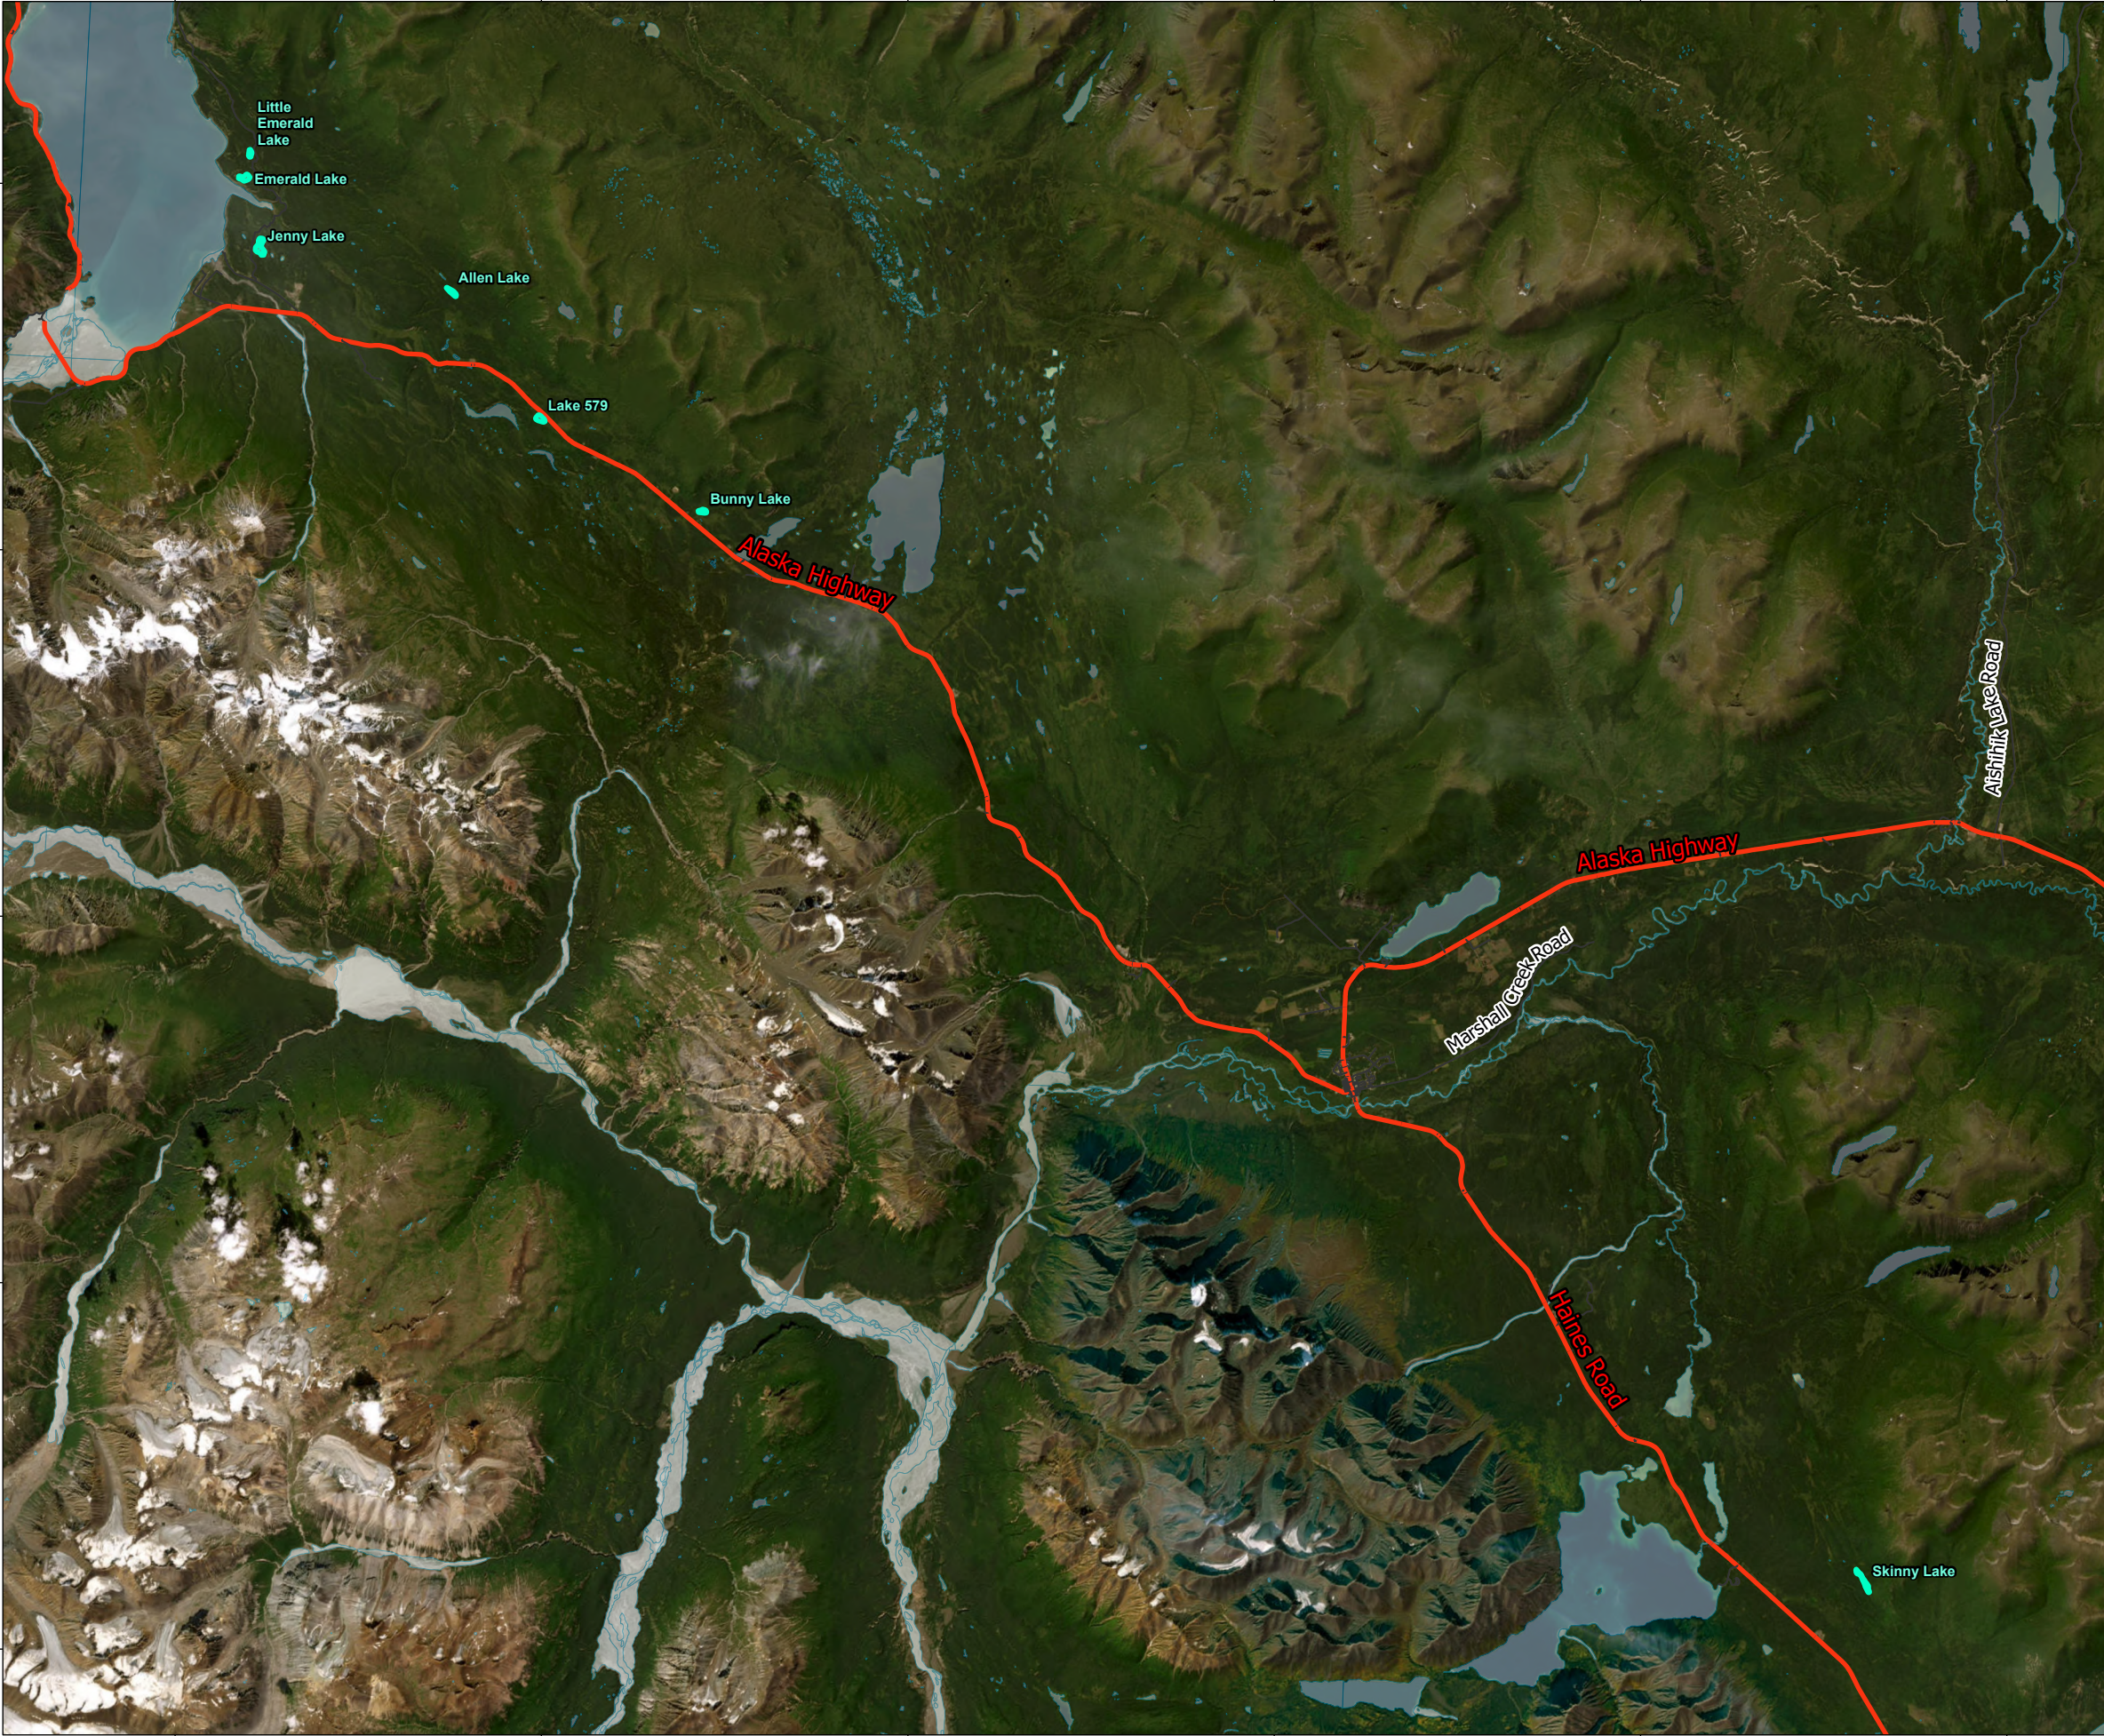
Drawn: O. Leblanc	Checked: A. MacPhail	Map 1	Date: 2023-03-28
----------------------	-------------------------	-------	------------------

Candidate stocked lakes visited during
March 2022

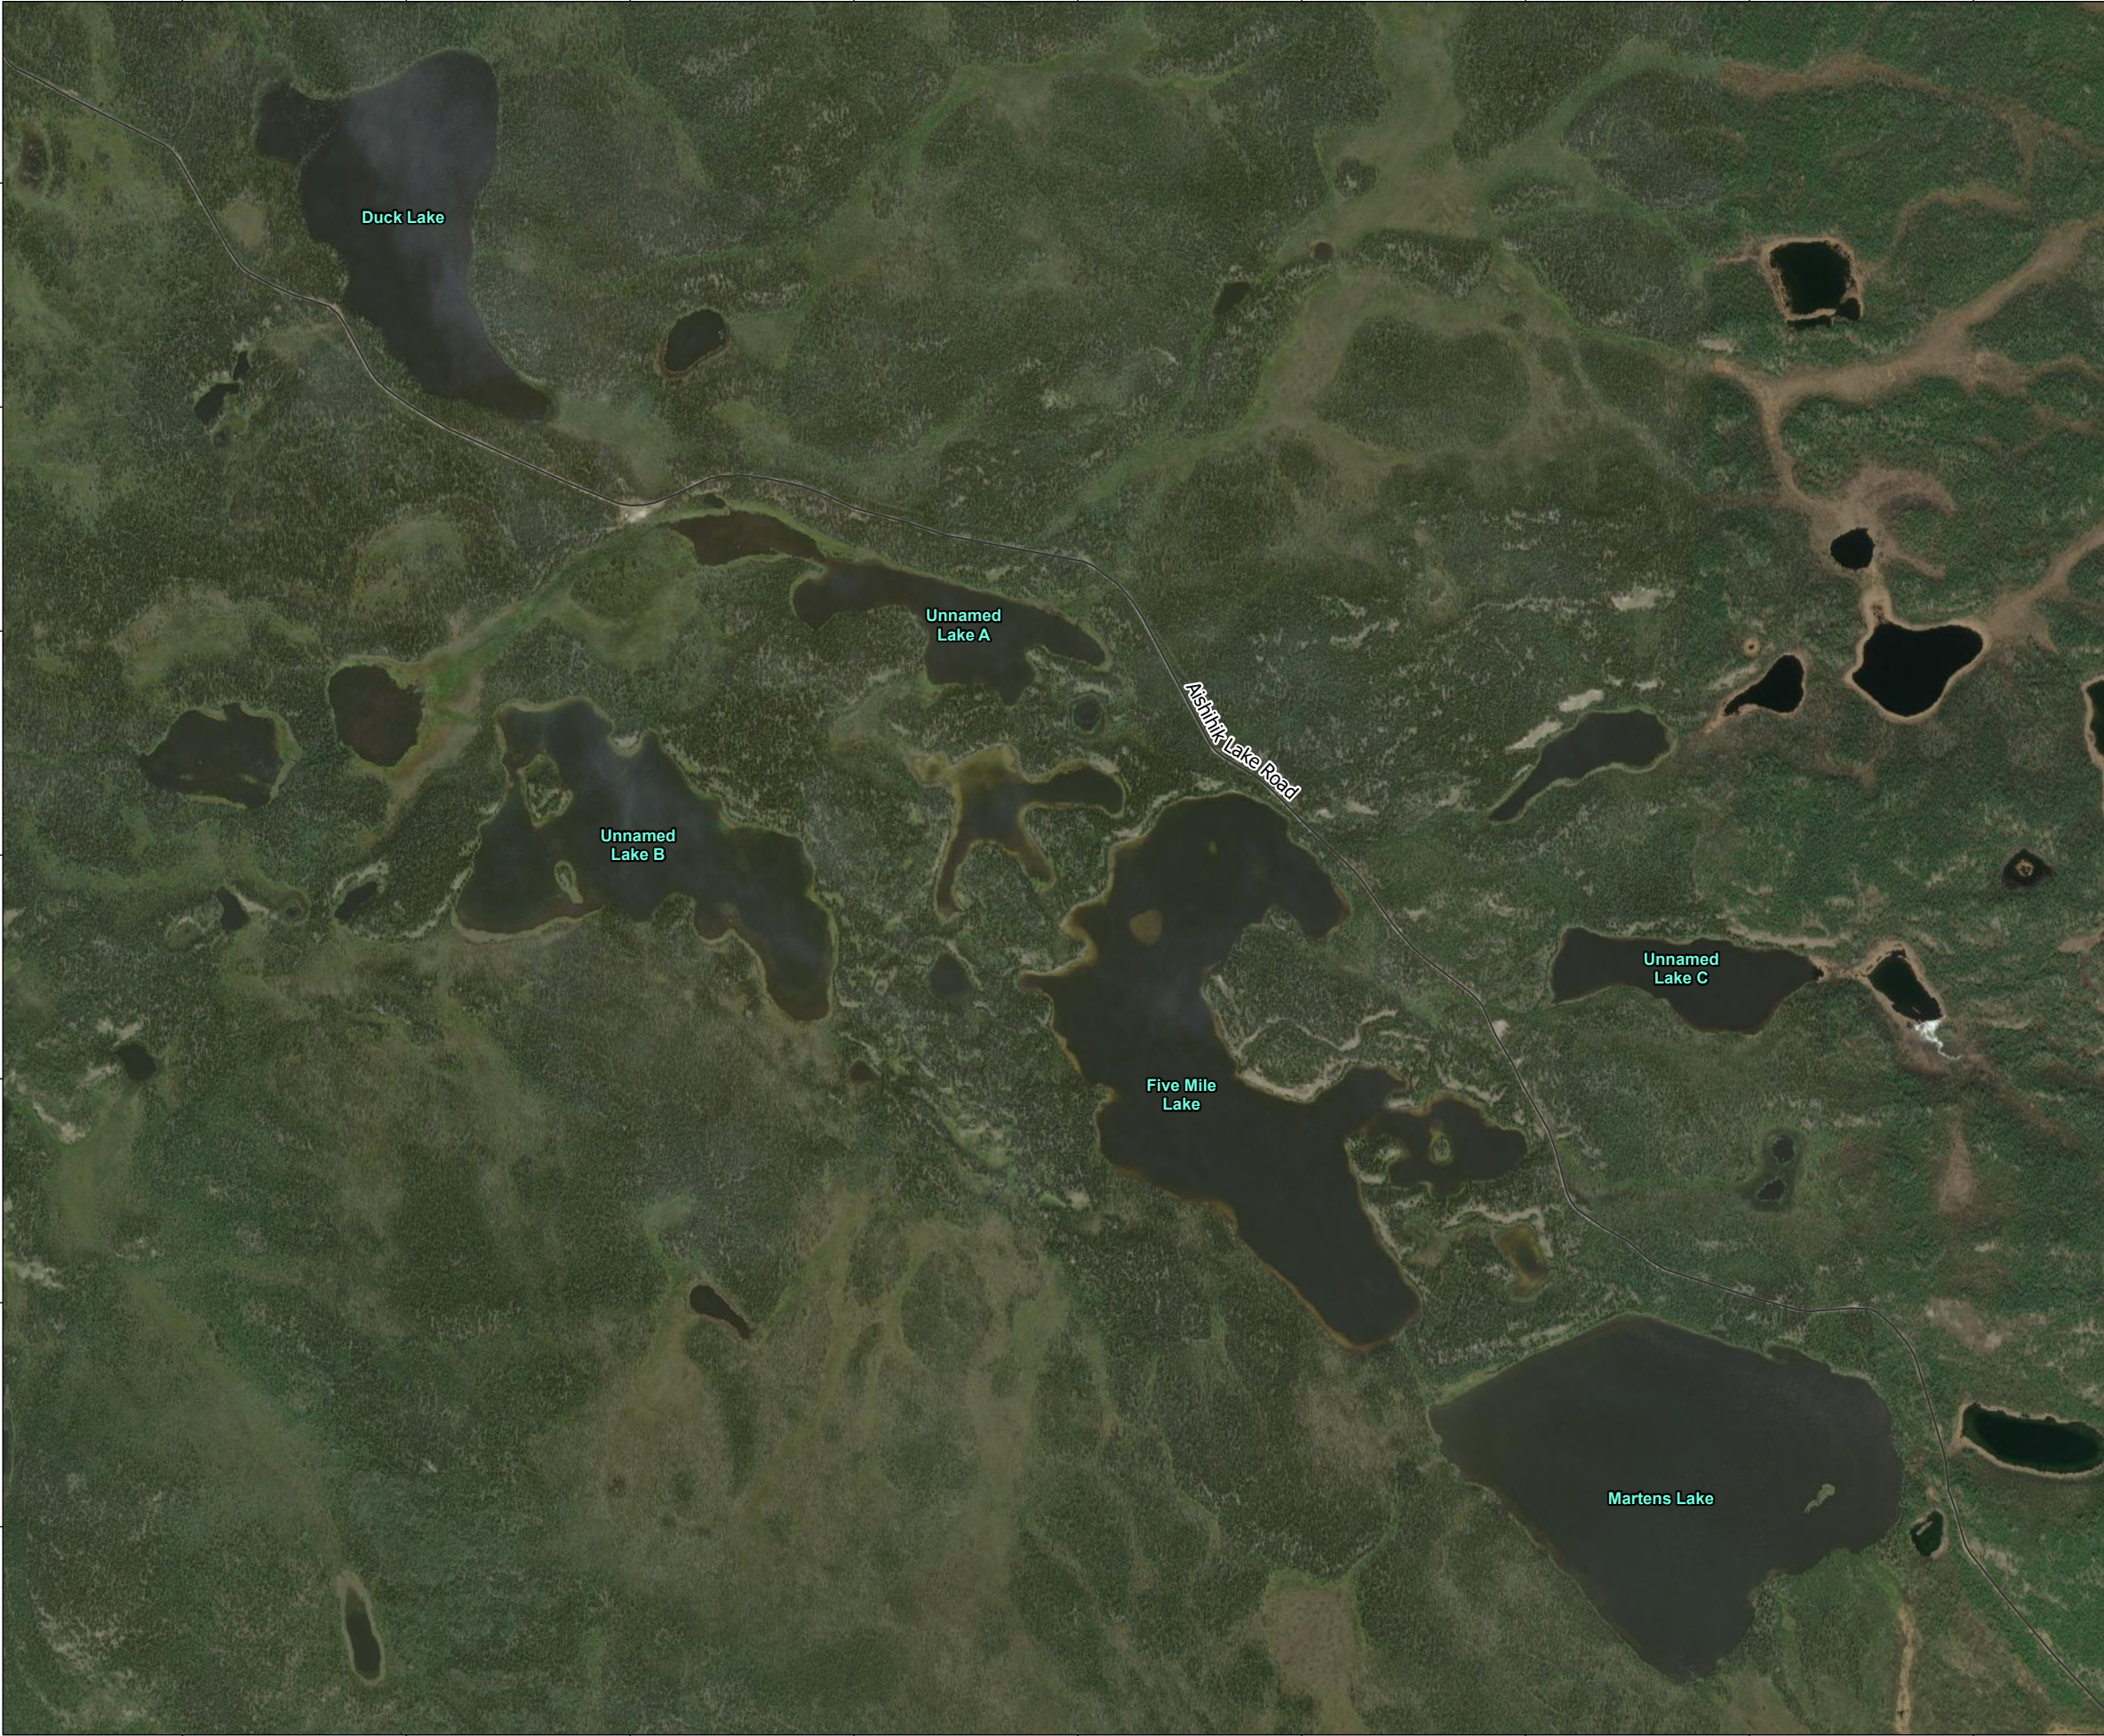
Map 2

Candidate Stocked lakes visited during
September 2023

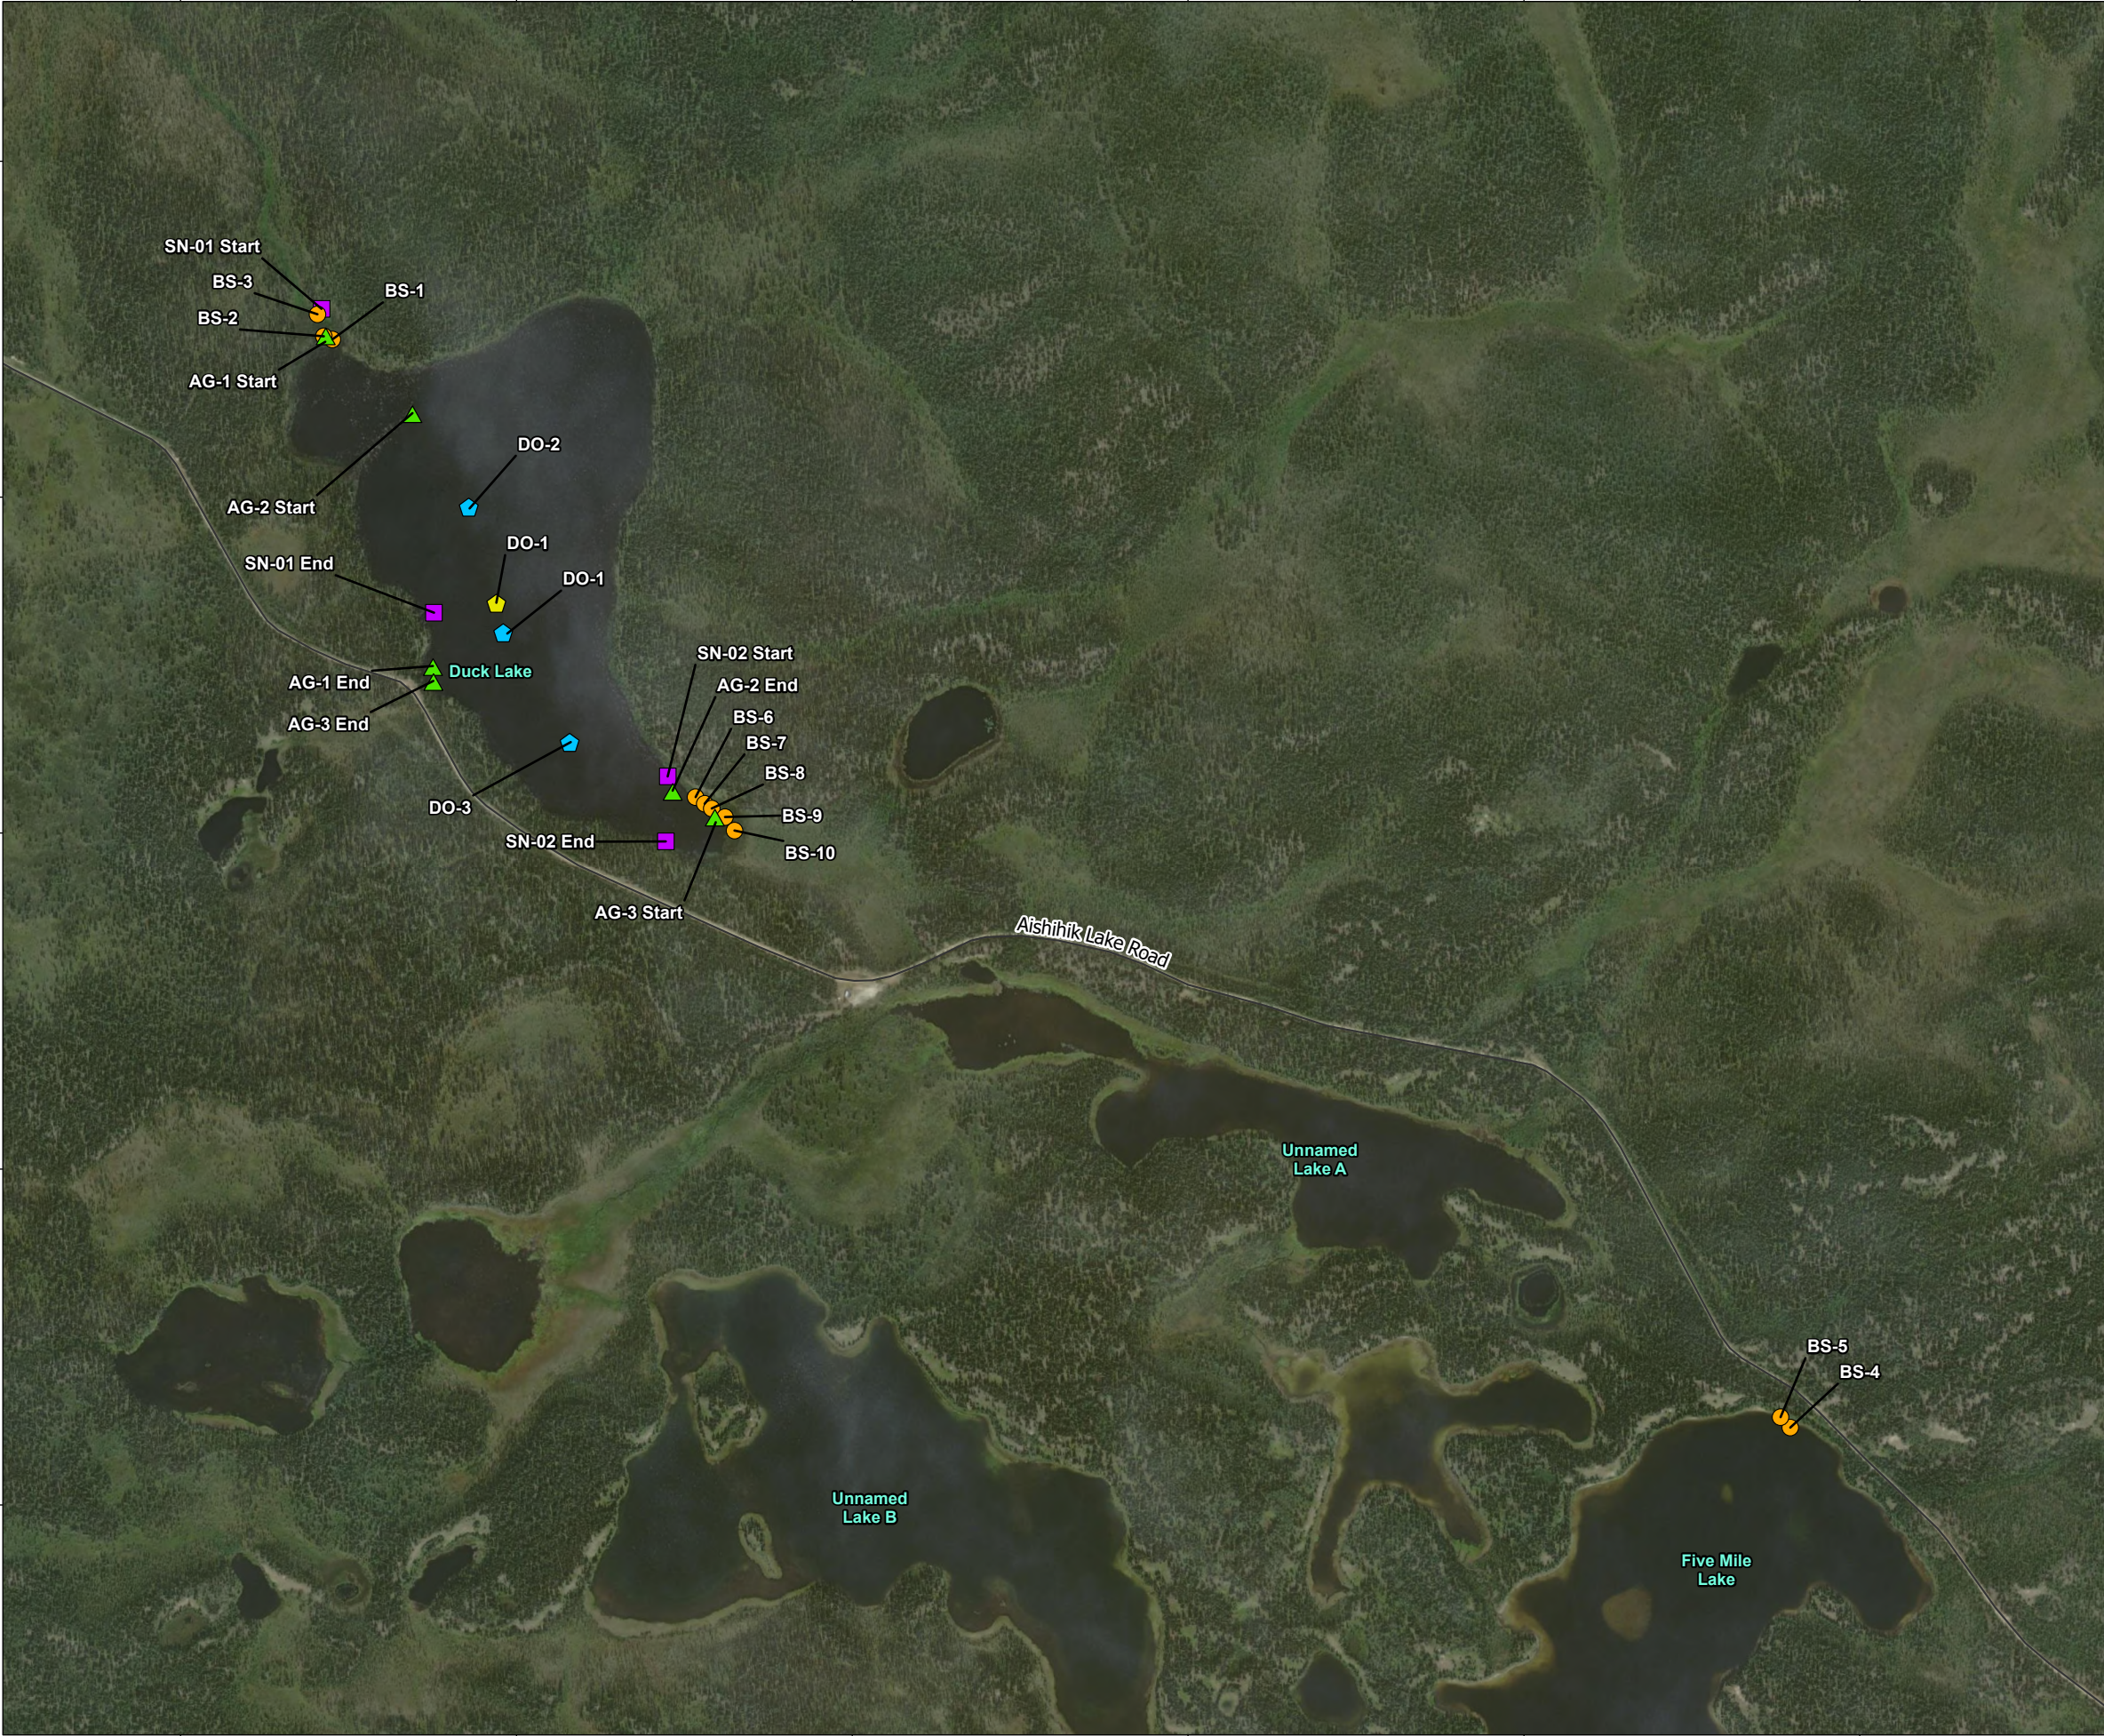
Drawn: O. Leblanc	Checked: A. MacPhail	Map 3	Date: 2023-04-04
----------------------	-------------------------	-------	------------------

September 2023 Fish Sampling Locations

- Angling
- Beach Seining
- Summer Dissolved Oxygen Profile
- Winter Dissolved Oxygen Profile
- Snorkel Surveys

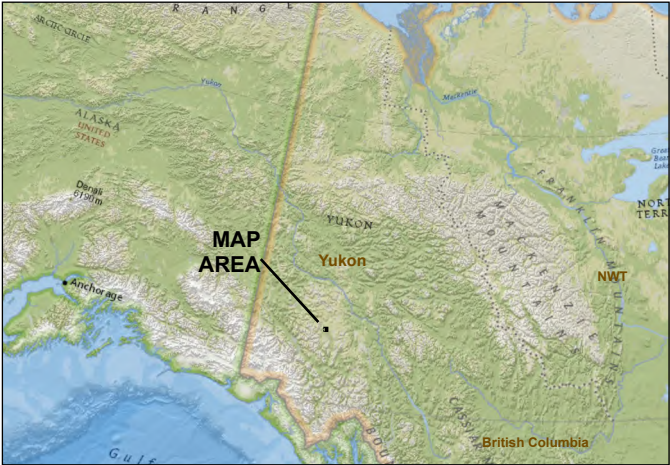
Map Scale = 1:10,000 (printed on 11 x 17)
Map Projection: NAD 1983 UTM Zone 8N

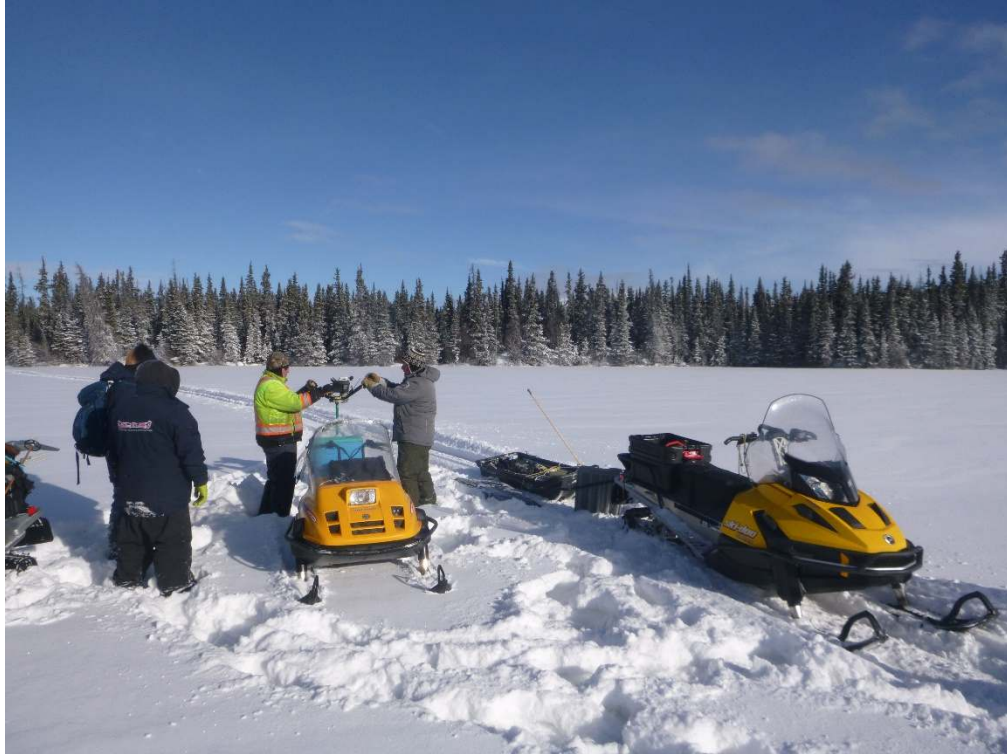
Appendix Photo A-1. Auguring a hole in the ice to investigate fish overwintering conditions at Jenny Lake (March 22, 2022).

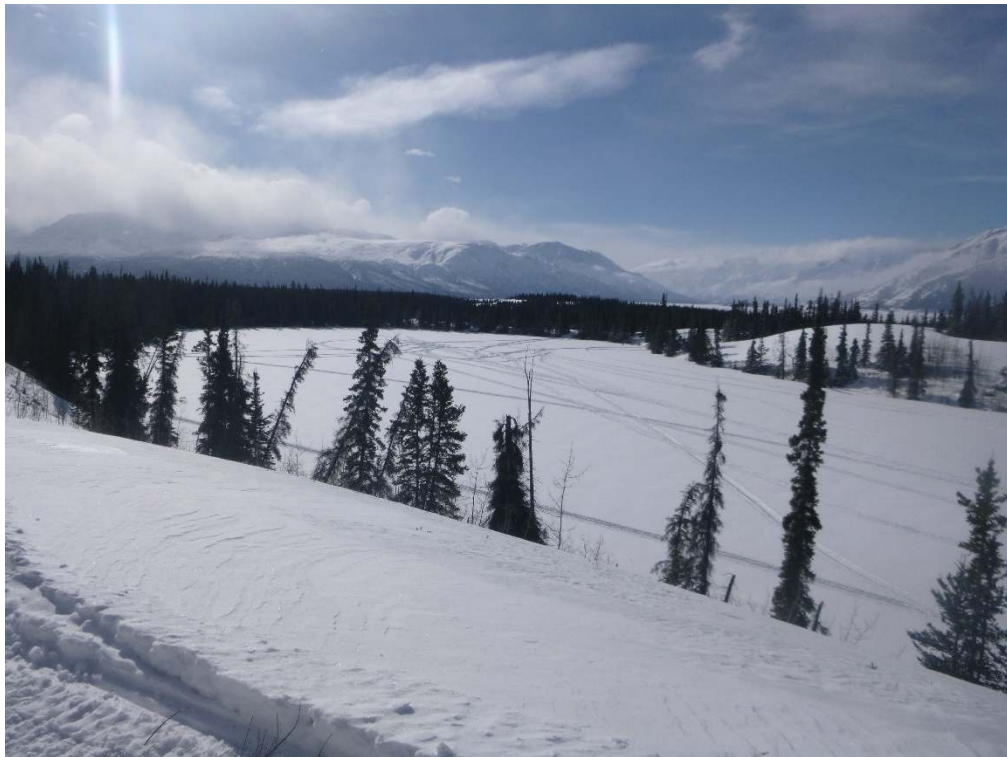
Appendix Photo A-2. Overwintering habitat investigation at Emerald Lake #2 (March 22, 2022).

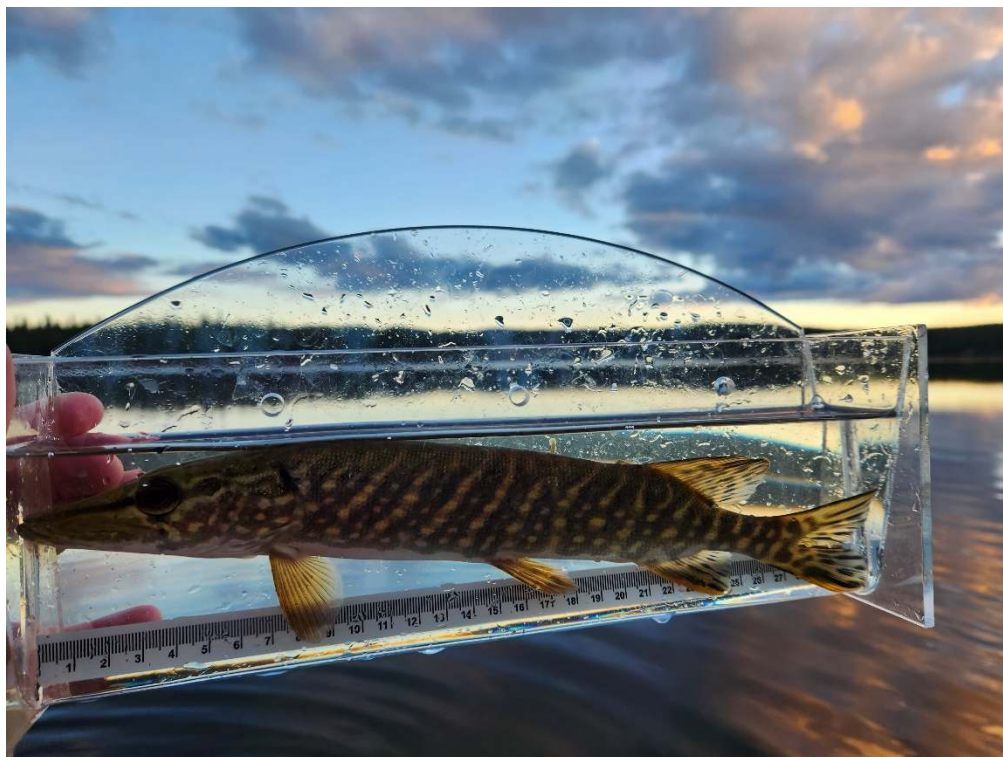
Fish sampling results are presented in Table 7. Two juvenile northern pike were caught via beach seining in Five Mile Lake. Given the suspected connectivity between the Five Mile Lake, Martens Lake, Unnamed Lake A and Unnamed Lake B, it was assumed that northern pike may be present within these waterbodies at certain times of the year. Stocked lake candidates require no other fish species present, as such, no further effort was applied in Martens Lake, Unnamed Lake A, or Unnamed Lake B.

Appendix Photo A-3. Juvenile Northern Pike caught in Five Mile Lake (September 7, 2022).

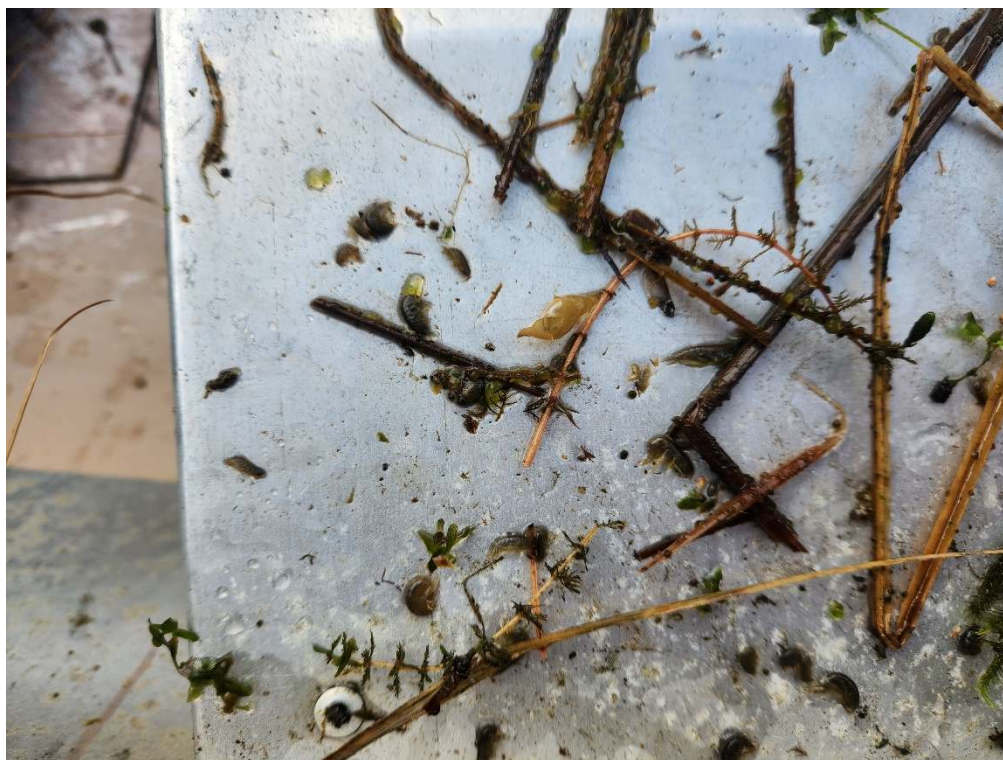
No fish were caught in Duck Lake via beach seining or angling. Snorkel surveys identified an abundance of invertebrates, but no fish were observed.

Appendix Photo A-4. Benthic invertebrates caught in Duck Lake (September 7, 2022).

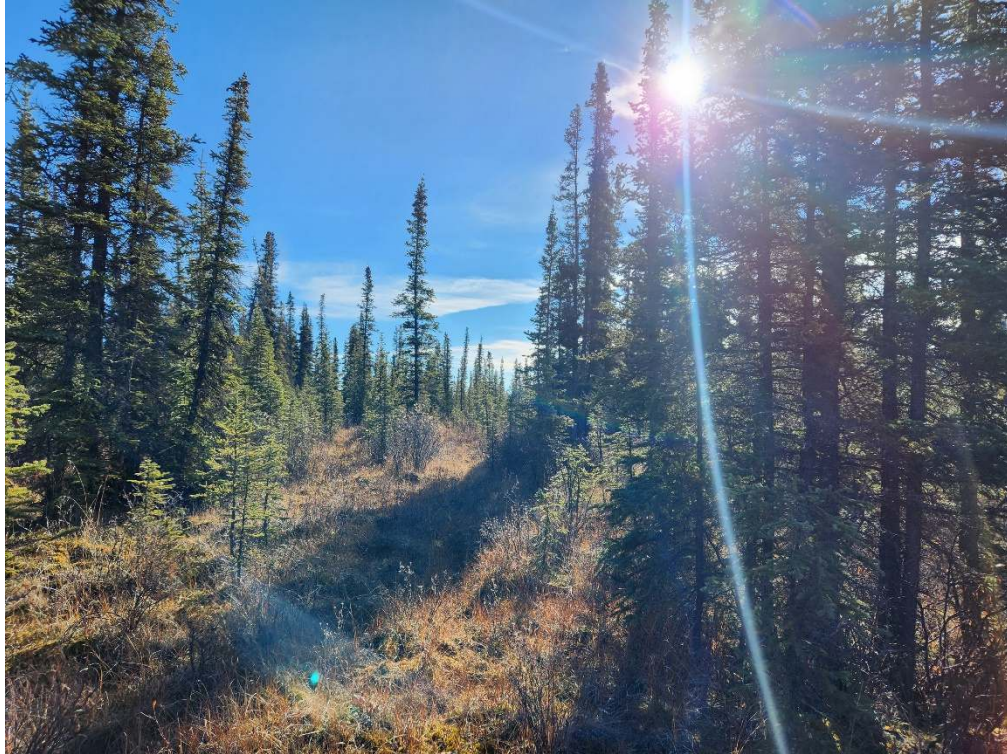
On the north side of the Aishihik Lake road, there appeared to be no connectivity between Duck Lake and any of the lakes on the south side of the road. There was an unwetted area approximately 400 metres (m) in length between the south end of Duck Lake and the Aishihik Lake Road with no culvert connecting the north and south side of the road. At the north end Duck Lake, minimal wetted habitat (small depressions filled with groundwater) with little to no fish value was observed. This transitions to an open forest before descending into a small marsh north of Duck Lake. The small marsh sits approximately 28 metres in elevation below Duck Lake, and there is no wetted fish habitat between the two waterbodies. As such, connectivity between Duck Lake and the small marsh is highly unlikely. Representative photographs of the area are provided in Appendix A.

Appendix Photo A-5. Upland forest habitat found between Duck Lake and small marsh to the north (September 7, 2022).

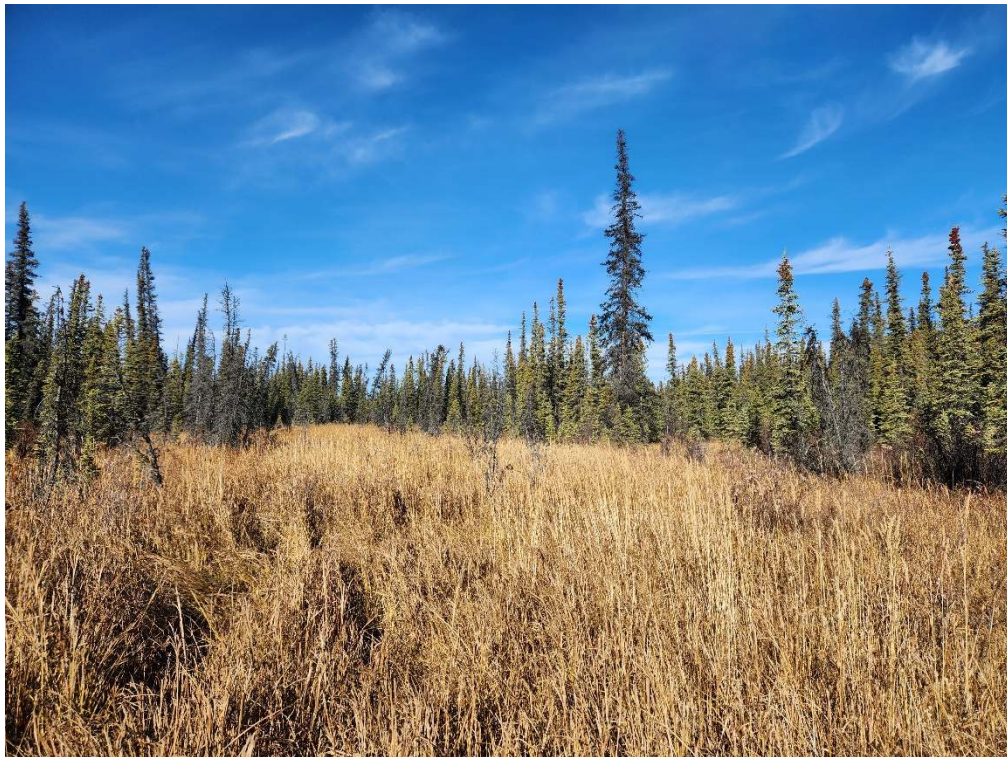
Appendix Photo A-6. Ground conditions at the south end of Duck Lake (September 7, 2022).

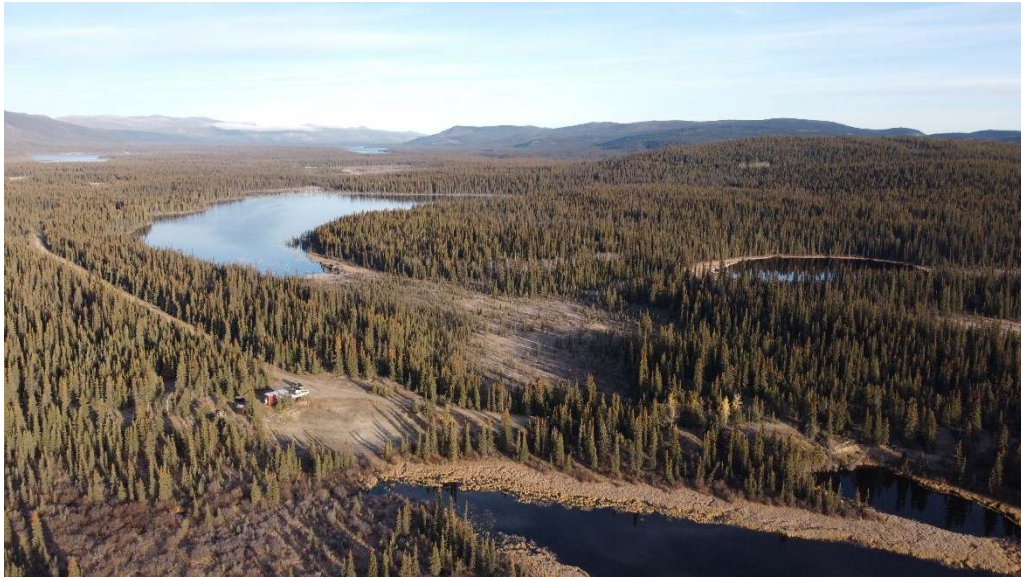
Aerial drone surveys conducted between the lakes on the south side of the Aishihik Lake road (Martens Lake, Five Mile Lake, Unnamed Lake A and Unnamed Lake B) suggest at certain times of the year (i.e., during freshet) there could be some connectivity between the lakes. No connectivity was identified at the time of the survey, however, without further assessment it can't be ruled out that there is connectivity between the lakes at certain times of the year.

Appendix Photo A-7. Aerial view looking at Duck Lake (top left) and Unnamed Lake A (bottom right; (September 7, 2022)

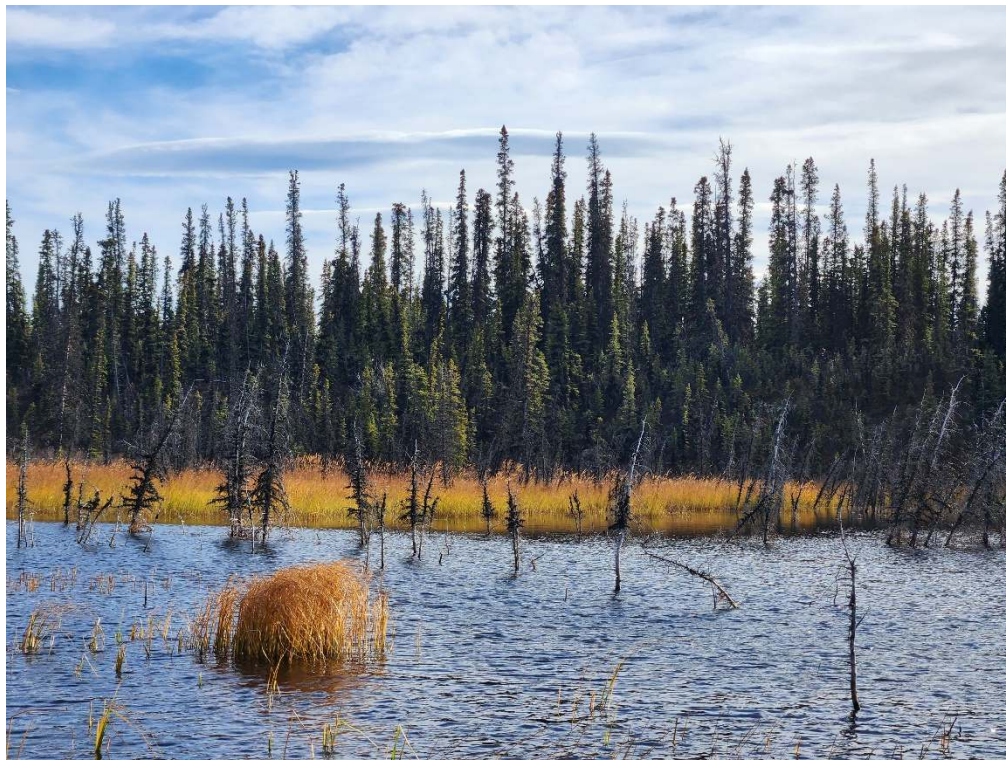
Appendix Photo A-8. Typical shoreline conditions found in Duck Lake (September 7, 2022).

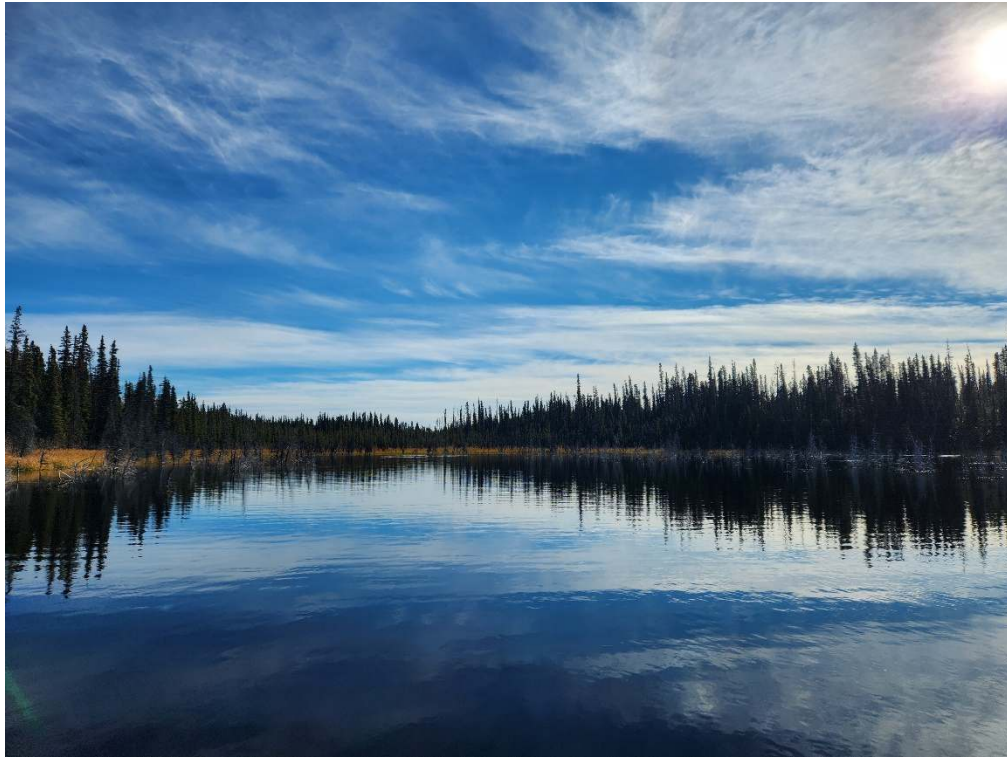
Appendix Photo A-9. Duck Lake looking south (September 7, 2022).
