Sidney Lake Fish and Fish Habitat Investigations

Yukon Fish and Wildlife Enhancement Trust
409 Black St.
Whitehorse, YT Y1A 2N2

EDI Environmental Dynamics Inc.
2195 – 2nd Avenue
Whitehorse, YT Y1A 3T8

22Y0292
Version: 1
April 2023

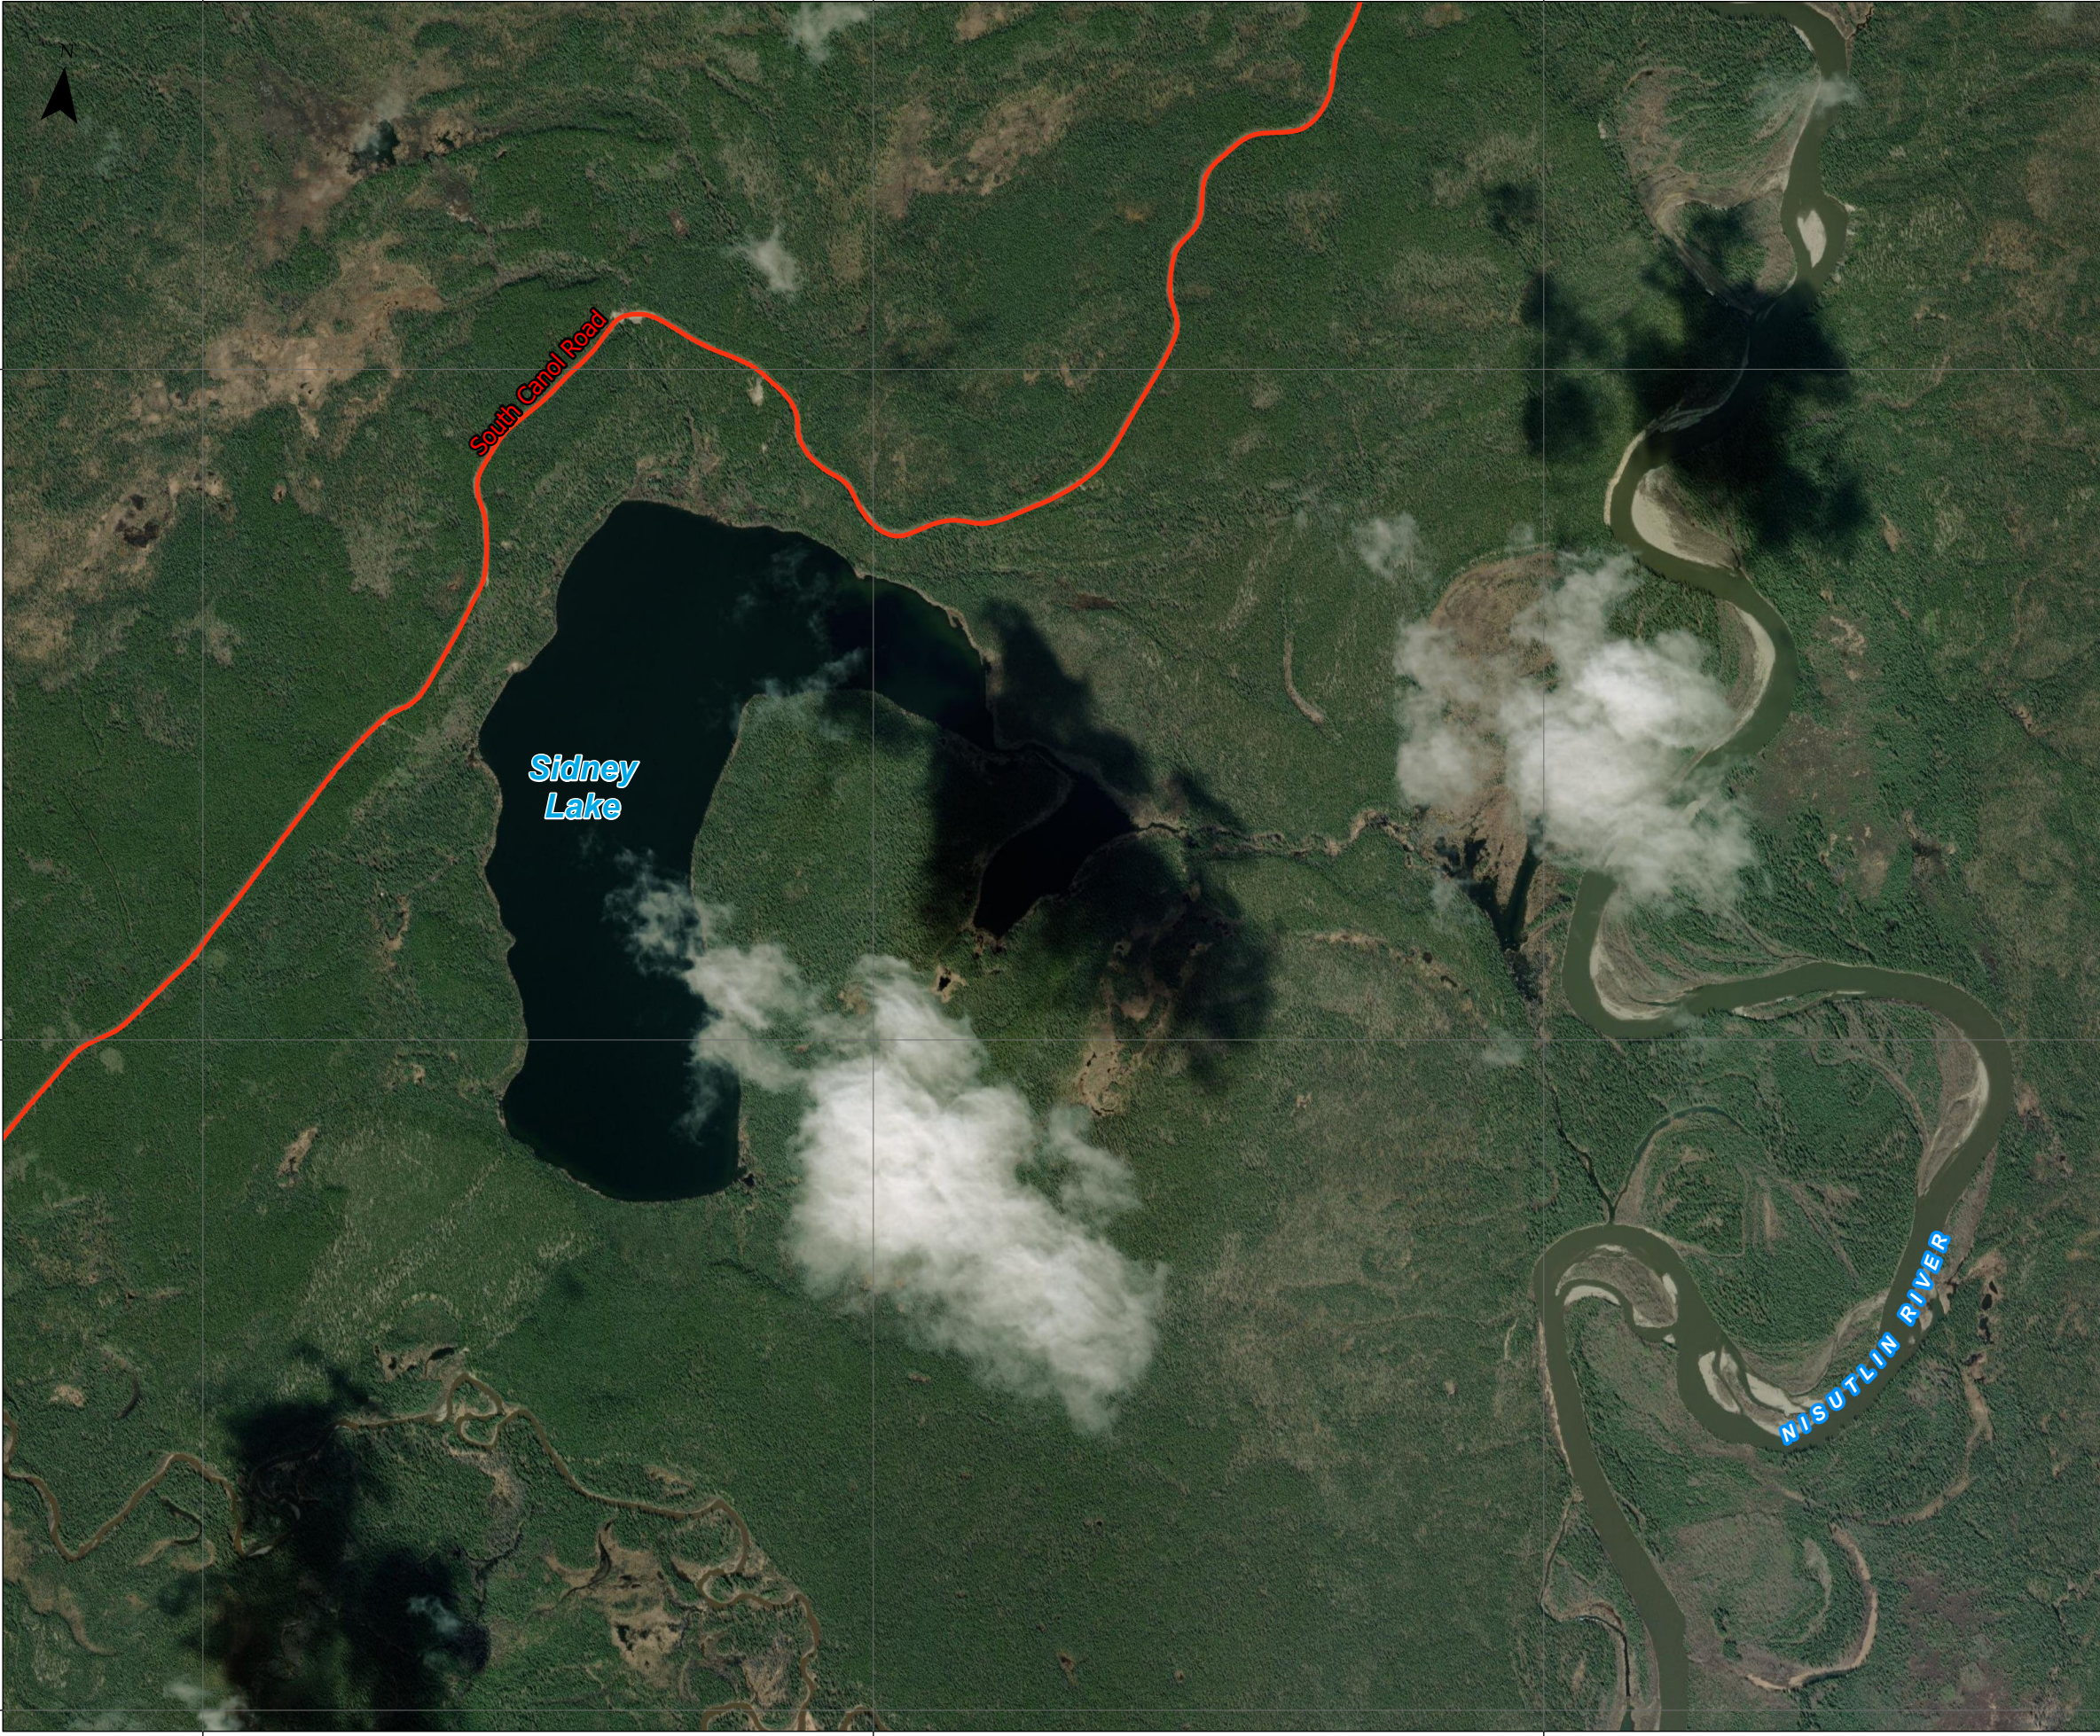
Map 1 - Overview of Sidney Lake

Sidney Lake is located adjacent to the South Canol road, approximately 45 km north of the South Canol road junction with the Alaska Highway. The lake has an approximate area of 1.60 km, including the east connected bay (Map 1). The outlet stream that connects Sidney Lake to the Nisutlin River is approximately 2.2 km in length and flows through a mature spruce and pine forest. A large wetland area is present near the lower section of the outlet stream before the confluence with the Nisutlin River.

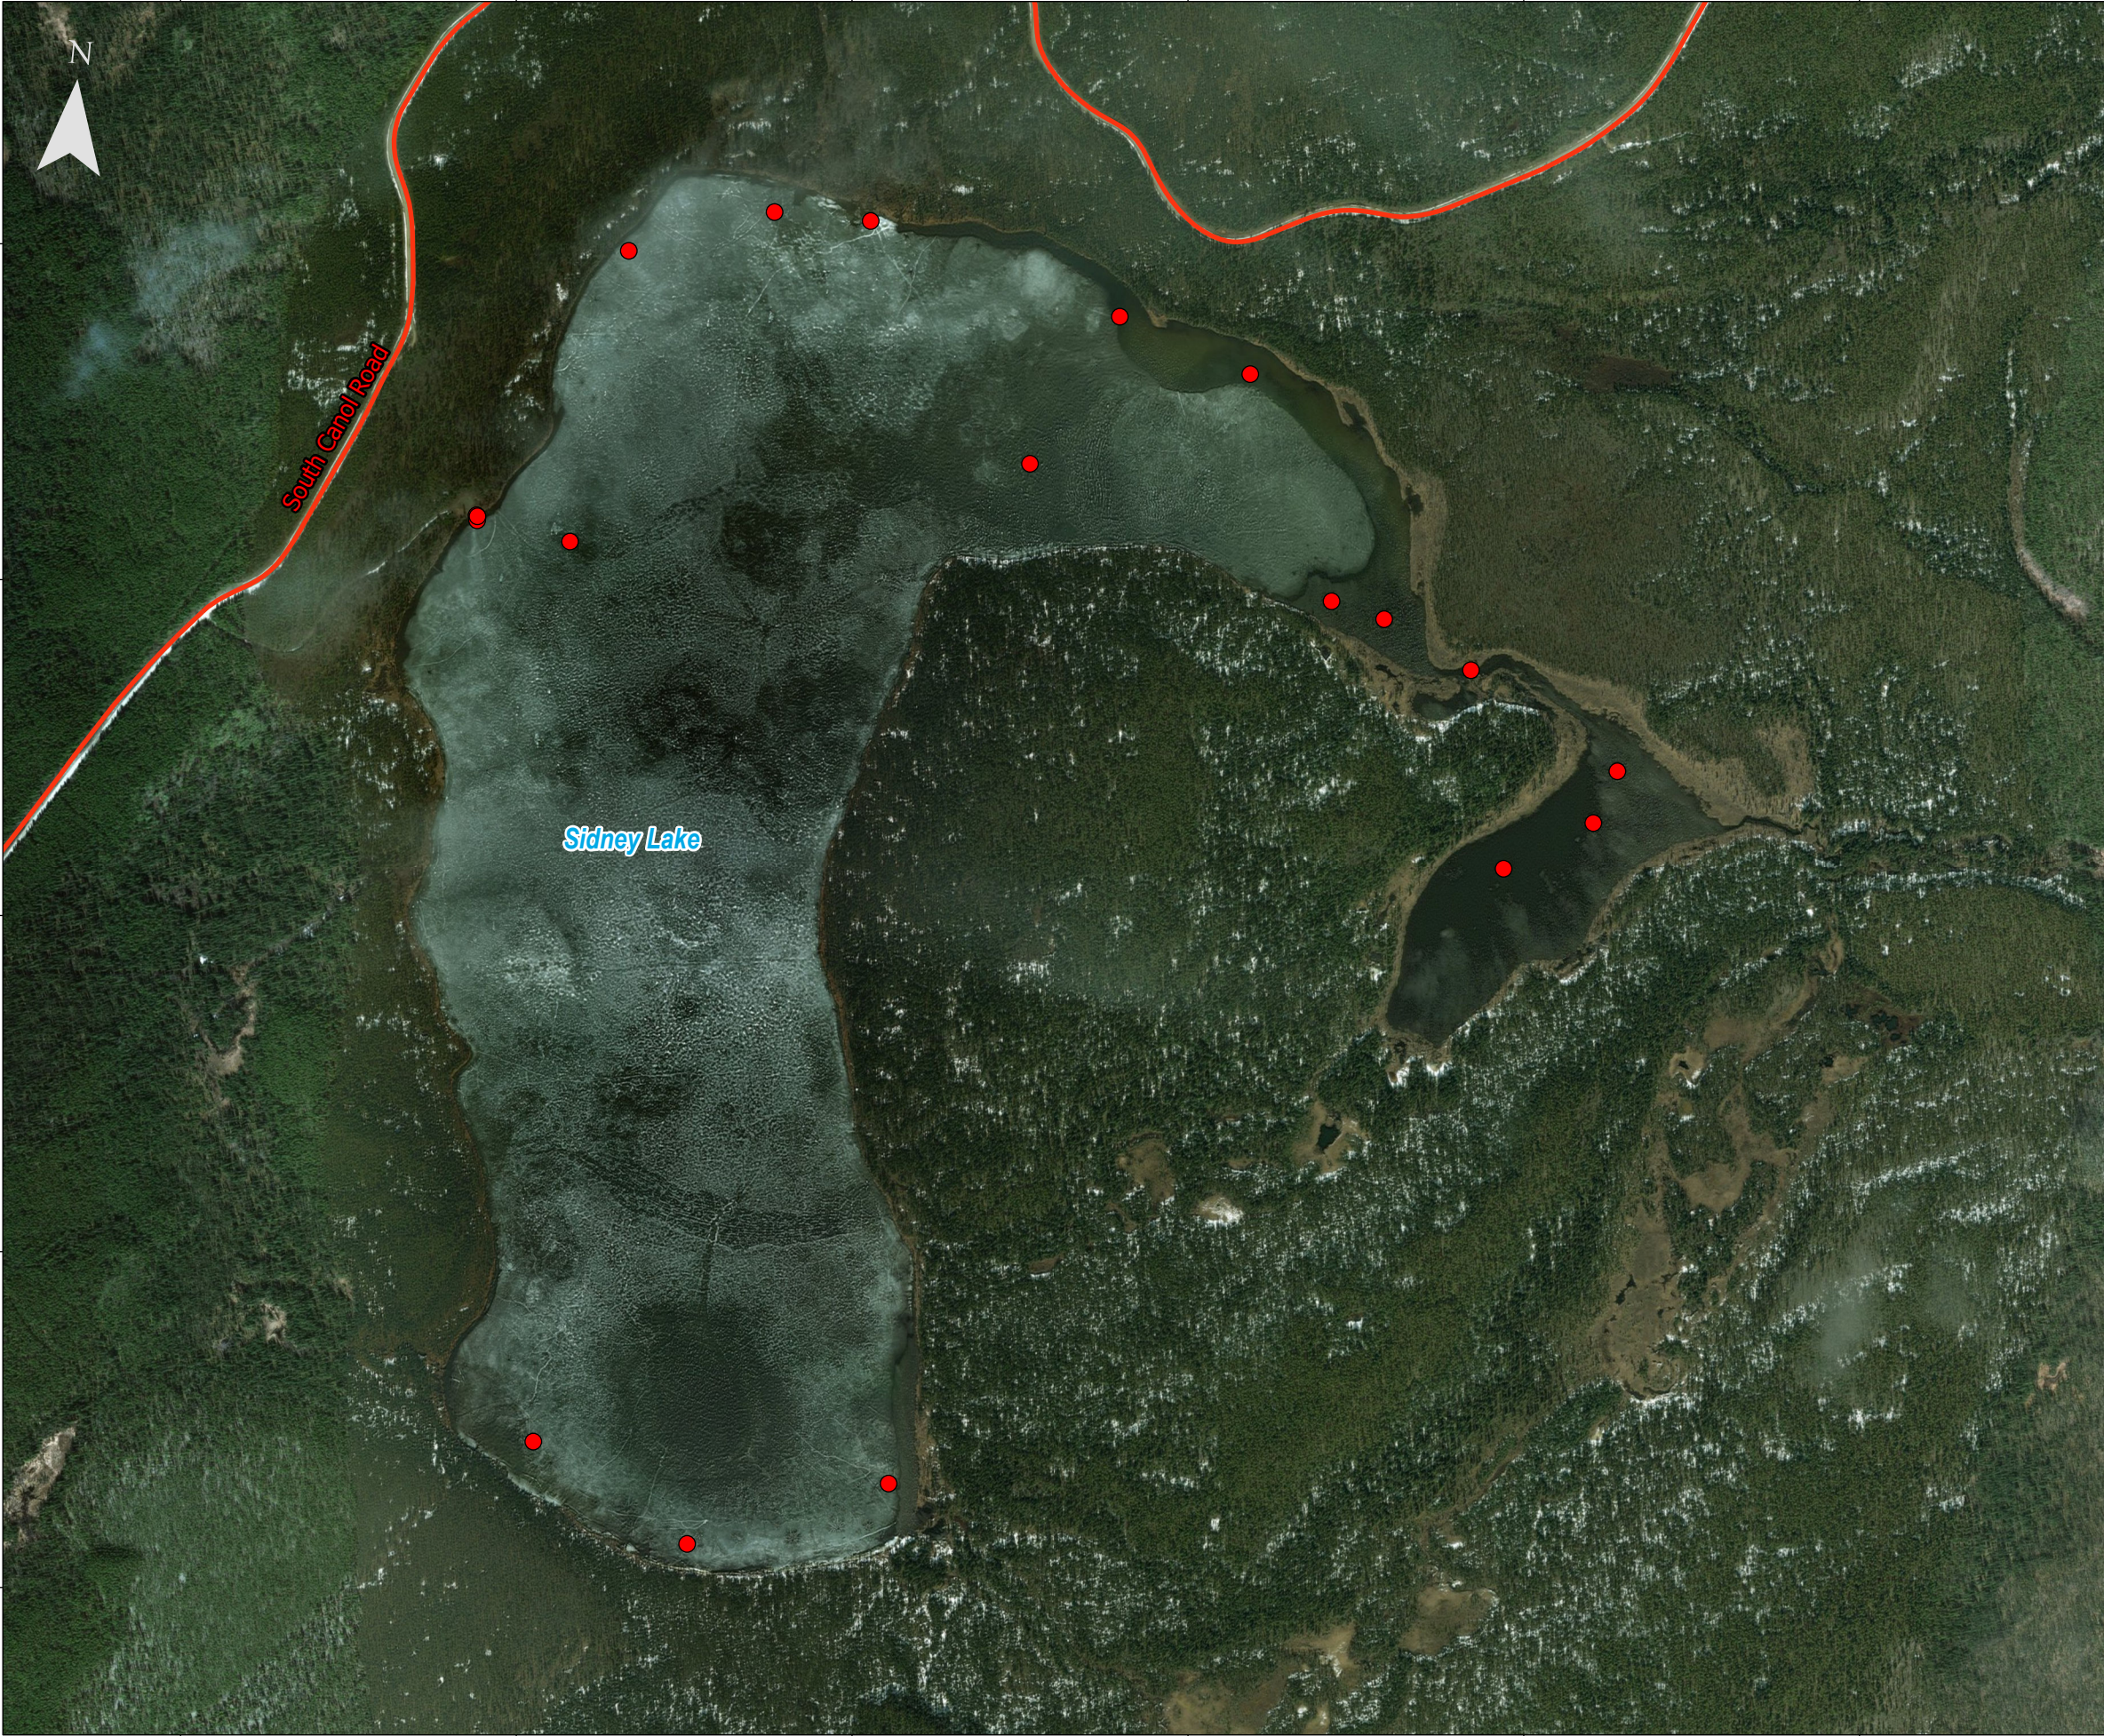
Map 2 - Sidney Lake Trap Netting Sites

A total of 24 trap net sets were completed during the September fish sampling in Sidney Lake (Map 2). The trap nets are comprised of four sections, including the lead, heart/house, catch box or crib, and wings. Traps were set in various locations around the lake and were left to soak for approximately 24 hours. The lead is 45 m (150 feet) long and 1.8 m (6 feet) deep with 250 g weights spaced 81 centre intervals and black plastic floats with 482 g buoyancy spaced at 3 m intervals. The lead is tied off to shore such that the start of the lead is located as close as possible to the waters edge. When set, the lead extends perpendicular from the shoreline and is attached to the heart. The heart and house of the trap is designed to funnel the fish into the crib/catch box and has a roof to limit fish from swimming up and out of the trap. Once within the heart of the trap, fish swim through a tunnel (funnel shaped) and into the crib/catch box where they are unable to escape. Wings attach to either side of the trap head and when pulled taut, are situated at approximately a 45-degree angle to the lead. Anchors are attached to either wing and the catch box bridle (king anchor) and pulled taut to hold the trap and wings in place. The coarse mesh traps are constructed of 57 mm (2.25 inch) mesh on the lead and top/bottom of the house and heart with 44 mm (1.75 inch) mesh on the remainder of the head and crib/catch box. The fine mesh traps are constructed of 38 mm (1.50 inch) mesh on the lead and top/bottom of the house and heart with 19 mm (0.75 inch) mesh on the remainder of the head and crib/catch box. The third type of trap net used was constructed from 210/10 green knotless nylon material of 19 mm (0.75-inch) stretch mesh with dimensions measuring 2 m x 2m x 2m with 5 m long wings and a 50 m long tapered lead. This trap is intermediate in mesh size relative to the fine and coarse mesh traps (EDI Environmental Dynamics Inc. 2021). A summary of effort for each trap type is provided below in Table 1.

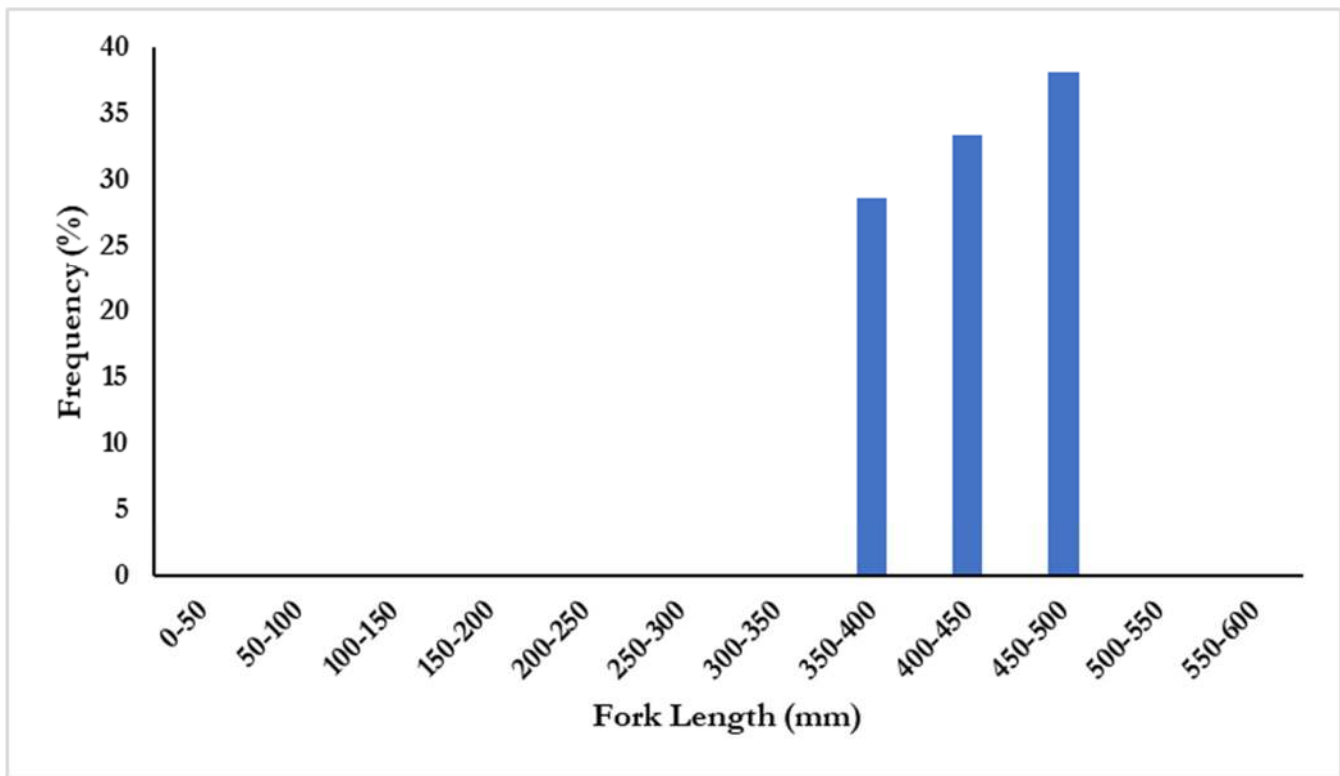
Figure 1. Length frequency histogram for lake whitefish captured in Sidney Lake in September 2022 ($n = 21$).

A total of 58 fish were captured in 20 overnight trap sets during sampling in September 2022. Set durations ranged from 19.2 hours to 25 hours with an average of 22.6 hours. Northern pike were the most frequently captured species with 37 individuals followed by lake whitefish with 21 individuals. Captured lake whitefish were all similar in length with no juveniles captured or observed during sampling (Figure 1). Various sizes of northern pike were captured with the majority being in the 450 mm to 600 mm fork length range, and a small number of larger individuals captured (Figure 2). Very few ($n=3$) juvenile pike were captured in the trap net sets and observed during the sampling event.

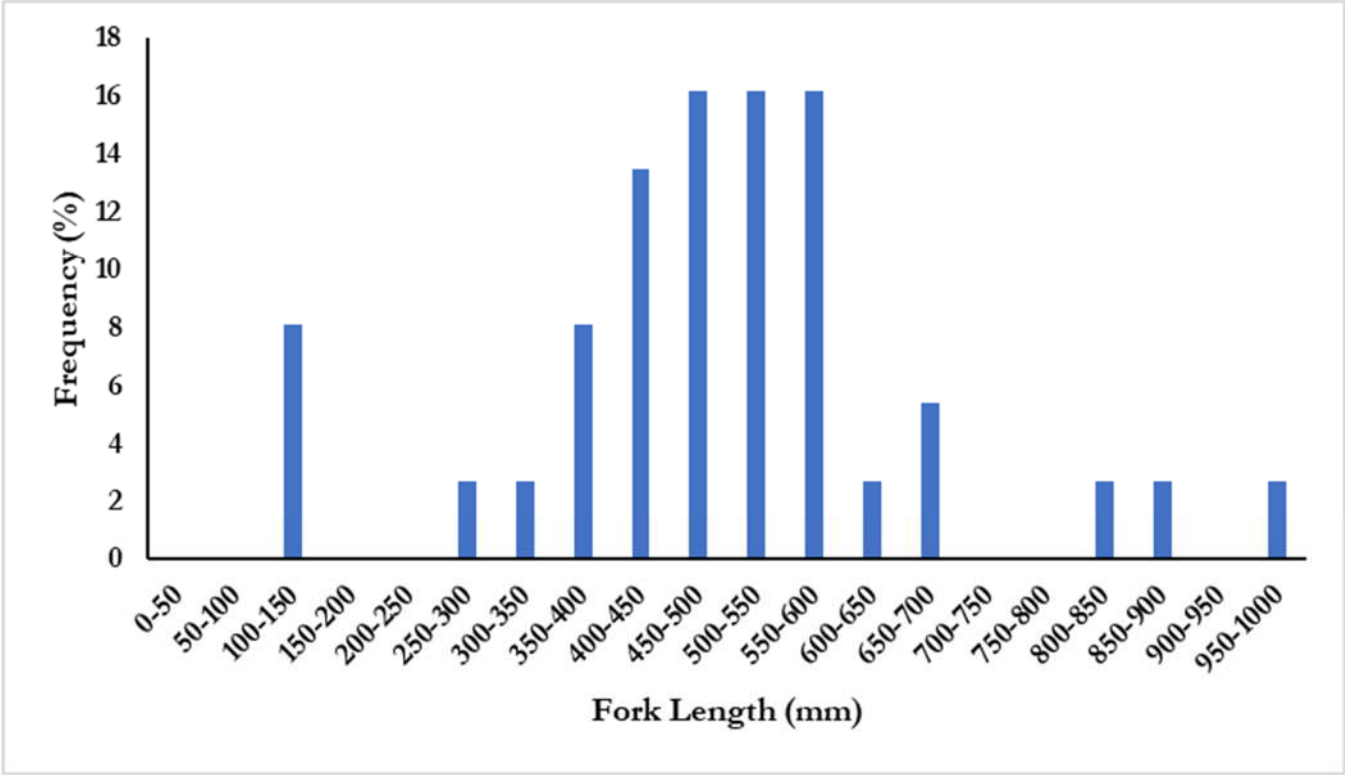
Figure 2. Length frequency histogram for northern pike captured in Sidney Lake in September 2022 (n = 37).

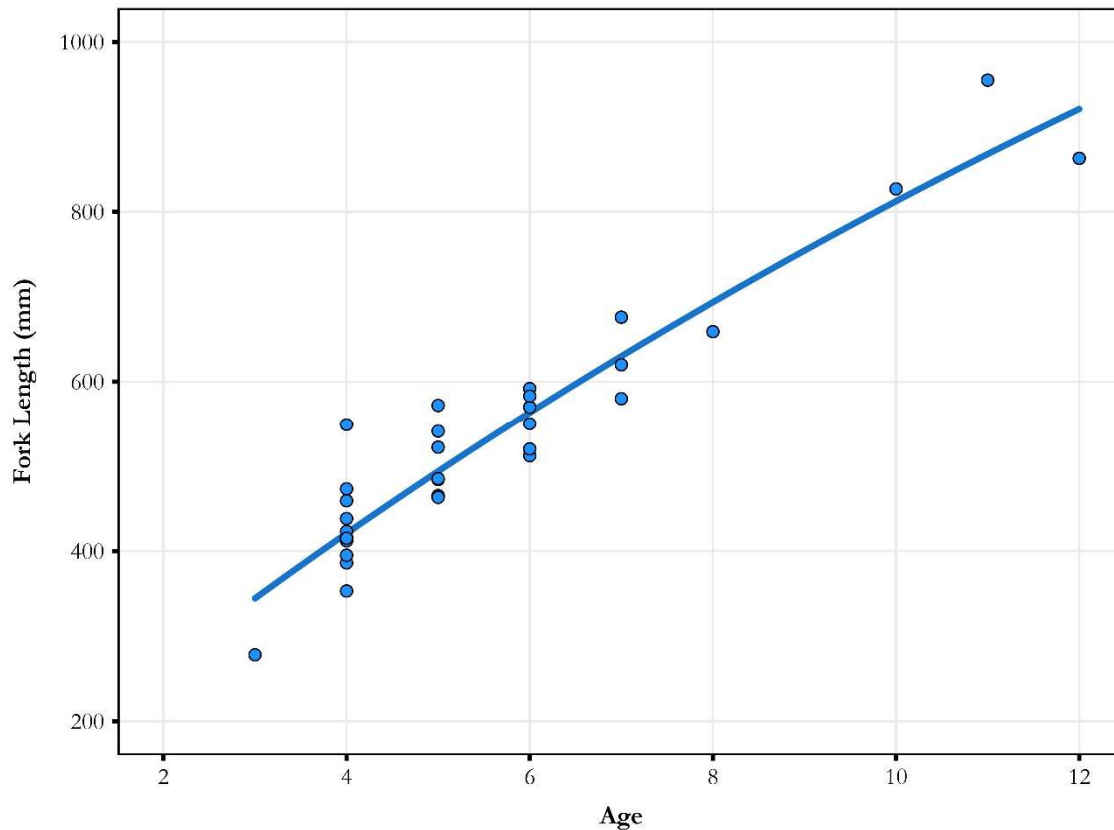
The VBGM for Northern Pike in Sidney Lake (2022) fit poorly, and none of the biologically relevant parameters (asymptotic length [L_{∞}], growth coefficient [k], and age at length 0 mm [t_0]) were statistically significant (Table 2). This was the result of a nearly linear relationship between (scale) age and fork length. One possible reason for this is that the maximum fork length is reached at ages older than northern pike caught in the current study (i.e., greater than 12 years old). These results are very different from the VBGM for northern pike in Nisutlin Lake (2021), where a clearer asymptote was identified from (fin ray) ages 10 to 16 (maximum fork length = 921.39 mm; Table 2). In this model, all biologically relevant parameters were statistically significant. The differences between VBGMs in Sidney Lake and Nisutlin Lake are not due to different ageing techniques. In fact, the relationship between fin ray ages and fork length for northern pike at Sidney Lake resulted in an exponential curve, which is farther from biological plausibility (Figure 3). The most likely explanation is that an insufficient number of older fish (> 12 years) were captured in Sidney Lake.

Figure 3. Von Bertalanffy growth model for northern pike captured in Sidney Lake during September 2022 (fin rays only; $n = 33$).

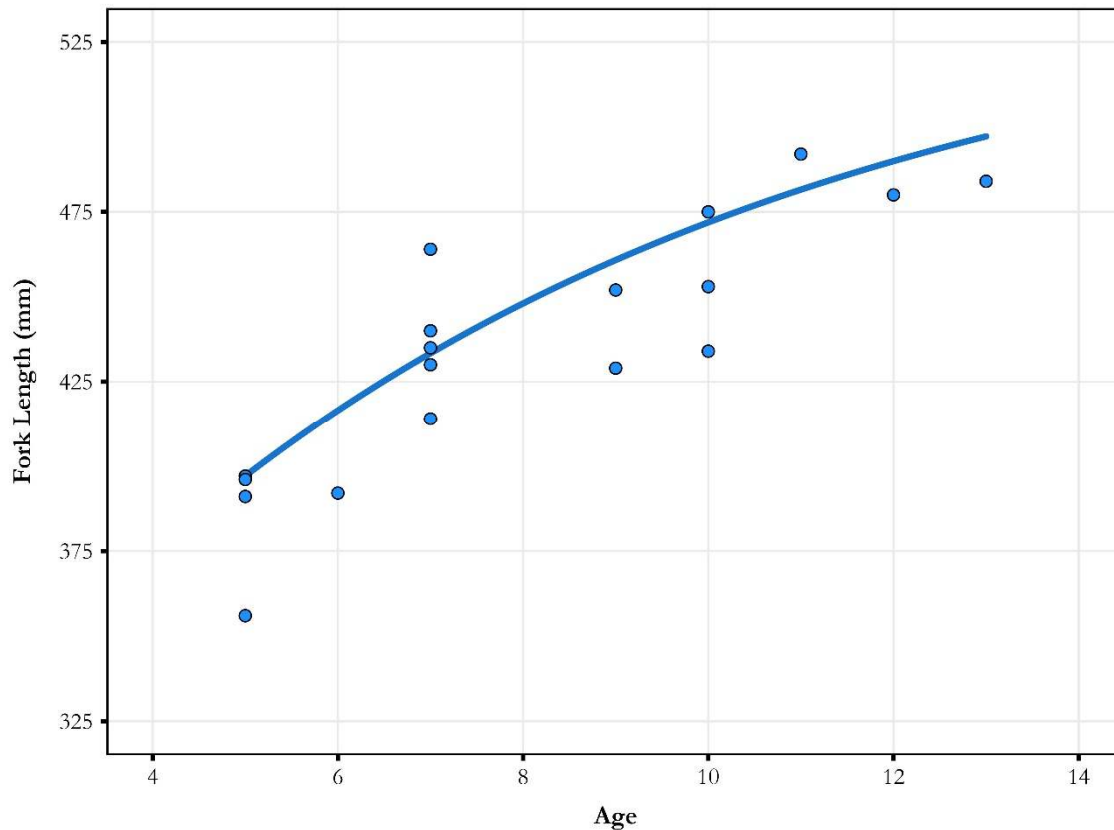
The VBGM for Lake Whitefish in Sidney Lake (2022) fit poorly, and only the asymptotic length (L_{∞}) was identified as statistically significant (Table 2). However, the confidence intervals for that estimate were very wide. Similar to the VBGM for northern pike in Sidney Lake, the VBGM for whitefish was fairly linear and did not identify a maximum fork length (Figure 4). The most likely explanation is that an insufficient number of older fish (> 13 years) were captured at Sidney Lake.

Figure 4. Von Bertalanffy growth model for lake whitefish captured in Sidney Lake during September 2022 (fin rays only; n = 18).

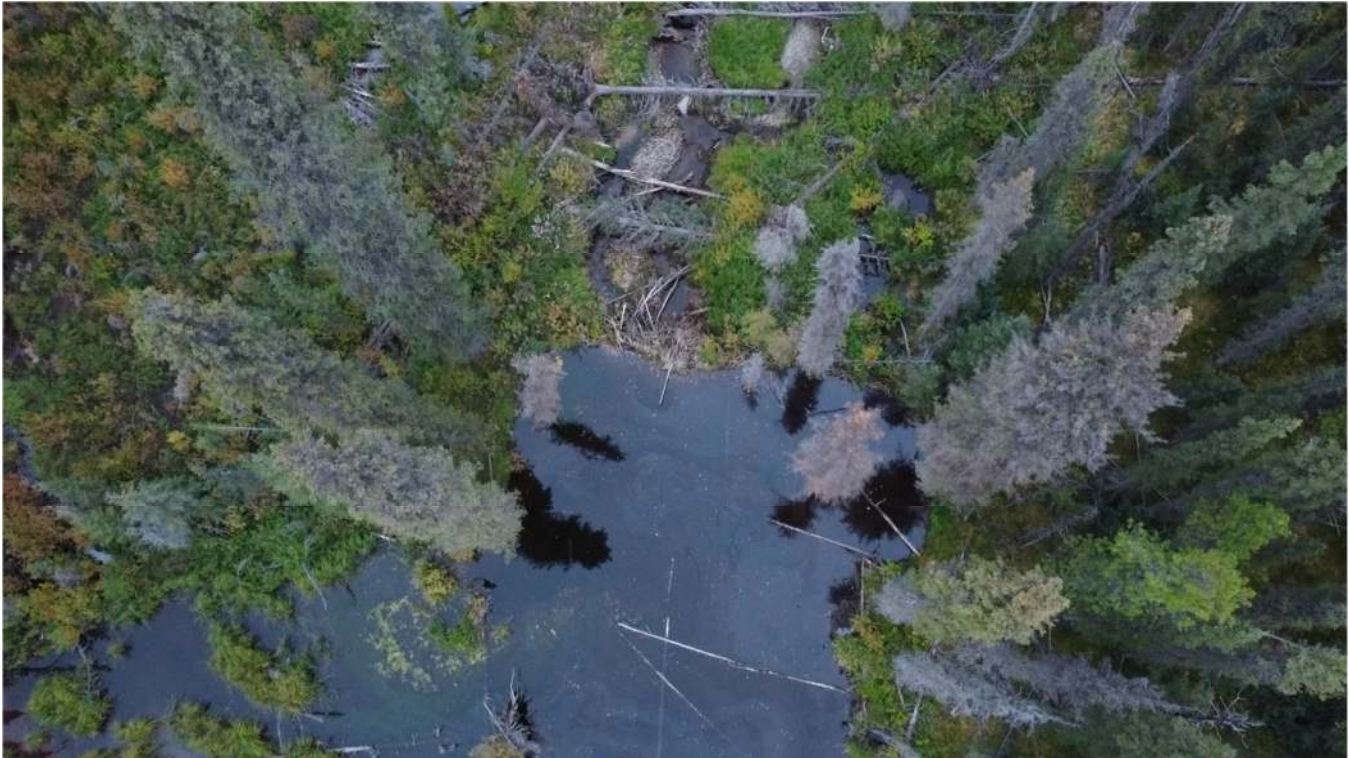
The first 250 m of the outlet stream was walked by field crews on September 12, with the remaining stretch of stream was walked on September 16. General stream morphology included slow moving flow through a relatively undefined channel, overgrown with aquatic and terrestrial vegetation and instream woody debris. Approximately 700 m downstream from the outlet of Sidney Lake field crews observed an old beaver dam about 15 m wide and 1.5 m in height (Photo 1). Observations suggest that the dam has been inactive for a number of years as there was terrestrial vegetation growing from the dam walls and no signs of recent beaver activity.

Photo 1. Beaver dam approximately 700 m downstream of the Sidney Lake outlet.

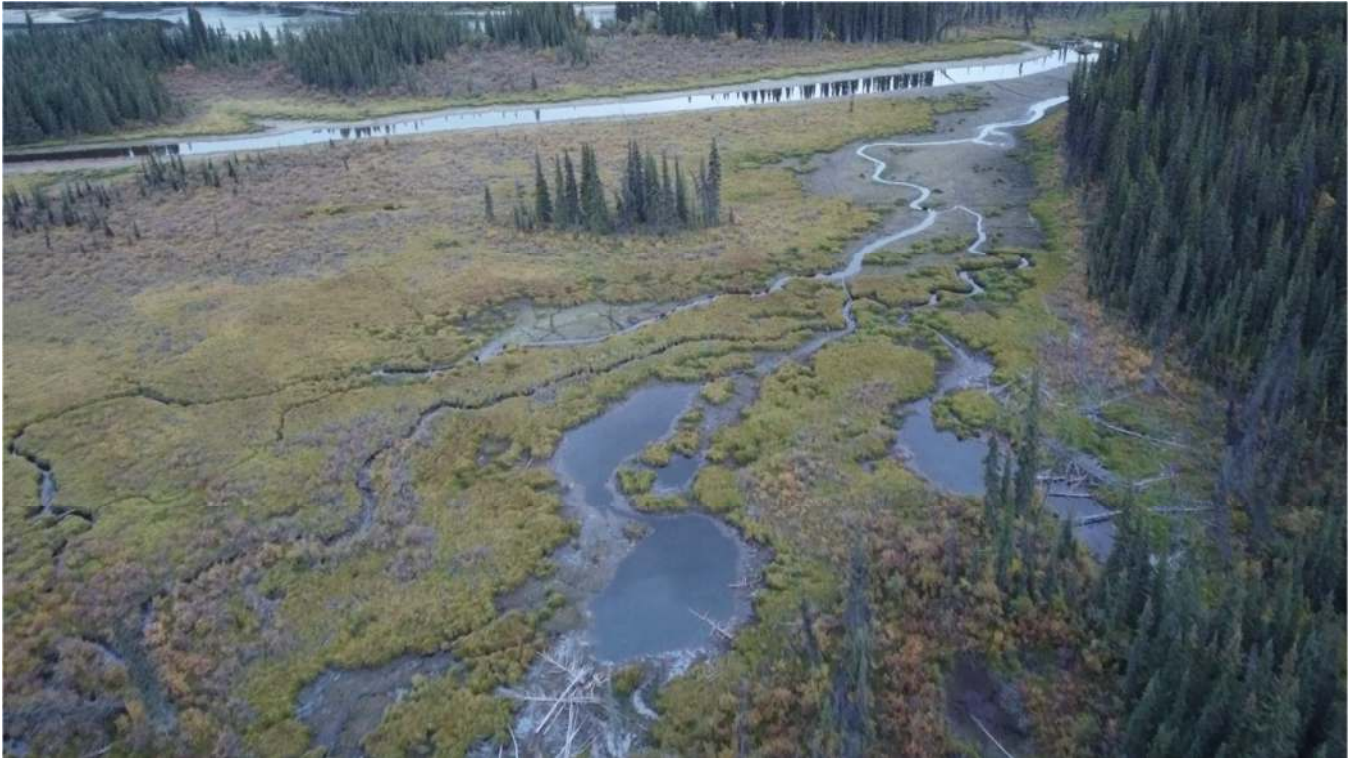
Immediately below the dam, flow was confined to a small channel with various pockets of exposed cobble approximately 4 cm in diameter on the banks of the stream (Appendix Photo 1). Pockets of exposed cobble suggest the stream has undergone change over time and/or has different levels of flow during certain times of the year. Below the cobble pockets, the stream shifts back to slow moving flow that was observed in the upper sections. Within this section are various stagnant pools. Field crews noted that the conditions in the pools were likely anoxic due to the presence of a strong odour of decaying organic matter. Below the stagnant pools, the stream flows through a large wetland with scattered mud flats and shallow pools (Photo 2). The stream channel in this section is characterised by narrow, meandering braids which converge at the southern end of the wetland, adjacent to the Nisutlin River. The stream then flows south through a forested area before connecting with the Nisutlin River. Recorded aerial imagery shows a more recently constructed beaver dam just before the confluence (Photo 3).

Photo 2. Outlet stream flowing through the wetland near the confluence with the Nisutlin River.

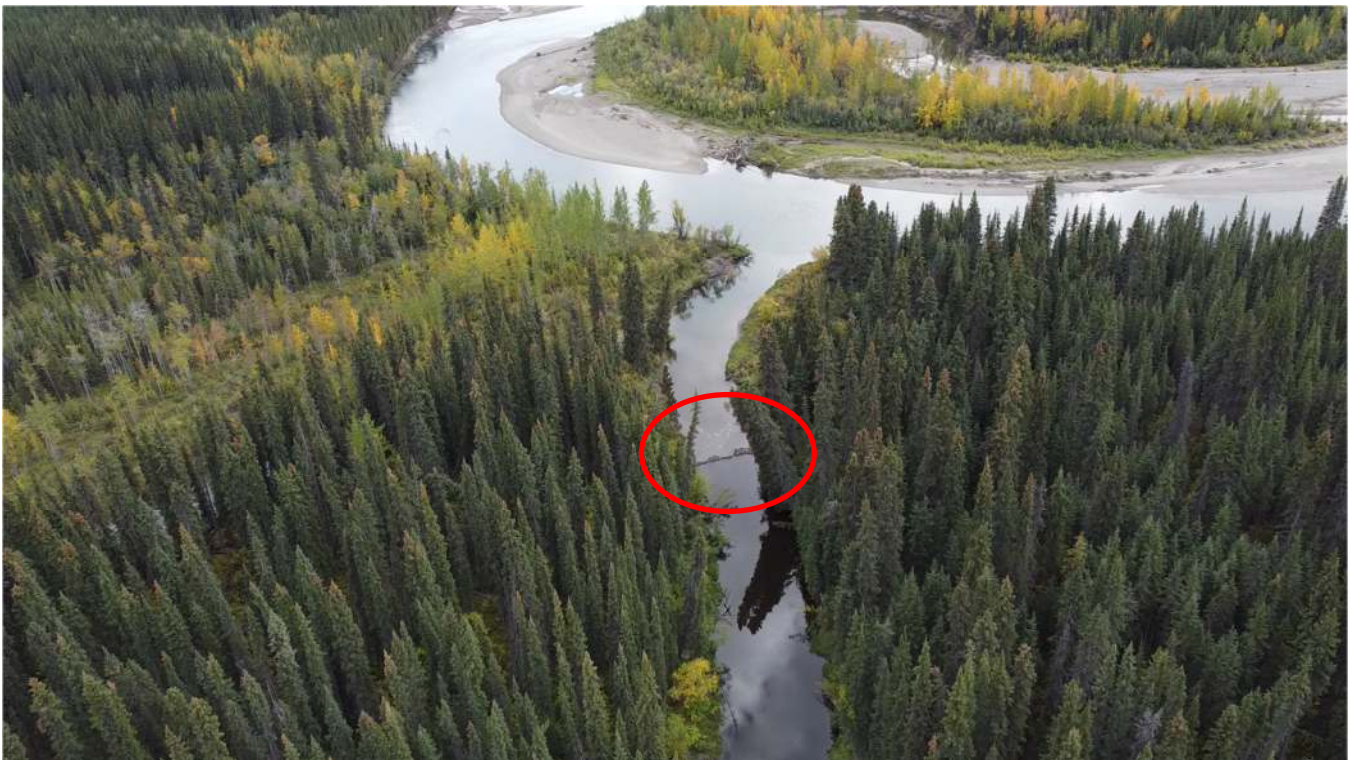
Photo 3. Confluence of the Sidney Lake outlet stream with the Nisutlin River. Note the beaver dam just before the last bend in the stream.

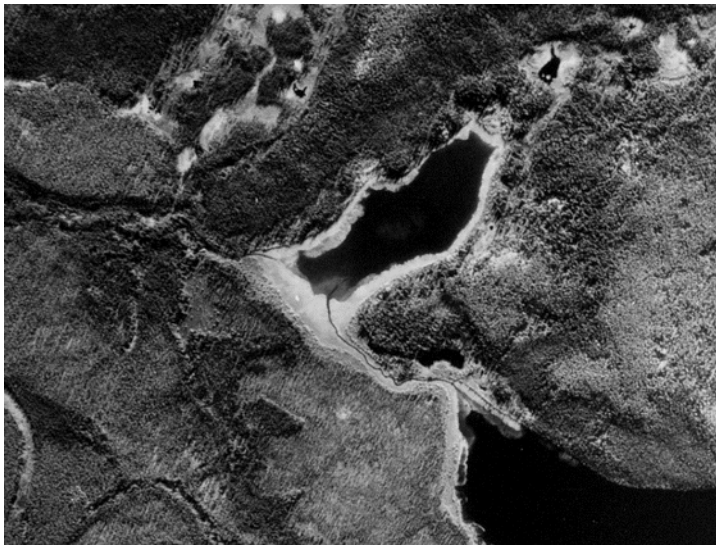
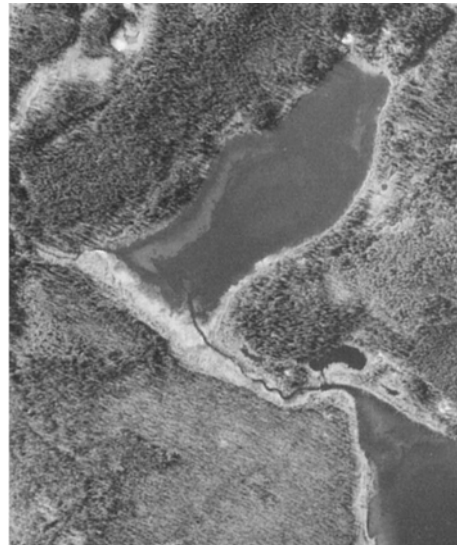
Additionally, knowledge holders noted that water levels in the lake have changed over time as they are higher now than in previous years. These observations are supported by historical aerial photos taken over the past seventy years. The water levels in the lake observed in aerial photos from 1973 were much different when compared to aerial photos taken 20 years later in 1993 (Photo 4). The channel connecting the back bay on the east side of Sidney Lake to Sidney Lake proper had a much more defined channel in the past compared to more recent years and these changes are even more prevalent when comparing the 1993 water levels to present day (Appendix Photo 2).

Photo 4. Aerial photos from 1973 (left) and 1993 (right) of the east back bay on Sidney Lake (Geo Yukon 2023). Note the changes in extent of water in the back bay and size of channel connecting the bay to the lake.

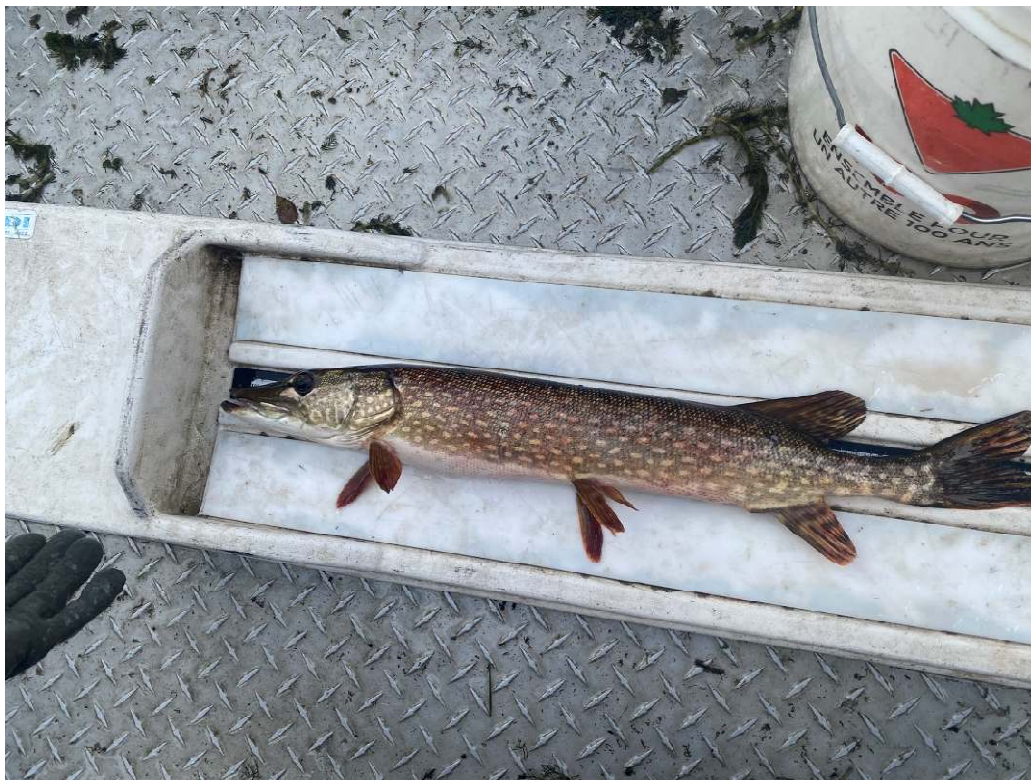
Of the northern pike caught in Sidney Lake, most were found to be long and slender (Photo 5), possibly indicating that food availability is limited in Sidney Lake. As discussed above, juvenile lake whitefish presence was also very limited in Sidney Lake. As an important part of northern pike diet, the lack of juvenile whitefish may be influencing the growth of northern pike in Sidney Lake, however, this could not be confirmed.

Photo 5. Northern pike captured during sampling in September 2022.

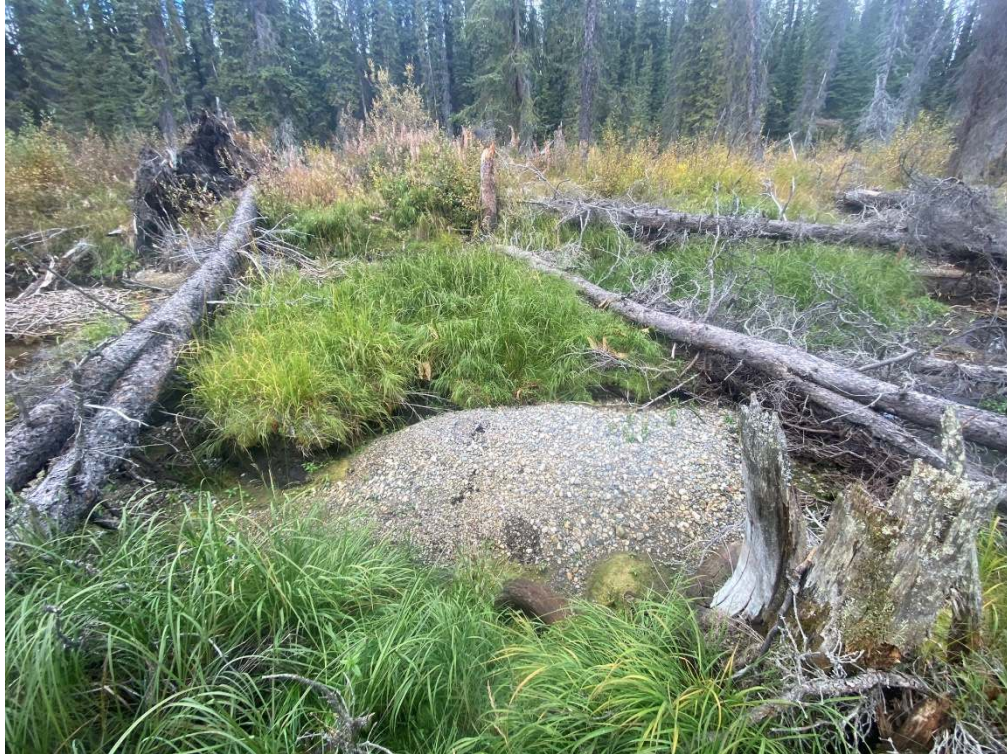
Appendix Photo 1. Pocket of exposed gravel downstream of the inactive beaver dam on the Sidney Lake outlet stream on September 16, 2022.

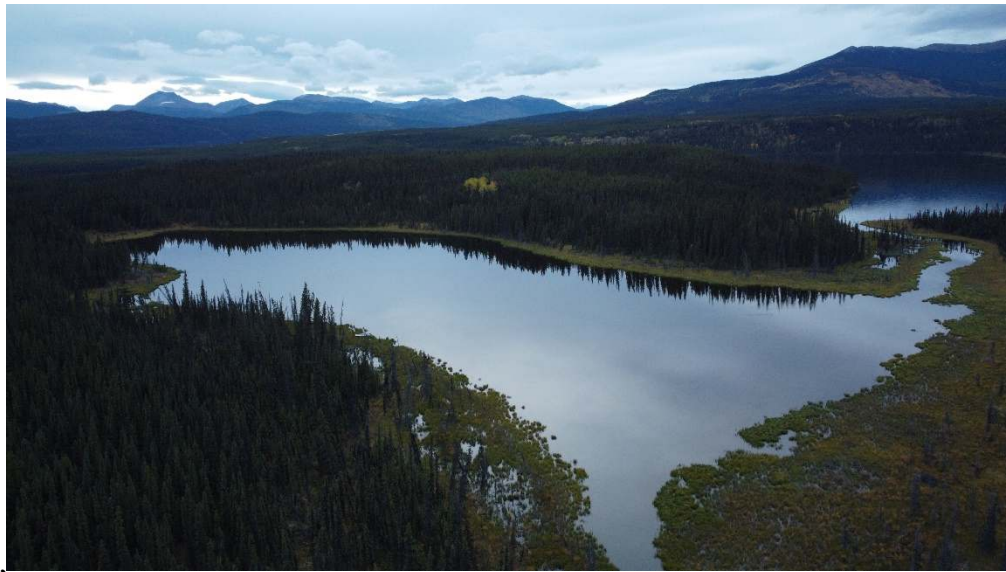
Appendix Photo 2. East bay and upstream section of the outlet stream on September 12, 2022.

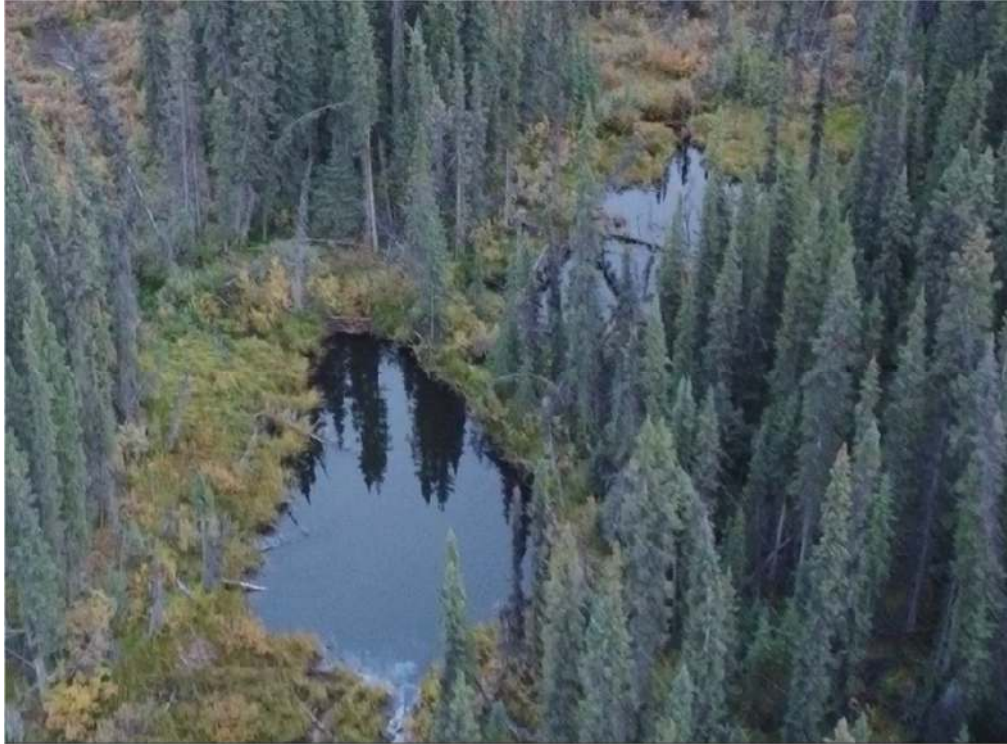
Appendix Photo 3. Stagnant pools separated by height of land downstream of the inactive beaver dam on the outlet stream on September 12, 2022.

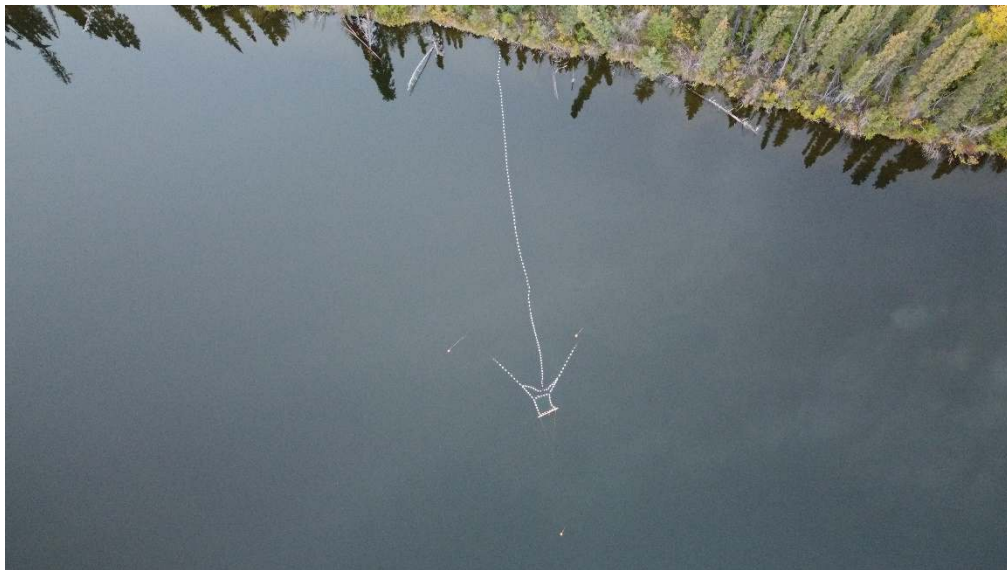
Appendix Photo 4. Aerial view of a trap net set in Sidney Lake on September 12, 2022.
