SWEDE JOHNSON CREEK FISH AND FISH HABITAT INVESTIGATION

EDI PROJECT NO.: 08-YC-0027

JANUARY 2009

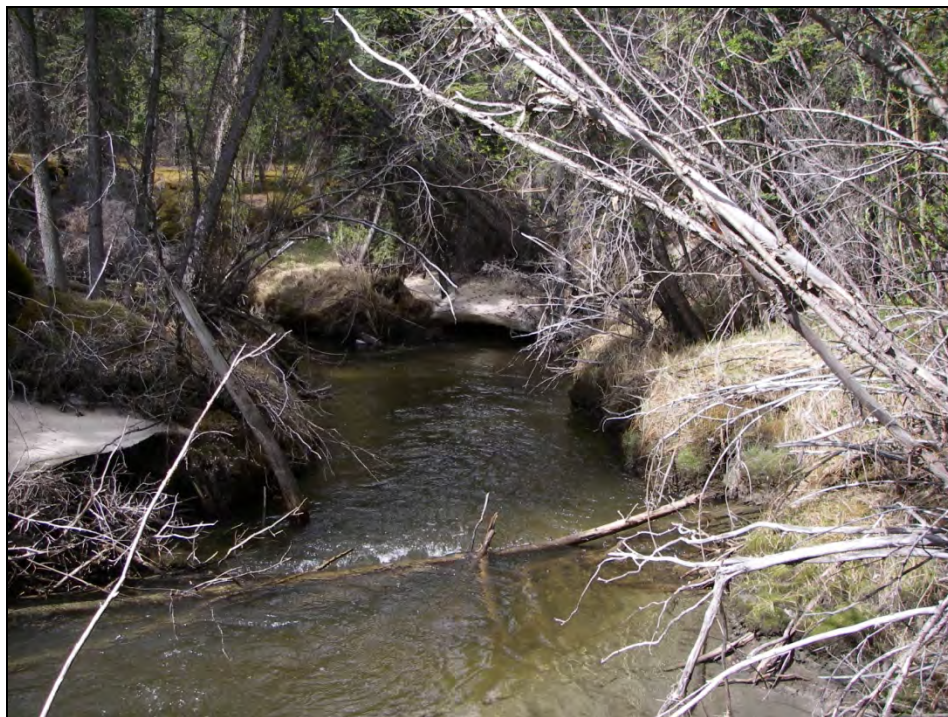
Fish and fish habitat in Swede Johnson Creek, upstream of the highway and wetland complex was investigated as part of the June 2008 site visit. Along this reach the channel width ranged from 2.9 to 5.5 m. Water levels were very high at the time of assessment, and the wetted width ranged from 2.4 to 4.9; the watercourse was nearly at bank full levels (Photo 4). There were a number of pools noted, some as deep as 1.25 m, and average channel depth varied from 0.75 to 1.0 m. Morphology of the stream can be described as riffle/pool, and the bed material was composed of fines with smaller amounts of gravels and cobbles. The channel pattern was irregular meander, and while no islands were noted, there were a number of bars present along stream margins. This reach was coupled with surrounding topography, and frequently confined.

Photo 4. Swede Johnson Creek upstream of highway and wetland complex.

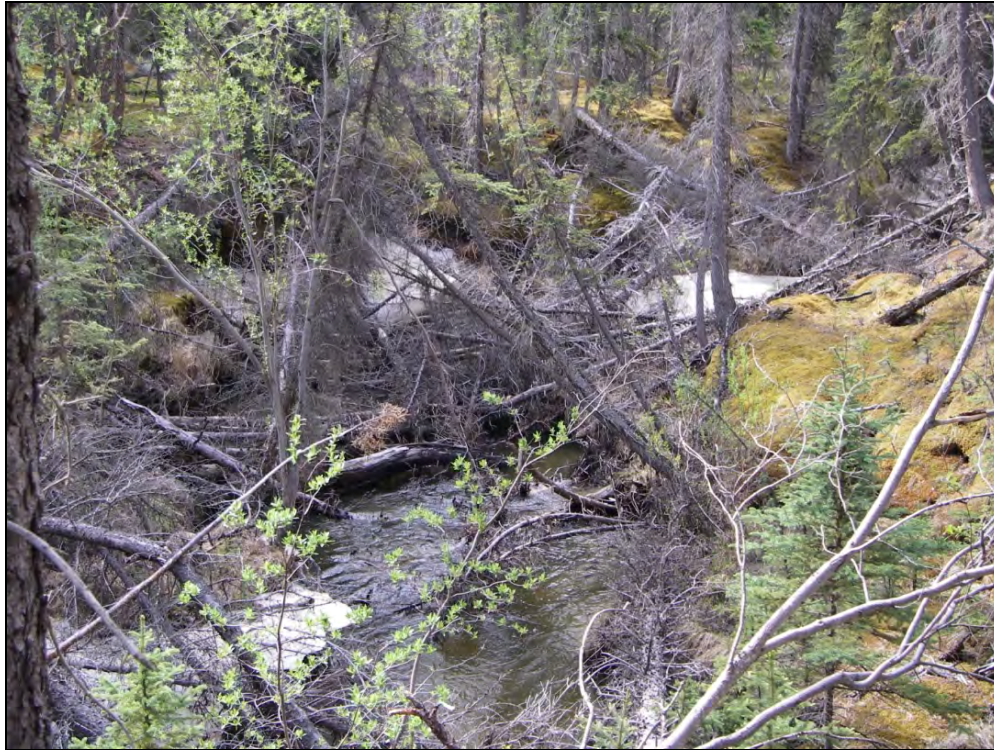
Instream cover was abundant; largely provided by large and small woody debris, with smaller amounts of overhanging banks, deep pools and instream vegetation. Evidence of permafrost melt was present throughout the area, and the resulting slumping of surrounding topography has lead to a large number of trees being uprooted and covering the watercourse (Photo 5). These trees have lead to many small log jams, and large amounts of instream cover.

Photo 5. Large amount of fallen trees surrounding the watercourse.

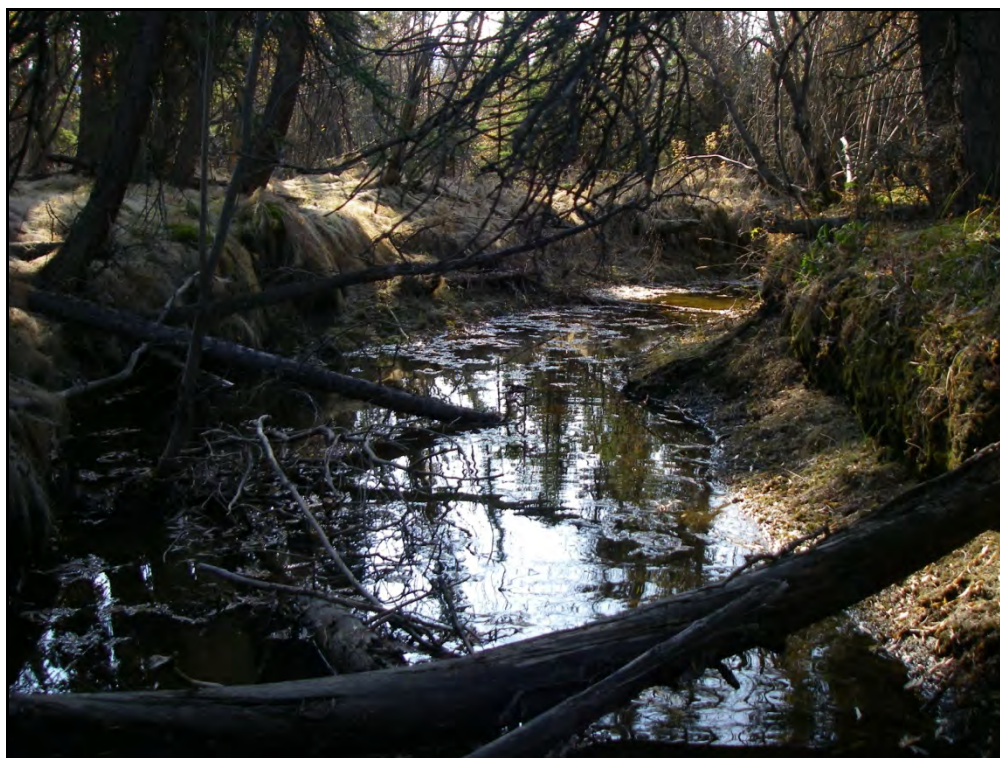
There are some small standing pools of water within the culvert, and some standing water downstream of the culvert. This water is likely due to precipitation and highway runoff. Approximately 100 m downstream of the highway all standing water disappears, leaving a dry, vegetated channel (Photo 7). This dry channel continues until approximately 200 m up from where Tributary 1 enters Swede Johnson Creek. At the confluence of Swede Johnson Creek and Tributary 1 there exists a small woody debris jam which creates a backwater area than extends into the dry Swede Johnson Creek channel (Photo 8 and Photo 9).

Photo 8. Swede Johnson Creek just up from confluence with Tributary 1.

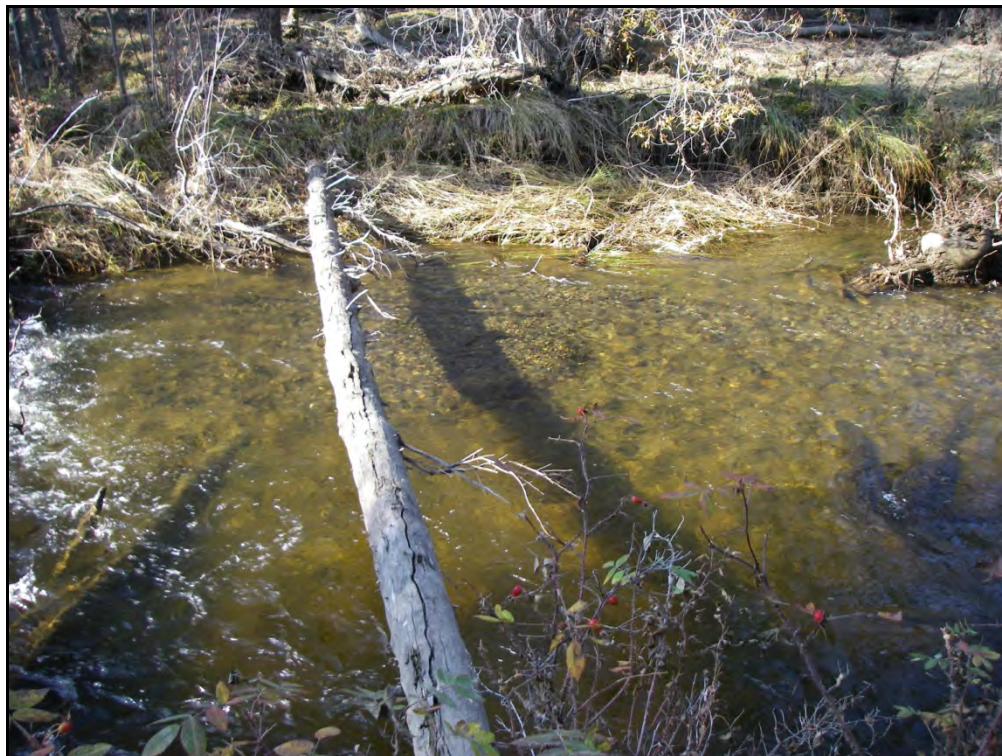
The majority of cover was provided by large woody debris, with smaller amounts provided by small woody debris, undercut banks, and deep pools. Riparian vegetation on both left and right banks consisted of mature coniferous forest, with some marshy wetland areas.

Photo 10. Bed substrate and cover material in lower reach of Swede Johnson Creek

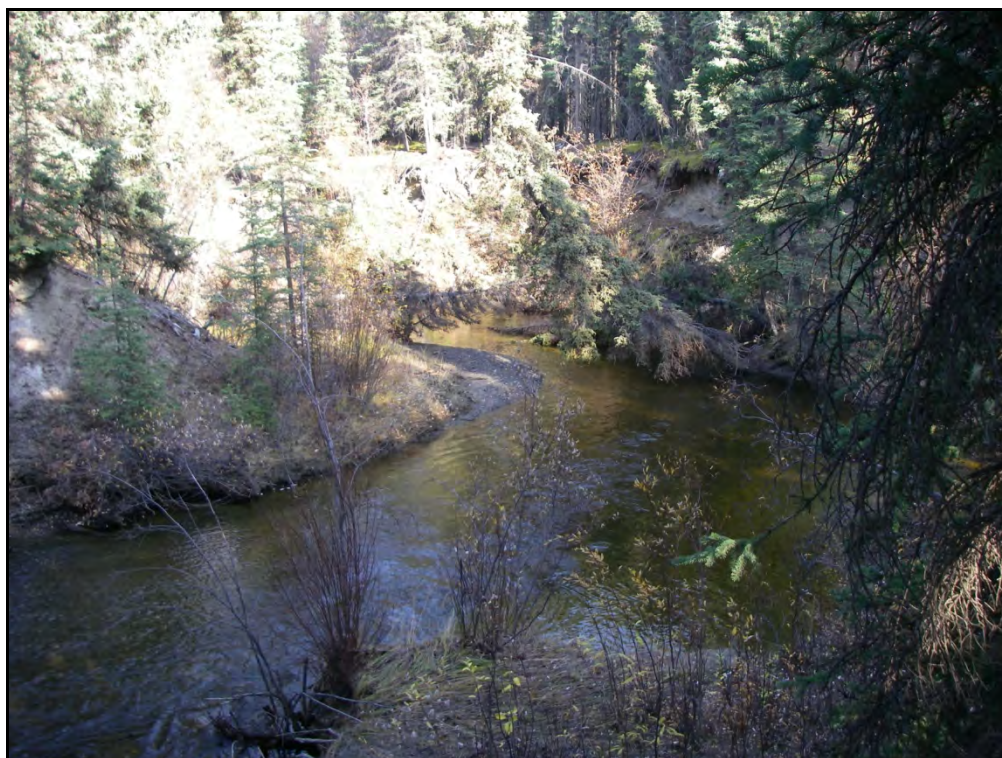
From the Swede Johnson-Tributary 1 confluence downstream to the Kluane River, the Swede Johnson Creek channel poses no barriers to fish migration. The channel width ranged from 5 to 11 m, and the wetted width in September ranged from 4.9 to 6.8 m. The stream channel widened with increasing proximity to the Kluane River. The morphology of the stream was riffle/pool, with a large number of pools present ranging in depth from 0.20 to 0.64 m. Water was clear and the bed material was composed of fines with some sections of gravel and cobble (Photo 10). Bars were present, both mid channel and along the margins throughout the length of the stream. The stream pattern was irregular meandering, and the stream channel partially coupled with surrounding topography (Photo 11).

Photo 11. Channel morphology of Swede Johnson Creek, lower reach.

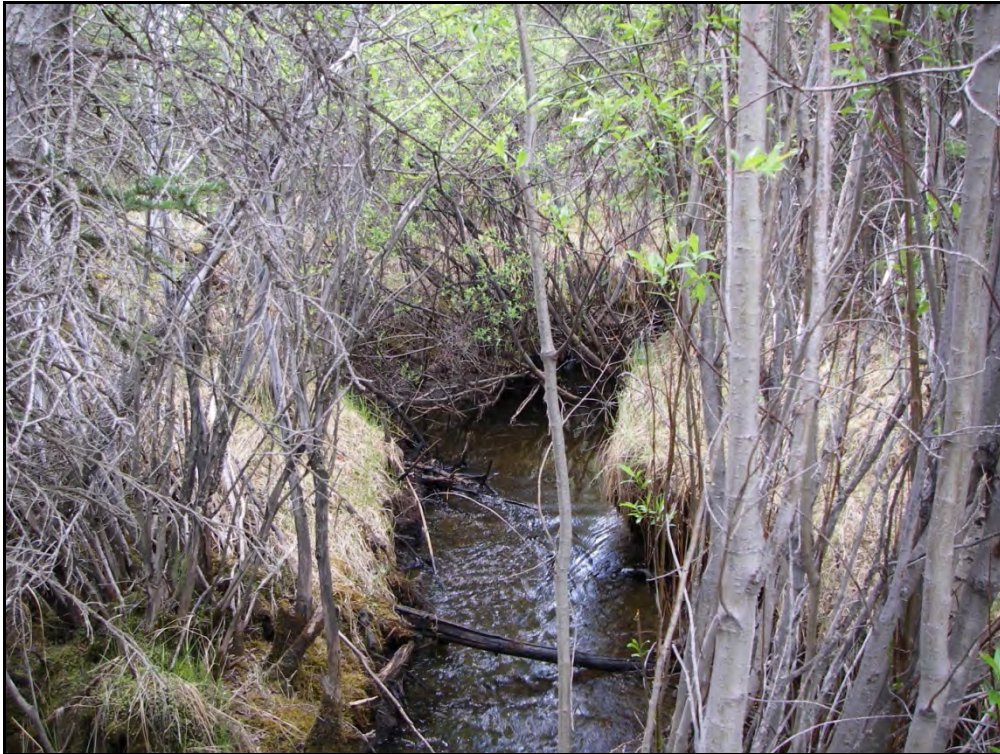
Tributary 1 was investigated at two locations, one upstream (Photo 12) and one downstream (Photo 13) of the highway crossing. Upstream of the highway the channel width ranged from 1.2 to 1.8 m, and the wetted width ranged from 1.10 to 1.97 m. Flooded conditions existed that prevented the channel and wetted width from being measured at the downstream location. Further investigation revealed that this flooding was due to downstream beaver activity. Bed material at the upstream site was composed of gravels with lesser amounts of fines. Where possible to ascertain bed type downstream of the crossing, it appeared to be composed of fines, with a lesser amount of gravels. Upstream of the highway the channel pattern was irregular meander, while downstream it straightened out somewhat to a sinuous pattern. At both sites the channel was occasionally confined.

Photo 12. View of Tributary 1 channel upstream of Alaska Highway crossing.

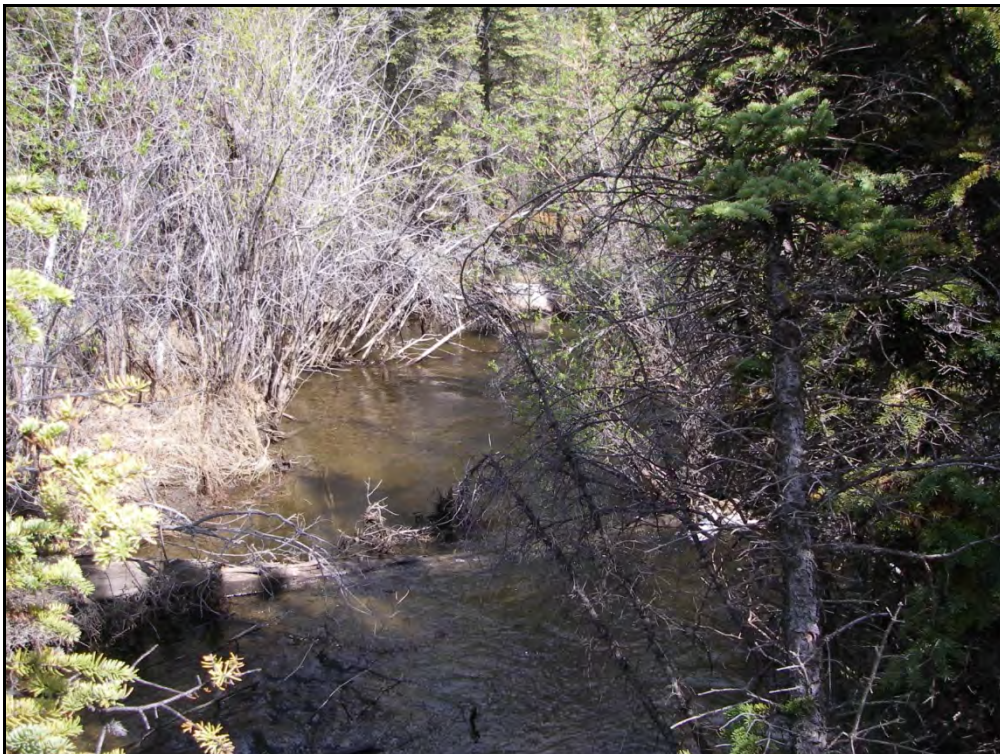
Photo 13. View of Tributary 1 channel downstream of Alaska Highway crossing.

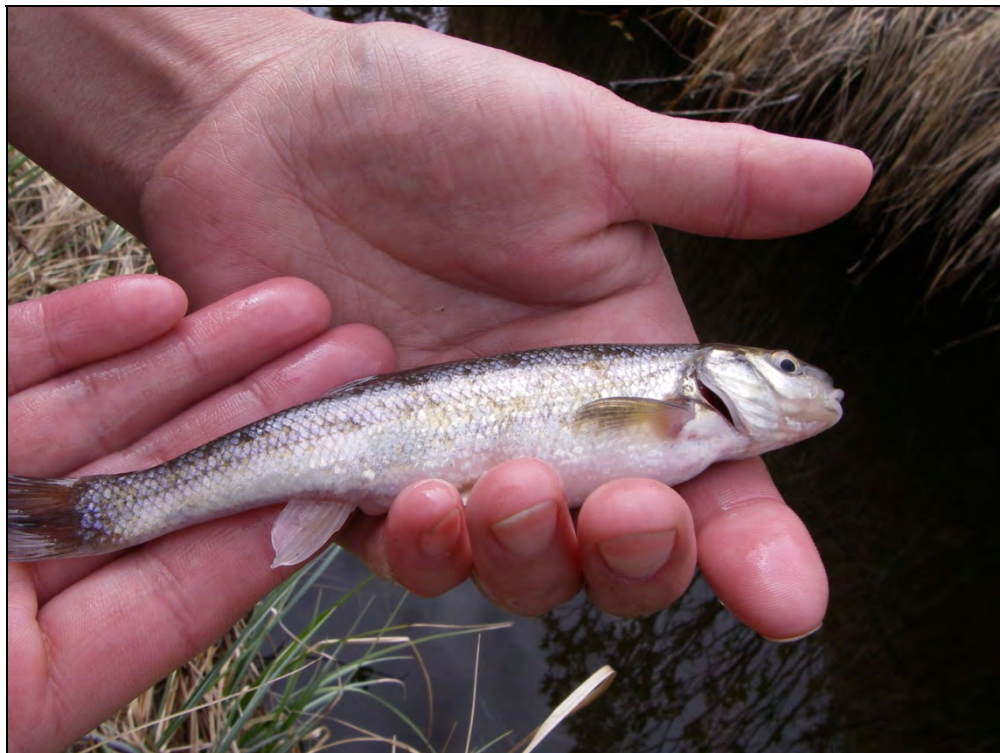
Fish sampling in Tributary 1 was conducted mainly in June with a small additional amount conducted in September (Table 4). A large number of slimy sculpin and lake chub (Photo 14) were captured in the spring, however no Arctic grayling, juvenile or adults, were captured or observed at any time.

Photo 14. Lake chub captured while electrofishing upstream of the Tributary 1 highway crossing.

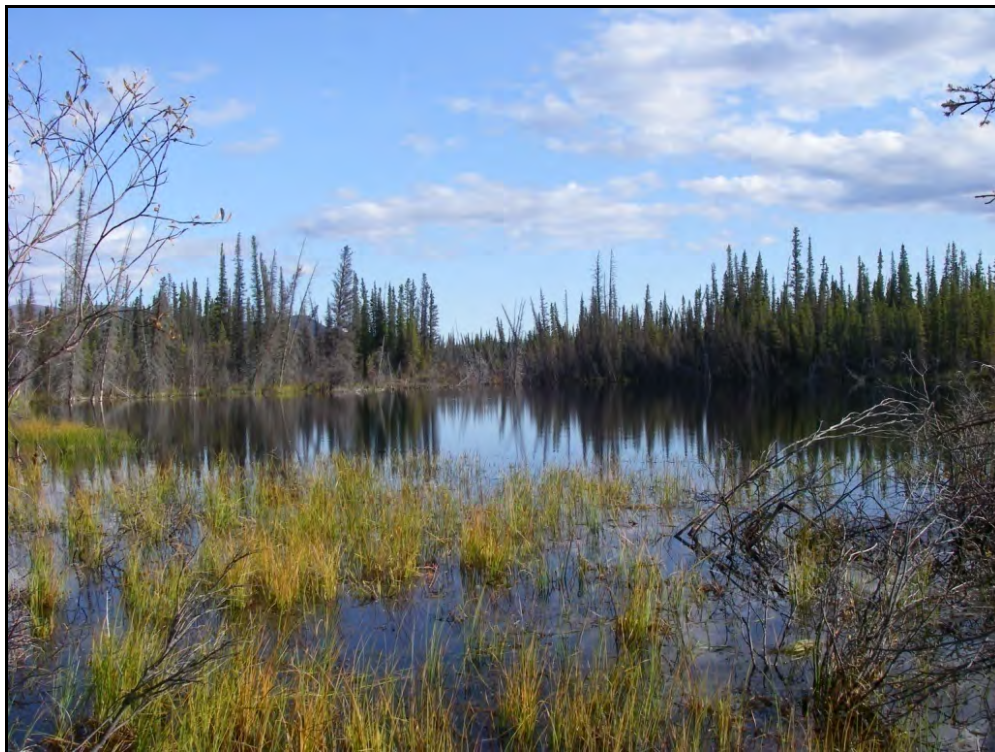
Approximately 500 m downstream from the Tributary 1 highway crossing (km 1799.2), a number of beaver dams have enlarged a pre-existing pond (Photo 15). This pond has beaver dams at both the inlet and outlet. While the upstream dam is not a complete barrier to fish passage (Photo 16), the downstream network of dams is very extensive, and can be considered an obstruction to fish passage (Photo 17).

Photo 15. View of beaver pond along Tributary 1.

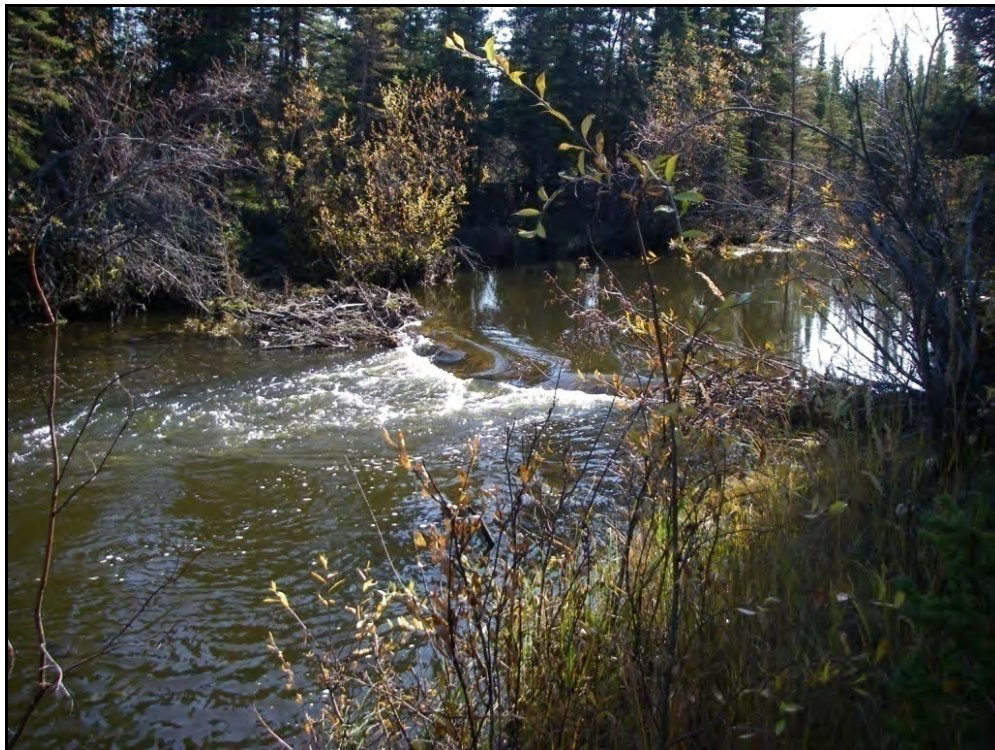
Photo 16. Beaver dam upstream (at inlet) of the pond on Tributary 1.

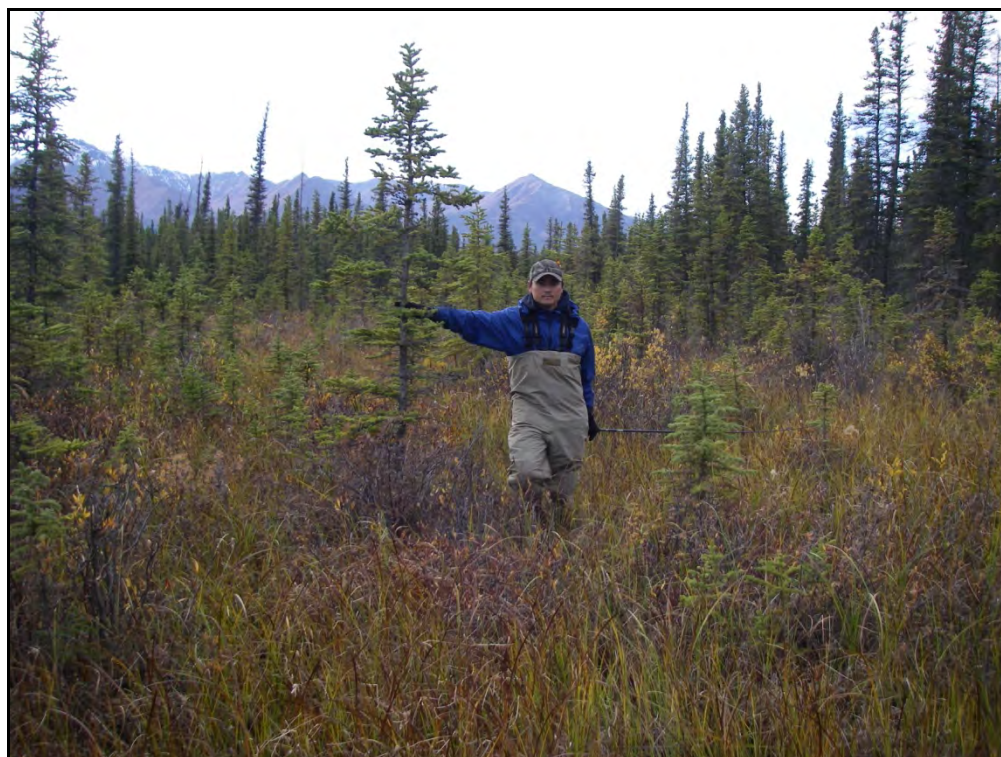
Photo 22. Location of mapped watercourse connecting Waterbody 1 and Tributary 2.

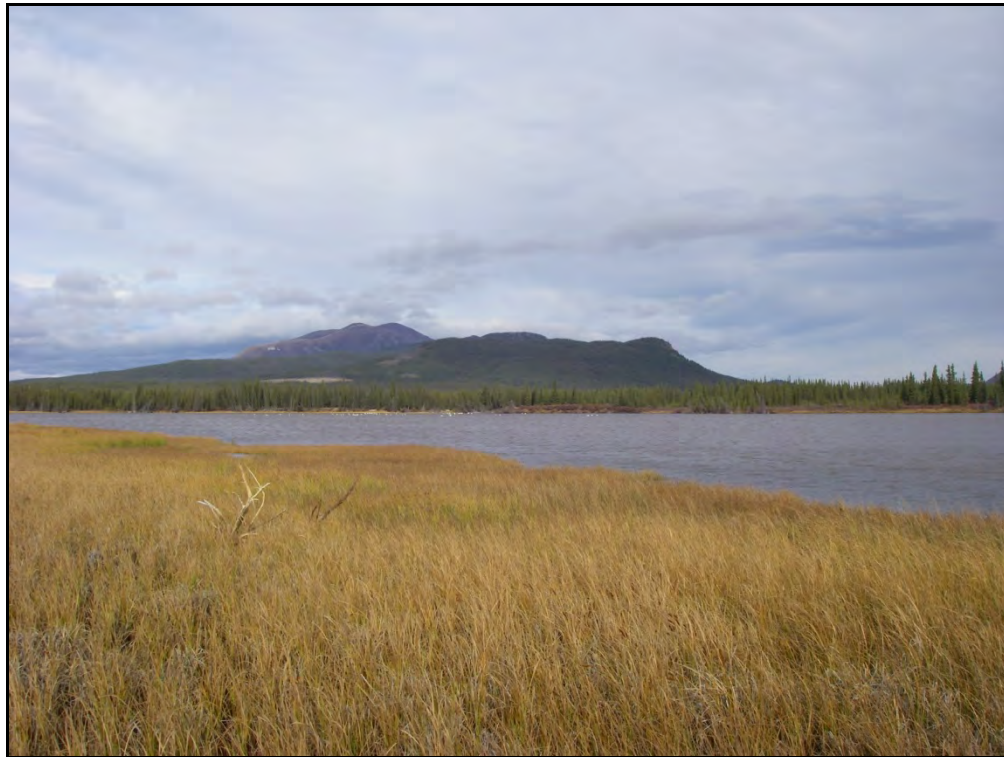
Waterbody 2 is the upstream source of Tributary 2 (Figure 2). This was the largest waterbody of the three investigated (Photo 24). The shorelines were marsh-like, and heavily vegetated with grass species. At the time of investigation there were a number of waterfowl present on the water surface (Photo 24). Water depth was likely deep enough to allow overwintering habitat; however, the series of beaver dams on Tributary 2 preclude any usage of Waterbody 2 by fish species within the Swede Johnson watershed at this time.

Photo 23. Overview of Waterbody 2 and surrounding area.

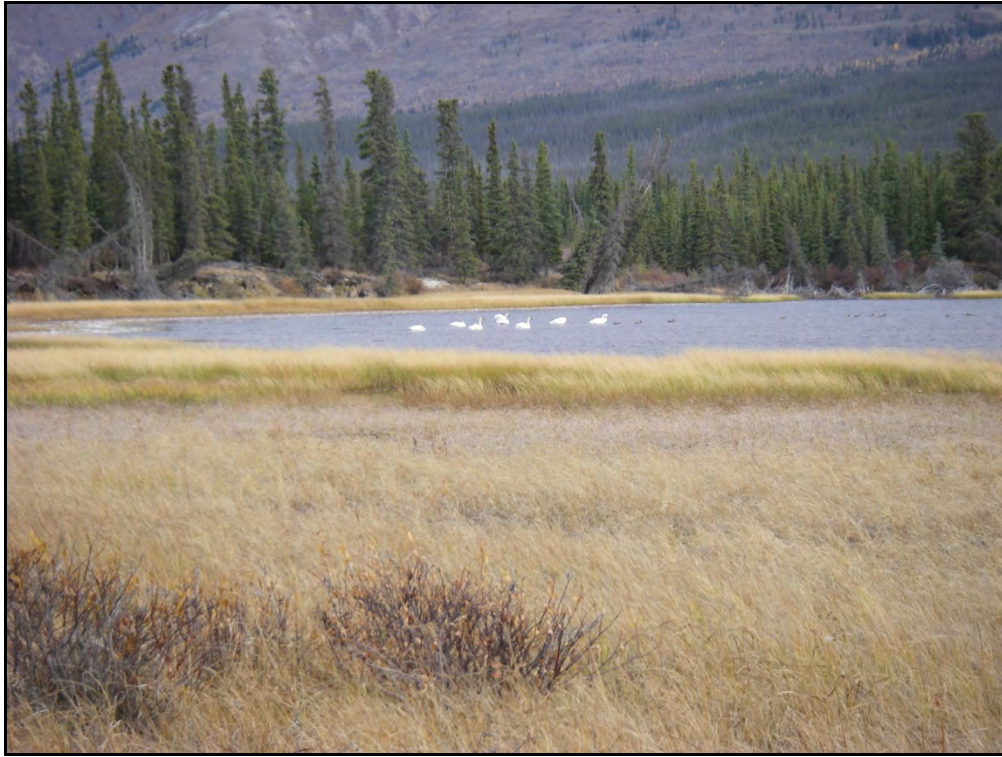
Photo 24. Waterfowl present on the surface of Waterbody 2. Also, note wetland vegetation along shorelines.

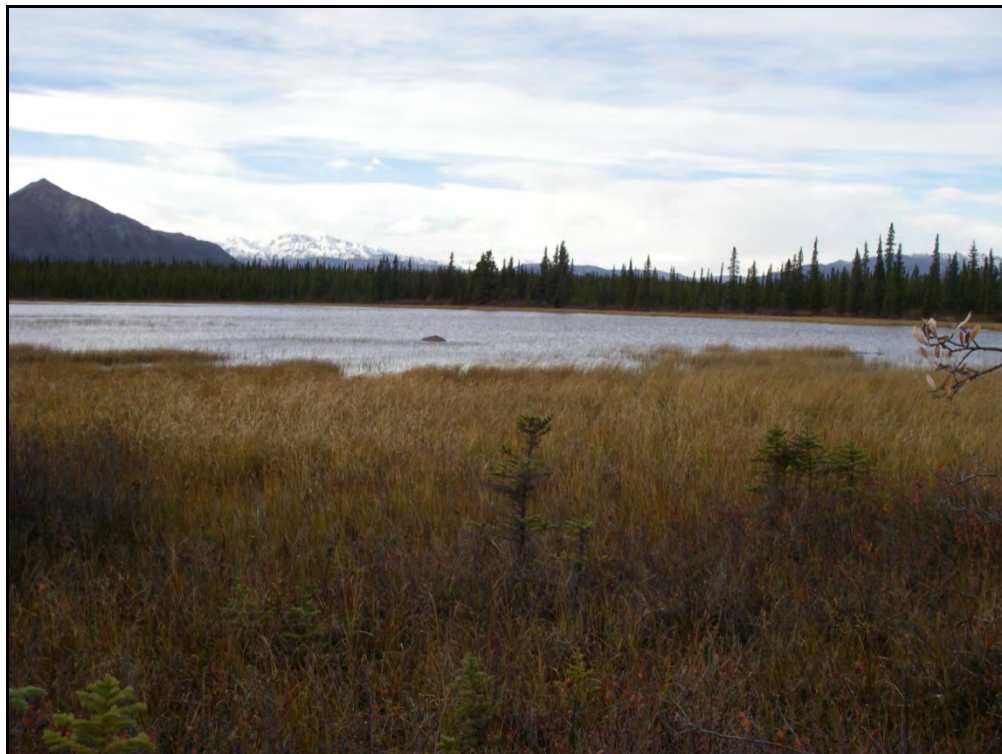
Waterbody 3 is upstream from Waterbody 2, and is located on the opposite (west) side of the Alaska Highway. This is another small, shallow waterbody, heavily vegetated with grasses along the margins (Photo 25). The watercourse that links Waterbody 2 and Waterbody 3 is heavily vegetated, and unlikely to be used by fish species. The tall grass growth in the channel indicates that water does not flow continuously through the channel (Photo 26). Waterbody 3 provides overwintering opportunities for fish in the lower Swede Johnson watershed.

Photo 25. Overview of Waterbody 3.

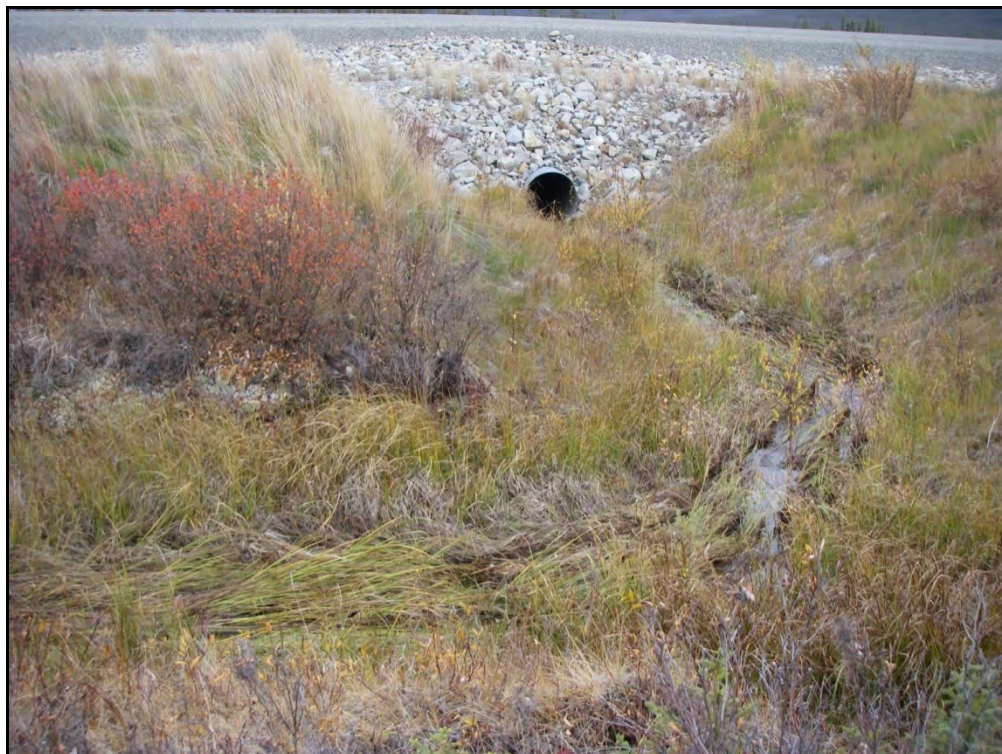
Photo 26. Watercourse linking Waterbody 3 with Waterbody 2.
